Roseland Community Building: Historic Preservation Assessment

September 3, 2019

Current Photographs
of the Roseland Community Building

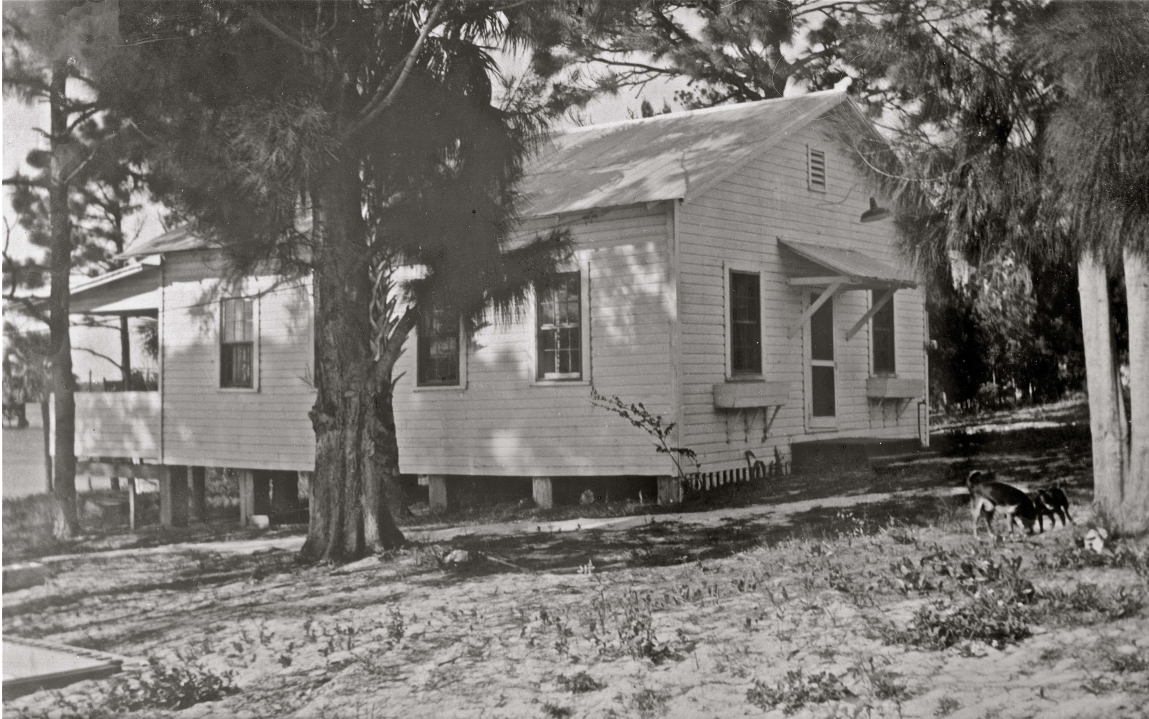
Roseland Community Building, c. 1930s. Source: Roseland Women's Club

Several changes have been made to the Roseland Community Building over time including the removal of the original bracketed awning over the front entry, as well as removal of the two window boxes originally located beneath each of the windows on the front façade. Additionally, as seen in the c. 1930 photograph above, there was a decorative wood scroll at the peak of the roof at the top of gable on the front façade. These simple architectural features could be replicated based on the available historic photographic documentation. In order to more authentically restore the character of this historic building, we suggest reconstructing each of these elements.
