FINAL STRUCTURAL REPORT

Roseland Community Center
12973 Bay Street
Sebastian, Florida 32958

Engineer's Project # 17-0201

August 15, 2017

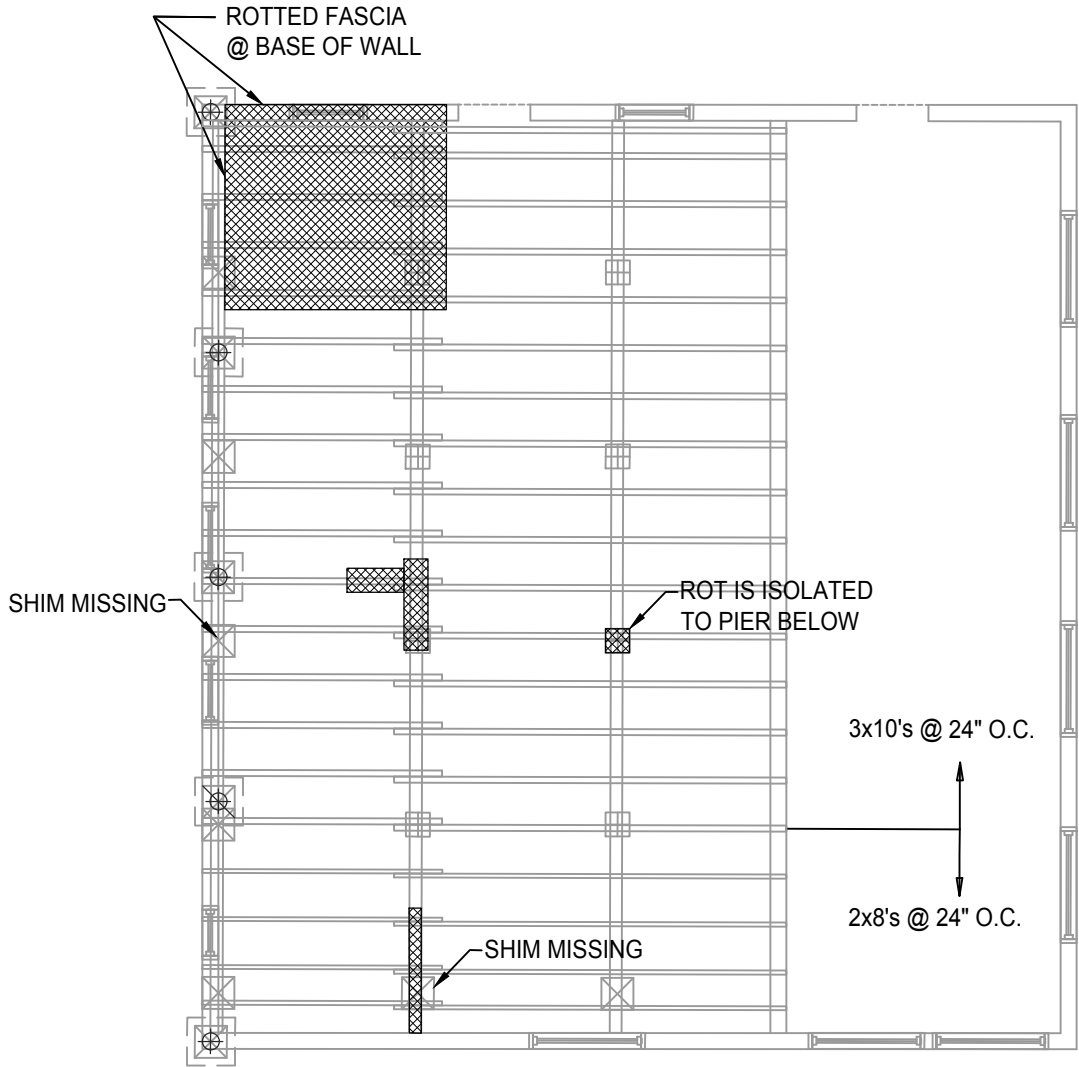
FLOOR FRAMING PLAN

- The floor system is composed of a wood finish above wood sheathing. This is on 3 x 10 or 2 x 8 members dependent on location. These members bear on 6x6 beams which then bear on either masonry or wood piers.
- Damages seen in the floor system were primarily deteriorated sections of the wood components due to termites. This type of damage was primarily found on the east side of the structure. Some members also exhibited rotting due to fungus accelerated by water damage. This could be seen in the wooden pier noted on the plans as well as a few floor members.
- One 6 x 6 member was not properly shimmed to the masonry pier below.
- One 6 x 6 member was not properly shimmed to the wooden pier below.

ROTTED MEMBERS/SHEATHING

- All rotted floor framing components shall be removed and replaced with new code compliant members. All floor sheathing in these areas shall also be removed and replaced appropriately. In order to have full access a great portion of the sheathing will have to be removed.
- Shims need to be installed at the locations noted on the plans in Appendix A.
- While the drywall is removed from the interior walls MBV Engineering, Inc. recommends jacking up the structure to bring the interior floor slopes within 0.5% slope. MBV Engineering, Inc. recommends bringing the structure up until no point is less than 1.25 inches beneath the zero set during the original investigation. The areas which need to be lifted are marked on the plans seen on sheet S6 in Appendix B.

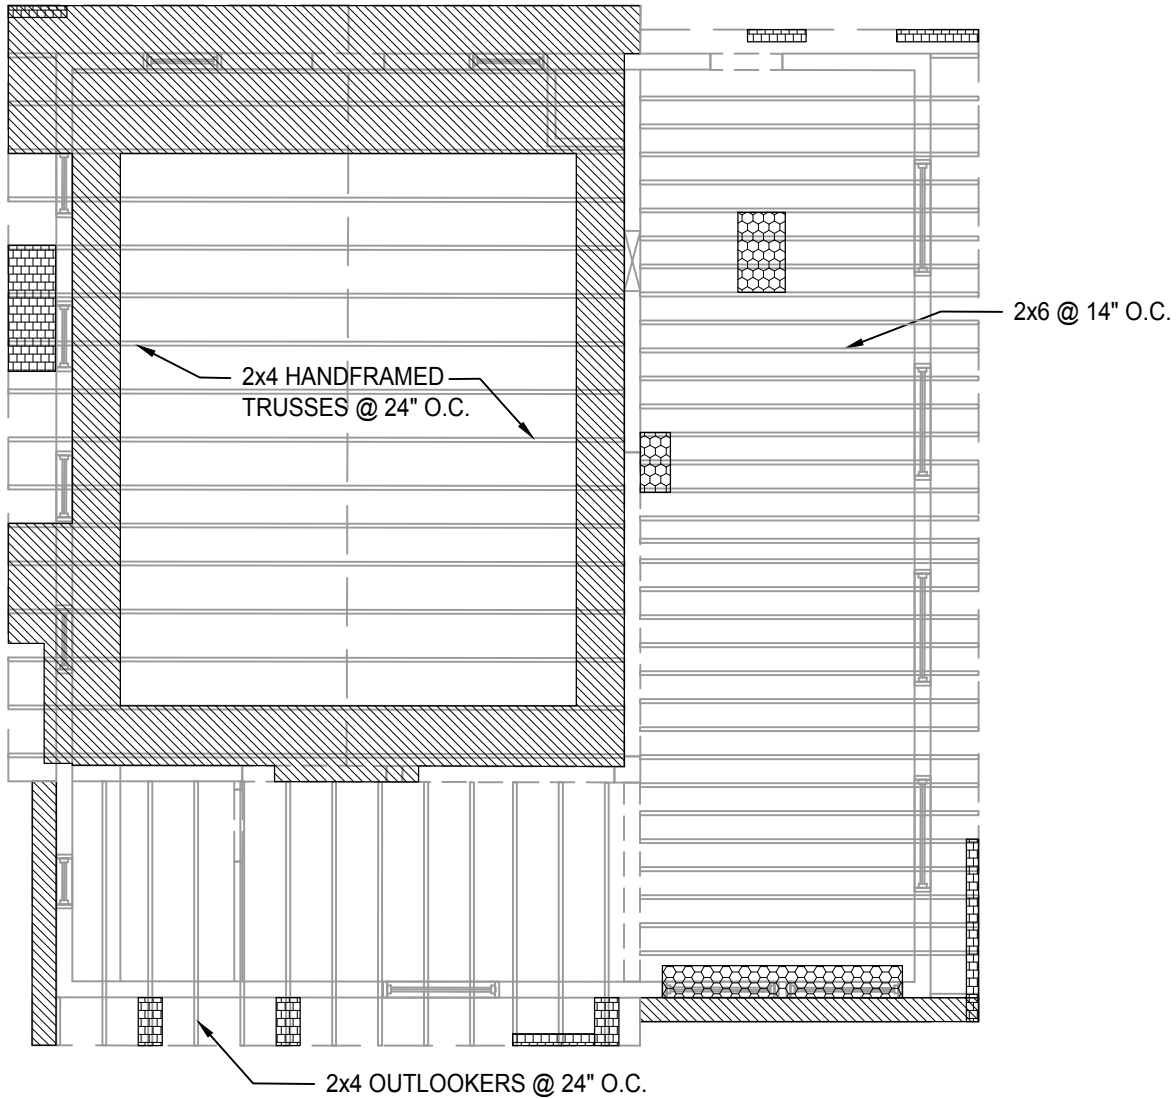
ROOF FRAMING PLAN

- The torch down roof on the west side of the structure exhibited multiple air pockets and the seams of the roof need to be resealed. The ceiling underneath the west flat roof showed signs of previous moisture intrusion into the structure in the form of water stains. At one of the laps on the west roof, a section of the torch down roof was peeling away. This roof area represents 34.1% of the total area.

- Multiple areas on the overhangs were damaged and are noted on the plans. This damage is seen on the sheathing, members, and fascia.

ROTTED MEMBERS/FASCIA
-

ROTTED SHEATHING
-

PREVIOUS MOISTURE DAMAGE

- MBV Engineering, Inc. proposes an entire reroof be performed. The Florida Building Code – Existing Building section 706.1.1 states, “Not more than 25 percent of the total roof area or roof section of any existing building or structure shall be repaired, replaced or recovered in any 12-month period unless the entire existing roofing system or roof section is replaced to conform to requirements of this code.” MBV Engineering, Inc. believes the amount of damages to the members and sheathing will encompass more than 25% of the roof area and due to this an entire reroof is necessary. Where marked on the plans roof sheathing needs to be replaced and nailed per the schedule on sheet S3 in Appendix B. We recommend keeping the same type of roofing systems on the different areas. Roofing materials shall be installed in accordance with current code requirements.

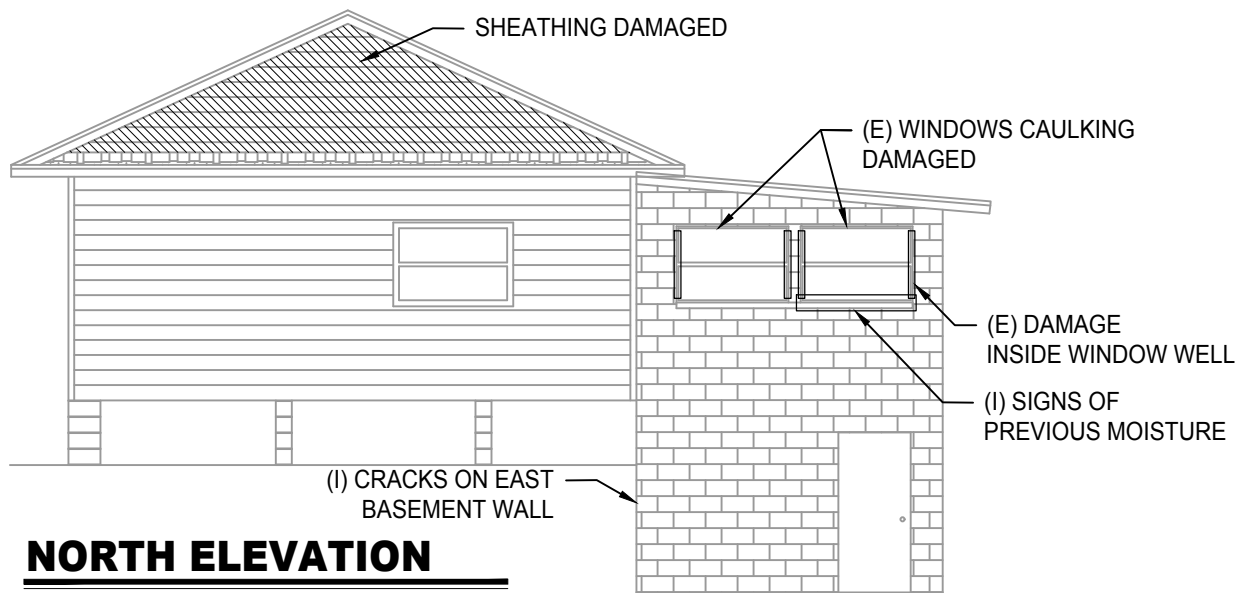
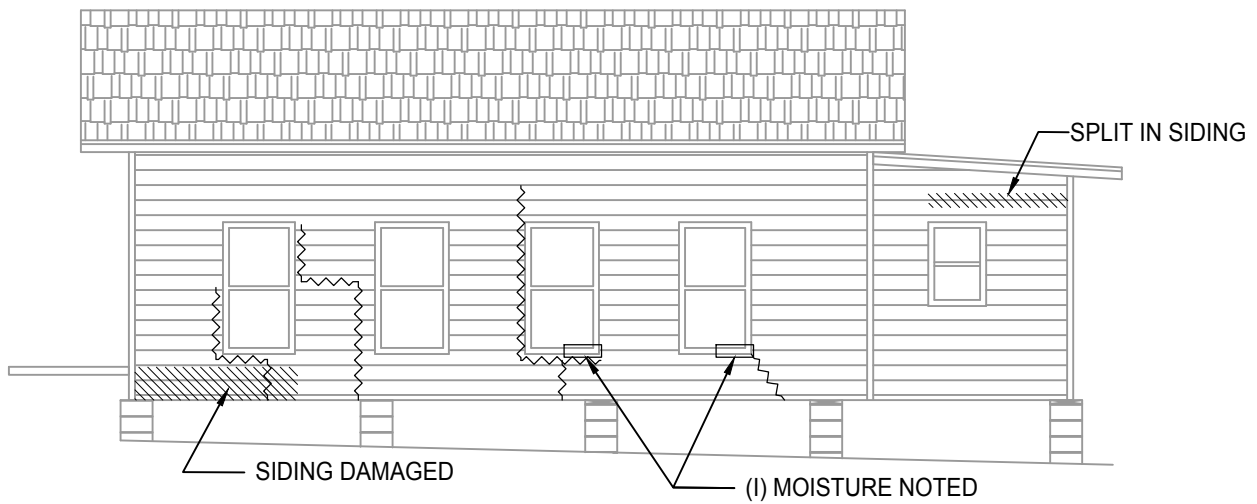
ELEVATIONS

- The drywall on the exterior walls is cracking in multiple areas. The majority of the cracks are limited to the eastern wall with the south showing a few cracks as well. MBV Engineering, Inc. attributes these cracks to the excessive settlement the building experienced as well as to the foundation reinforcement project.

- The lap siding on the exterior of the structure is showing some areas of moisture damage. The majority of the paint which protects the structure is peeling away and will need to be redone.

- Multiple areas were found to be missing proper insulation in the frame walls.
- The north gable wall has multiple damaged members, as well as damaged sheathing.

- MBV Engineering, Inc. recommends the complete removal and replacement of all interior drywall on the east and south wall. During this process all wall members should be reviewed for any possible damages due to termites or moisture and should be removed and replaced as deemed appropriate. Also, any areas missing insulation shall have insulation installed.

- The north gable wall shall be repaired and if appropriate retrofitted per the Florida Building Code – Existing Buildings 5th Edition. The sheathing on this gable end has been determined to be of poor condition and will require an entire replacement. An entire rebuild of this wall should be considered.

- The lap siding on the wood framed structure is damaged in many areas and will need to be removed and replaced in these areas. Also, all of these walls will need to be repainted. We estimate 35% of the siding will require replacement. All of the walls shall be water blasted, cleaned, sealed and then repainted with an acrylic paint.

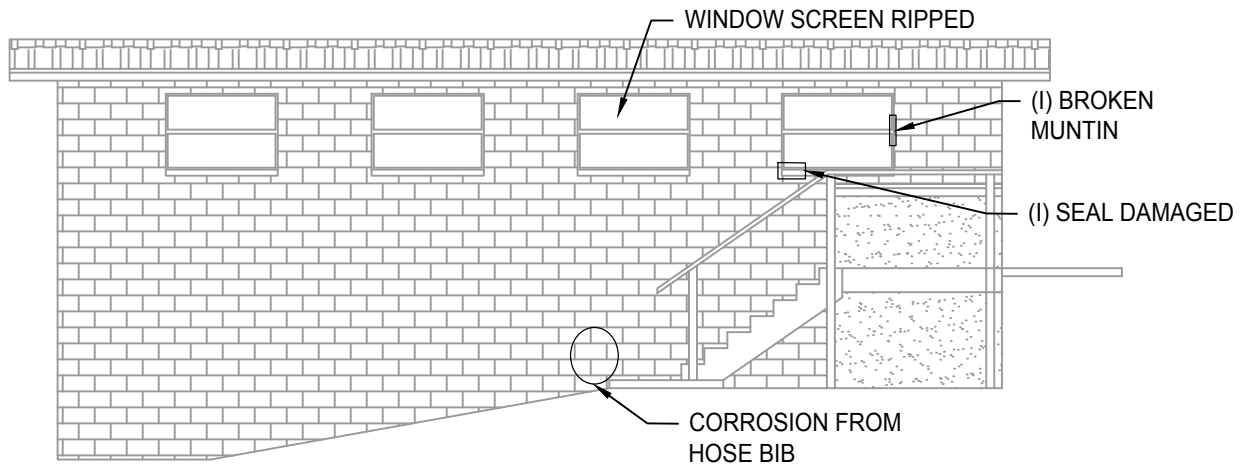
WEST ELEVATION

- MBV Engineering, Inc. performed an exterior elevation survey at the south side of the structure to determine current ADA compliance with the sidewalk slopes and to determine the current nature in which water drains in this area.
- The stairs to the west of the structure are currently out of level and the risers are not within code tolerances.
- A block structure hiding a water system was found on the west side of the structure between the stairs and the western wall. This system being on the exterior of the building with no entry door and no permanent roof is not code compliant.

- The stairs on the west side of the structure shall be removed and properly redesigned and built to meet all of today's codes and standards. As they currently stand, the stairs are not code compliant and also un-level.

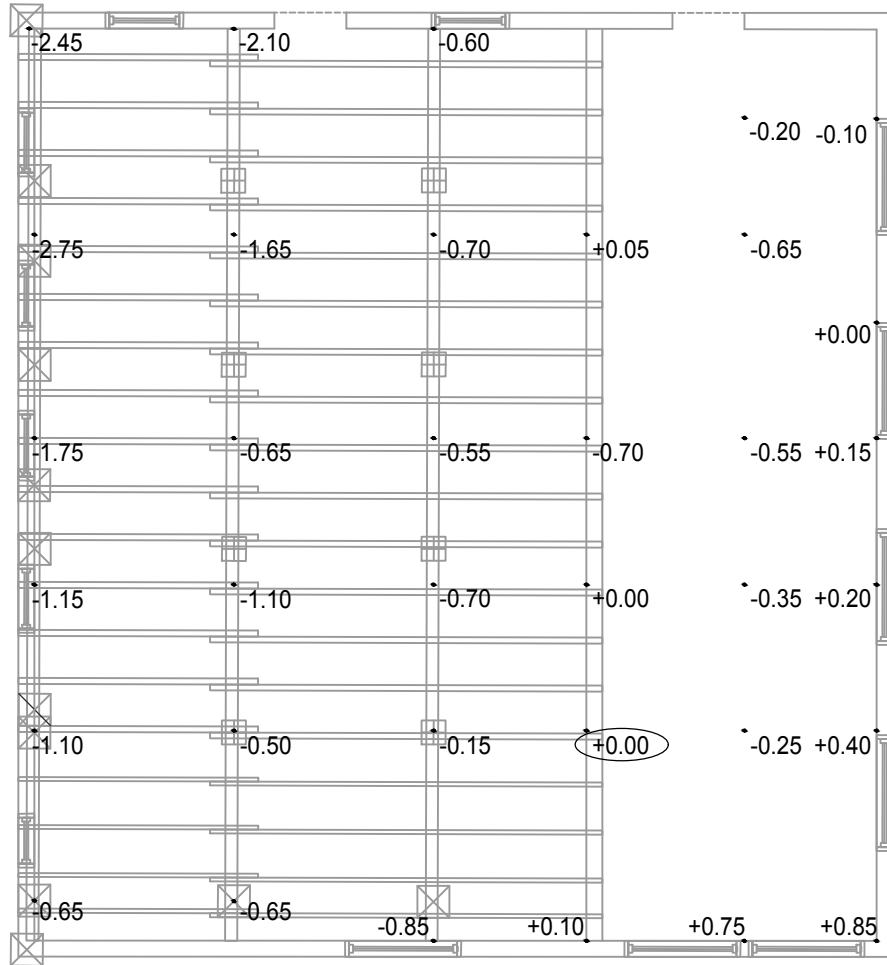
INTERIOR
 ELEVATION PLAN

- MBV Engineering, Inc. performed an interior elevation survey to determine if the current floor slopes within the structure meet the ADA standards of not exceeding 1 unit vertical for every 48 units horizontal. An attached topographic map of the floor system can be seen and it was noted at the time of an inspection there is a 2" drop off in the southeast corner of the structure. After our investigation MBV Engineering, Inc. has determined the floor slopes are within the ADA tolerances.

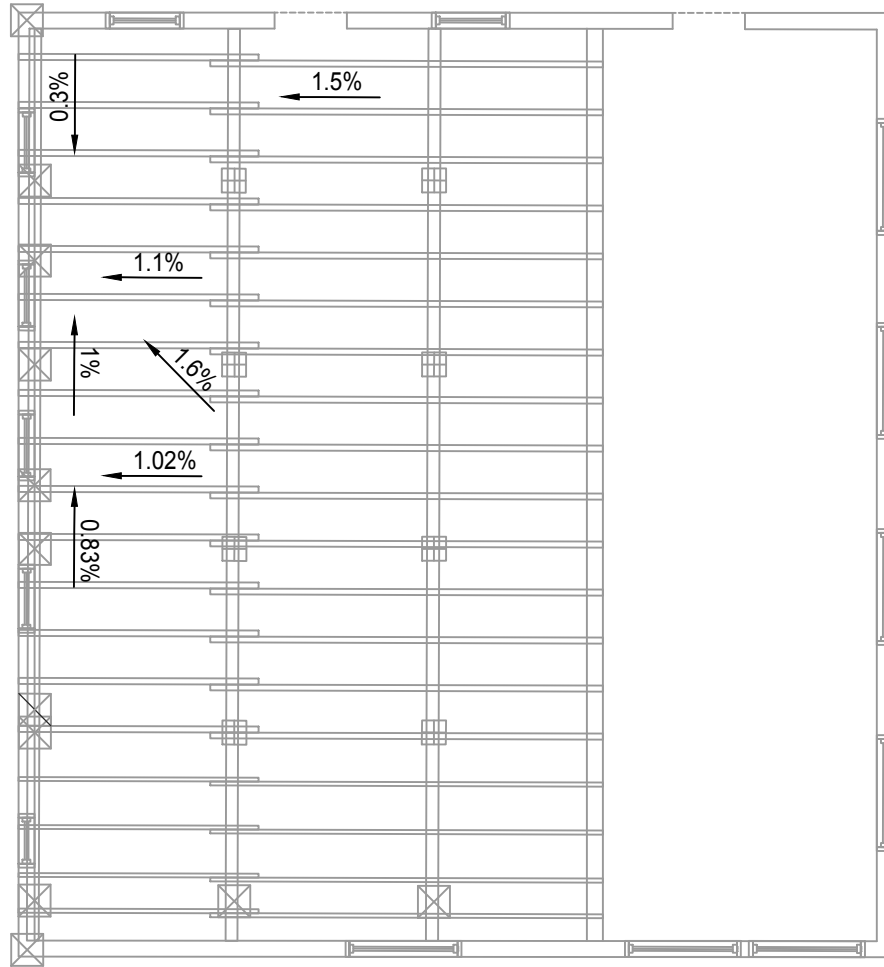
INTERIOR
SLOPE PLAN

AREA THAT EXCEEDS THE LIMIT

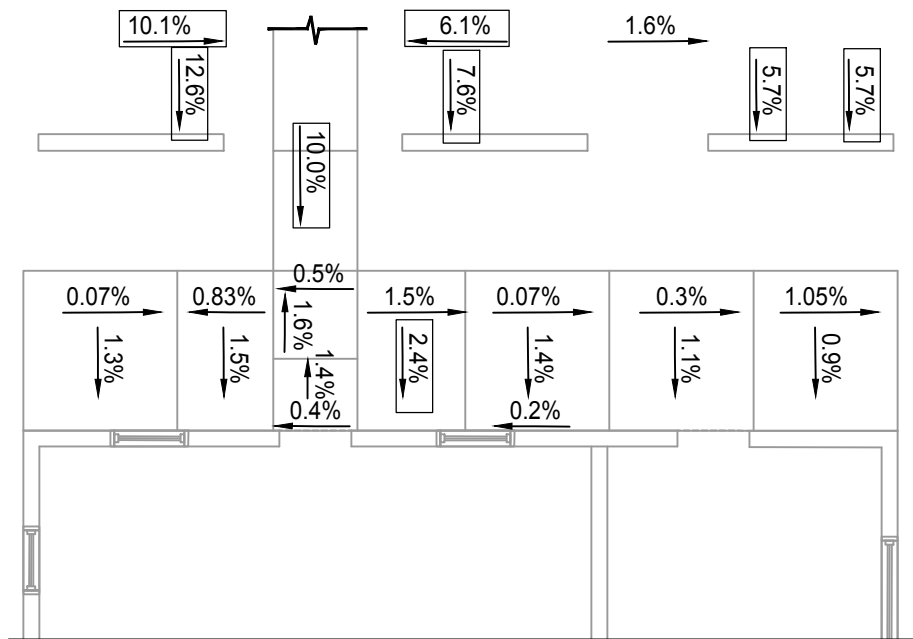
EXTERIOR
SLOPE PLAN

AREA THAT EXCEEDS THE LIMIT

- The exterior findings show the adjacent parking lot and sidewalks are all sloping towards the structure. It appears this is contributing to the rotted sheathing at the bottom of the structure as well as the erosion of the slope seen at the southeast corner of the structure at the time of inspection. MBV Engineering, Inc. proposes installing a block retaining wall or concrete curb and leveling off the parking area. This wall will also aid in preventing water from sheet flowing towards the structure and down the adjacent slope to the back of the structure. MBV Engineering, Inc. also proposes adding a storm water inlet and piping system to carry water past the eastern slope to help combat future erosion problems. The location of these items can be seen on sheet S7 in Appendix B.

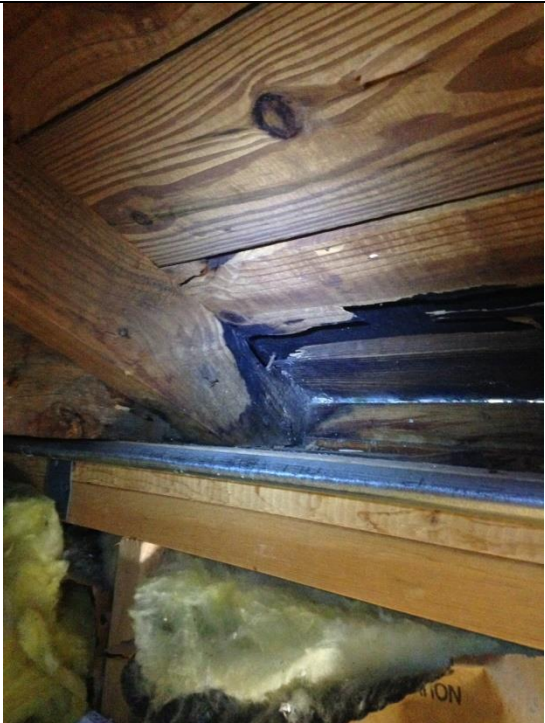
Picture No.: 1	DESCRIPTION: Damaged roof sheathing and member

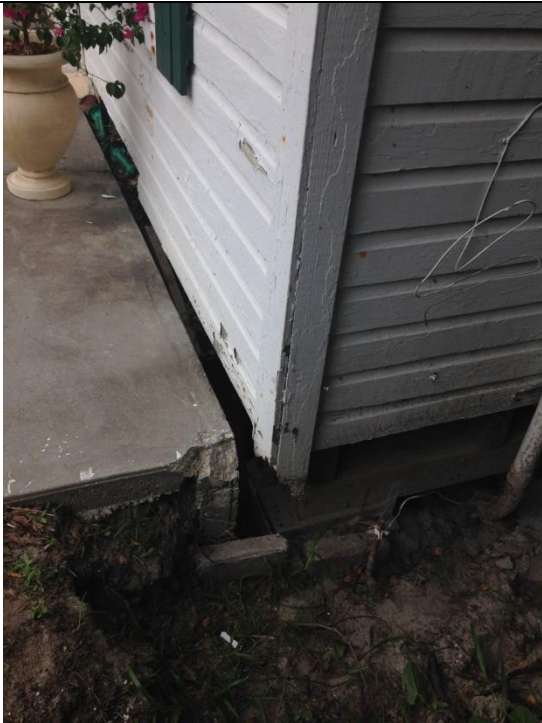
Picture No.: 5	DESCRIPTION: Damaged wall sheathing, signs of erosion and settlement in sidewalk

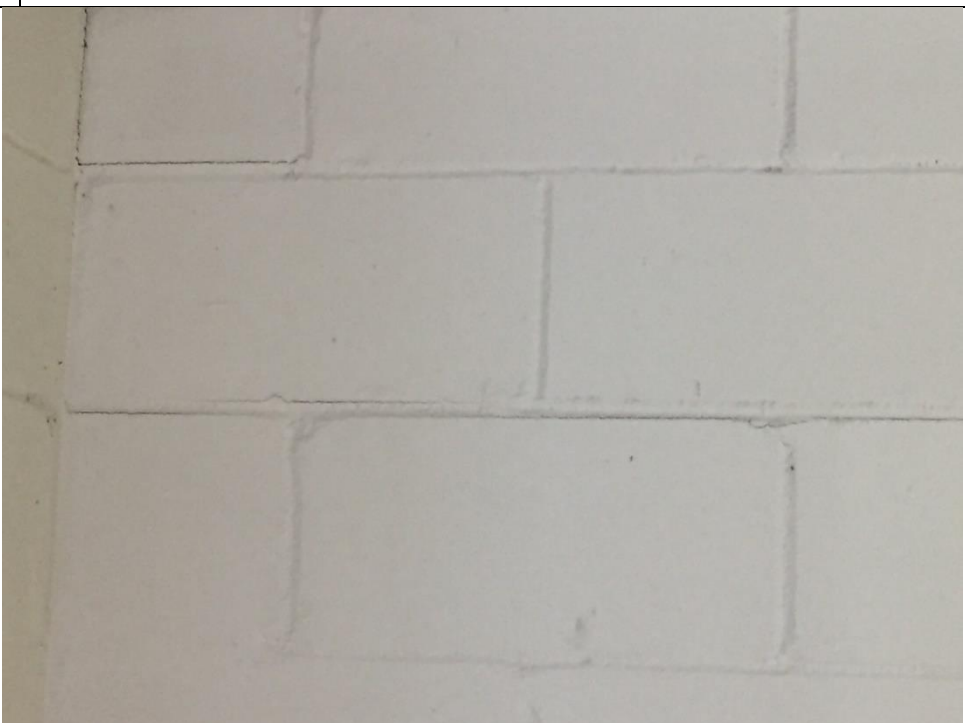
Picture No.: 10	DESCRIPTION: Cracks in basement wall

- The cracks in the masonry walls shall be patched with appropriate epoxy materials per manufacturer's recommendation based on crack width and depth at each area. Caulking the cracks smaller than 1/8" with an appropriate sealant is very important in reducing potential damage to the structural components and also in preventing moisture from entering the structure.

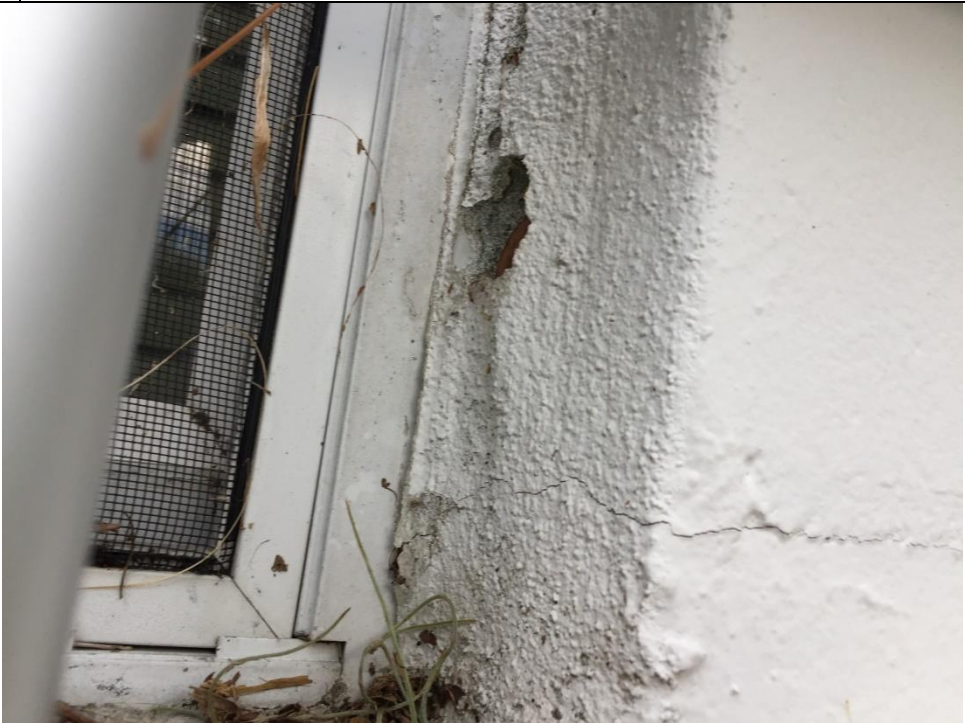
Picture No.: 11	DESCRIPTION: Damaged stucco and peeling sealant

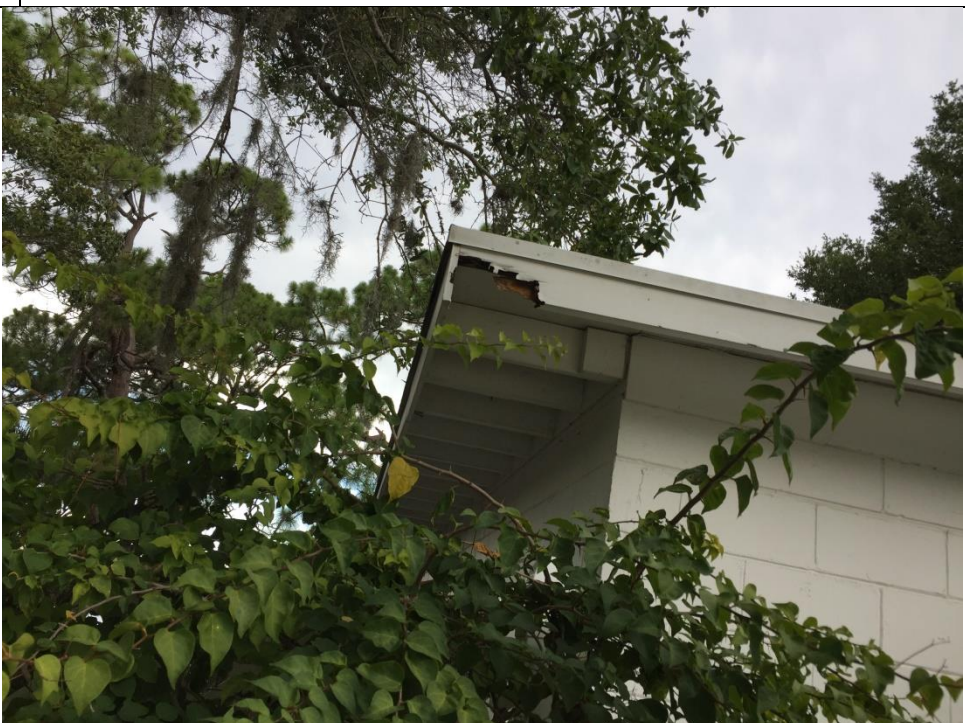
Picture No.: 12	DESCRIPTION: Damaged fascia

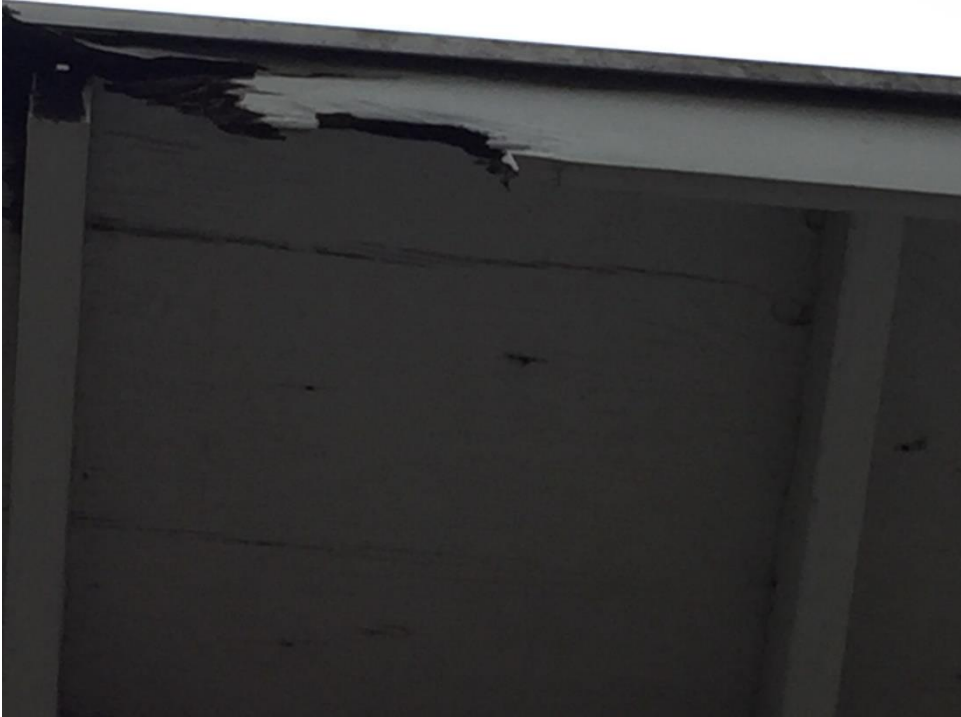
Picture No.: 13	DESCRIPTION: Damaged fascia

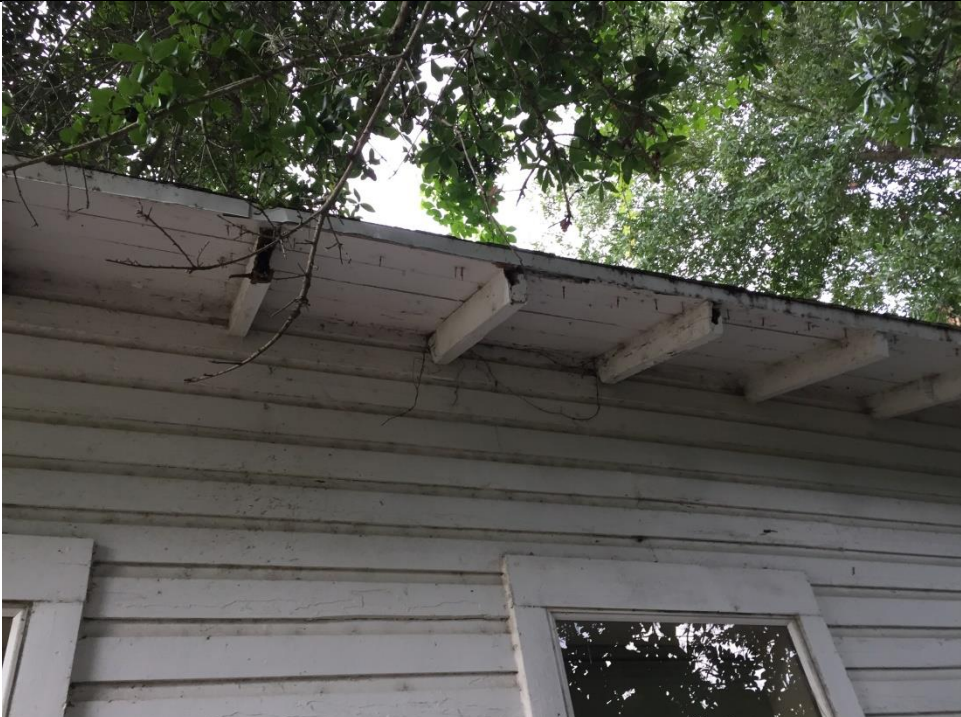
Picture No.: 14	DESCRIPTION: Damaged roof members and sheathing

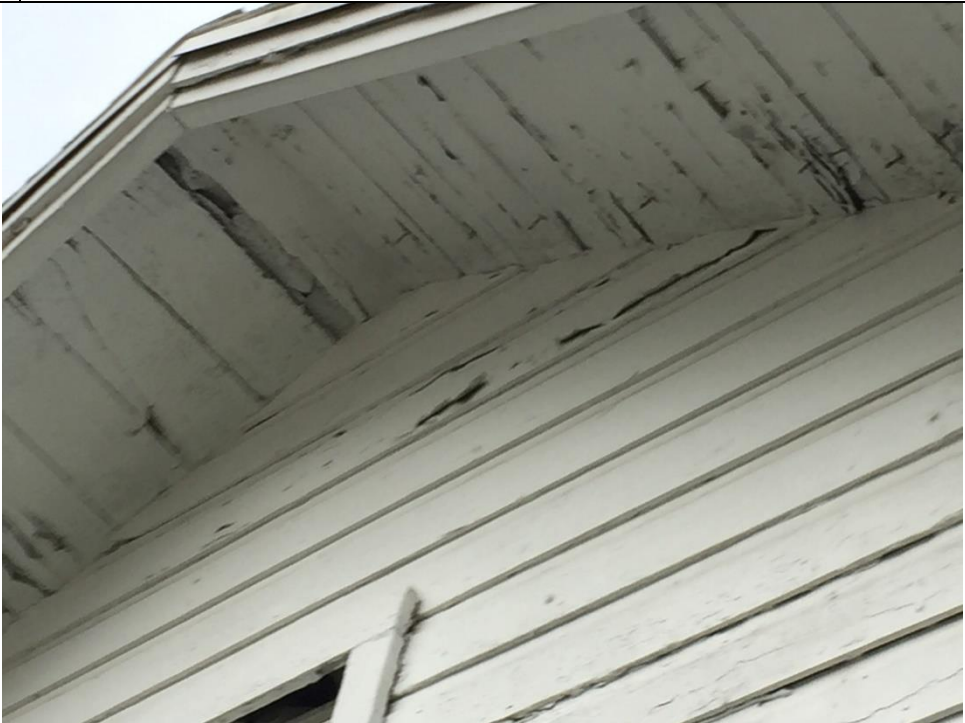
Picture No.: 15	DESCRIPTION: Damaged sheathing, damaged fascia, and peeling paint
