FINAL STRUCTURAL REPORT

Roseland Community Center
12973 Bay Street
Sebastian, Florida 32958

Engineer's Project # 17-0201
August 15, 2017

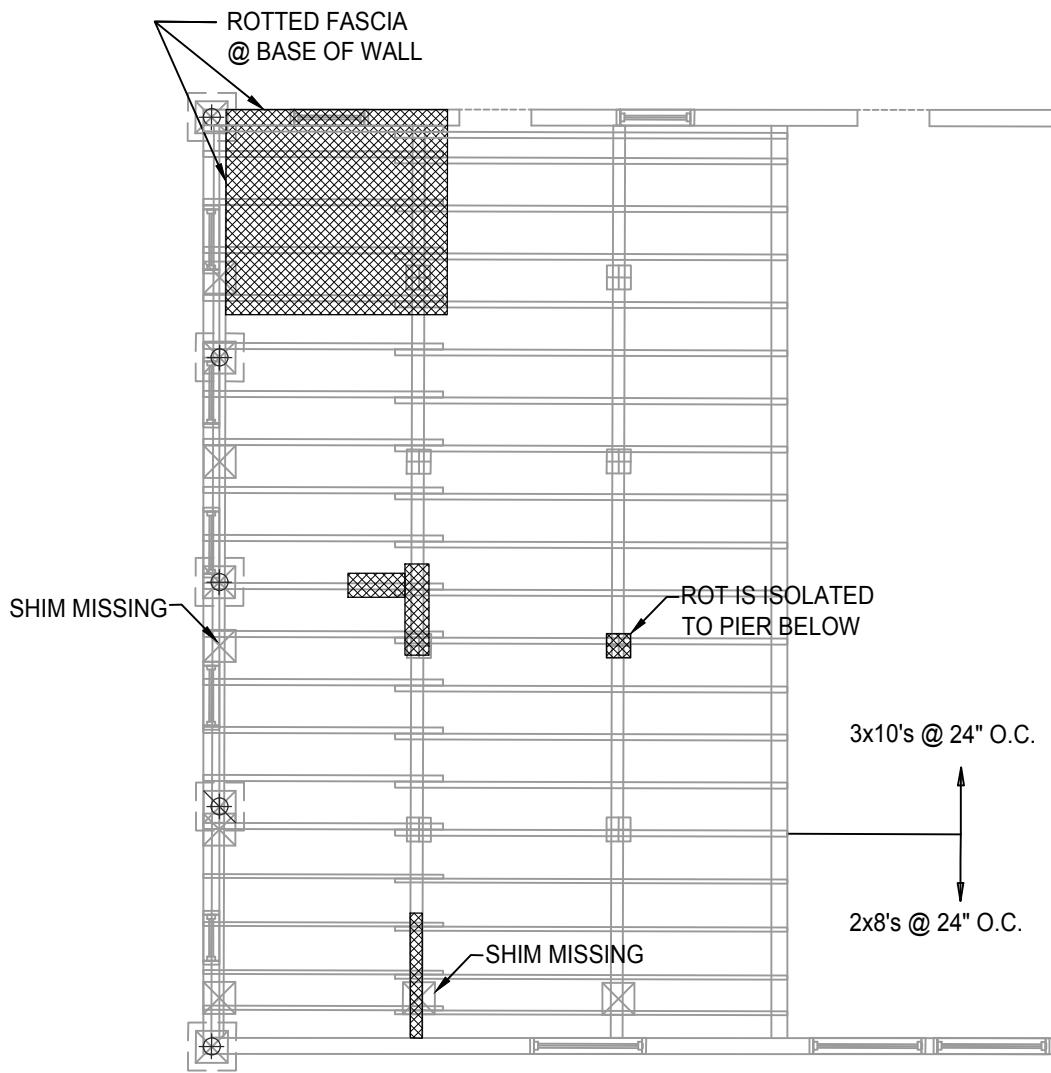
FLOOR FRAMING PLAN

- The floor system is composed of a wood finish above wood sheathing. This is on 3 x 10 or 2 x 8 members dependent on location. These members bear on 6x6 beams which then bear on either masonry or wood piers.
- Damages seen in the floor system were primarily deteriorated sections of the wood components due to termites. This type of damage was primarily found on the east side of the structure. Some members also exhibited rotting due to fungus accelerated by water damage. This could be seen in the wooden pier noted on the plans as well as a few floor members.
- One 6 x 6 member was not properly shimmed to the masonry pier below.
- One 6 x 6 member was not properly shimmed to the wooden pier below.

- All rotted floor framing components shall be removed and replaced with new code compliant members. All floor sheathing in these areas shall also be removed and replaced appropriately. In order to have full access a great portion of the sheathing will have to be removed.
- Shims need to be installed at the locations noted on the plans in Appendix A.
- While the drywall is removed from the interior walls MBV Engineering, Inc. recommends jacking up the structure to bring the interior floor slopes within 0.5% slope. MBV Engineering, Inc. recommends bringing the structure up until no point is less than 1.25 inches beneath the zero set during the original investigation. The areas which need to be lifted are marked on the plans seen on sheet S6 in Appendix B.

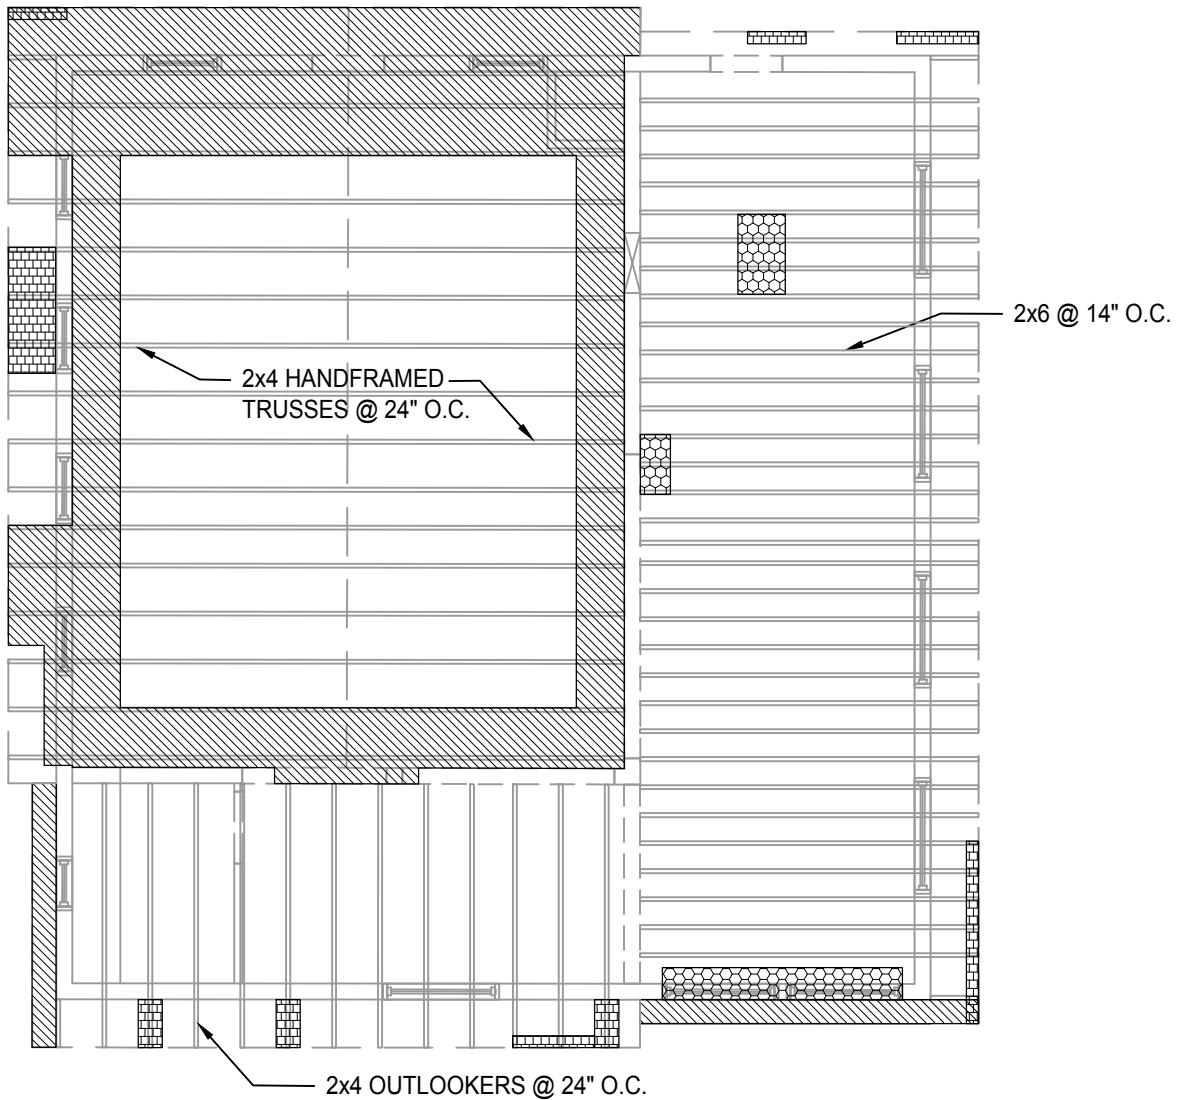
ROOF FRAMING PLAN

- The torch down roof on the west side of the structure exhibited multiple air pockets and the seams of the roof need to be resealed. The ceiling underneath the west flat roof showed signs of previous moisture intrusion into the structure in the form of water stains. At one of the laps on the west roof, a section of the torch down roof was peeling away. This roof area represents 34.1% of the total area.

- The asphalt shingles on the gable roof were determined to be in good condition and have a projected life of approximately 5 years. A few bubbles could be seen in the finishes; however, the 1 x 6 planks were determined to be in fair condition with multiple damages found as marked on the plans in Appendix A. This roof area covers the remaining 49.6% of the total area.

- Multiple areas on the overhangs were damaged and are noted on the plans. This damage is seen on the sheathing, members, and fascia.

- MBV Engineering, Inc. proposes an entire reroof be performed. The Florida Building Code – Existing Building section 706.1.1 states, “Not more than 25 percent of the total roof area or roof section of any existing building or structure shall be repaired, replaced or recovered in any 12-month period unless the entire existing roofing system or roof section is replaced to conform to requirements of this code.” MBV Engineering, Inc. believes the amount of damages to the members and sheathing will encompass more than 25% of the roof area and due to this an entire reroof is necessary. Where marked on the plans roof sheathing needs to be replaced and nailed per the schedule on sheet S3 in Appendix B. We recommend keeping the same type of roofing systems on the different areas. Roofing materials shall be installed in accordance with current code requirements.

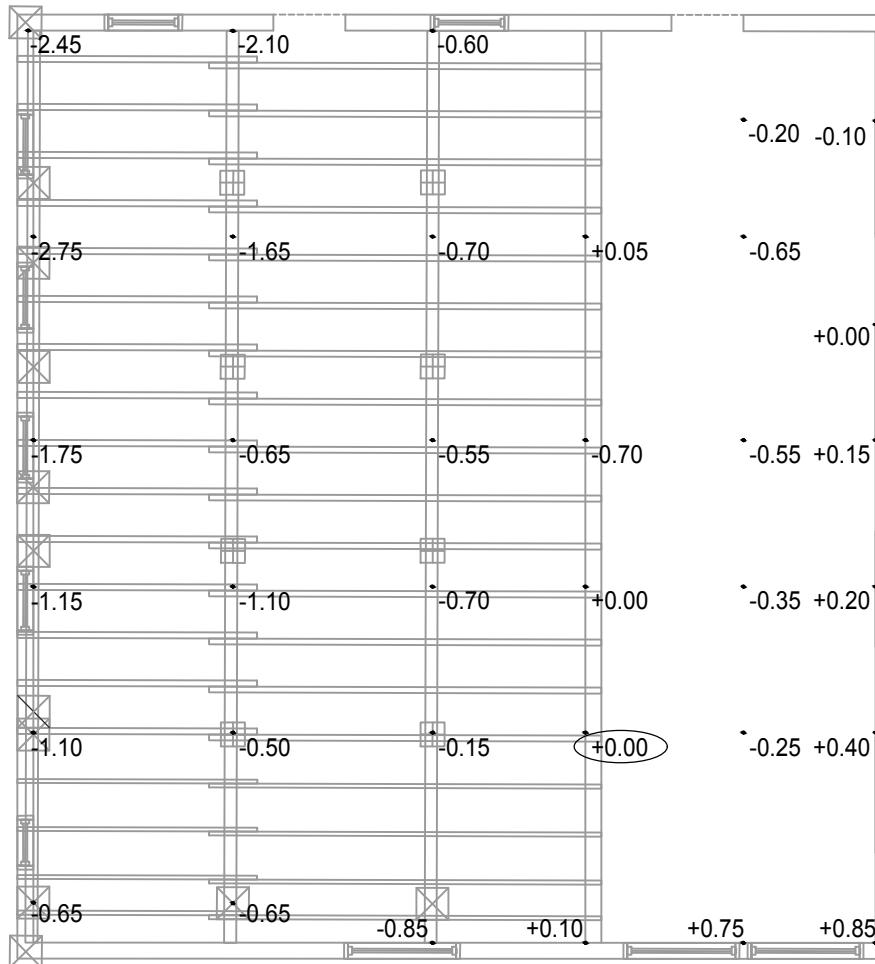
INTERIOR ELEVATION PLAN

- MBV Engineering, Inc. performed an interior elevation survey to determine if the current floor slopes within the structure meet the ADA standards of not exceeding 1 unit vertical for every 48 units horizontal. An attached topographic map of the floor system can be seen and it was noted at the time of an inspection there is a 2" drop off in the southeast corner of the structure. After our investigation MBV Engineering, Inc. has determined the floor slopes are within the ADA tolerances.

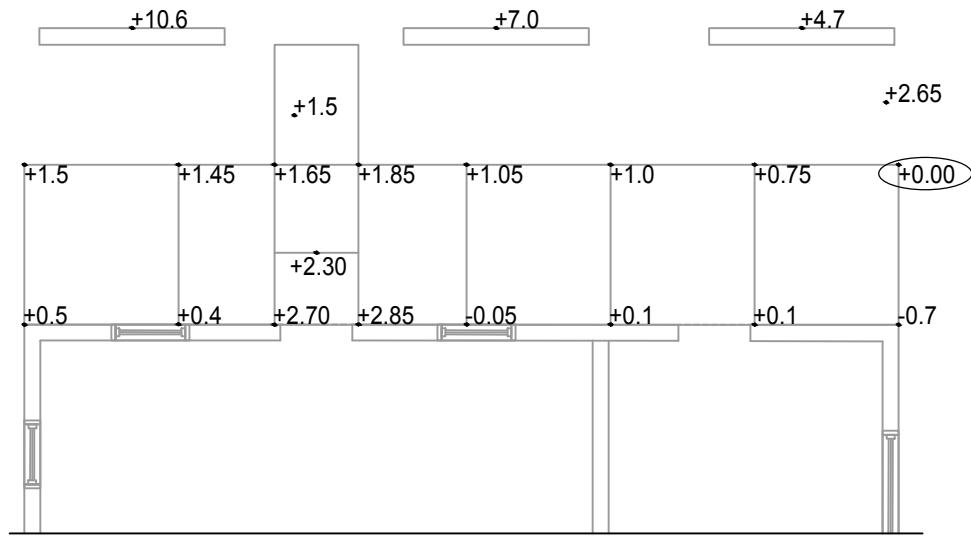
EXTERIOR ELEVATION PLAN

- MBV Engineering, Inc. performed an exterior elevation survey at the south side of the structure to determine current ADA compliance with the sidewalk slopes and to determine the current nature in which water drains in this area.
- The stairs to the west of the structure are currently out of level and the risers are not within code tolerances.
- A block structure hiding a water system was found on the west side of the structure between the stairs and the western wall. This system being on the exterior of the building with no entry door and no permanent roof is not code compliant.

- The exterior findings show the adjacent parking lot and sidewalks are all sloping towards the structure. It appears this is contributing to the rotted sheathing at the bottom of the structure as well as the erosion of the slope seen at the southeast corner of the structure at the time of inspection. MBV Engineering, Inc. proposes installing a block retaining wall or concrete curb and leveling off the parking area. This wall will also aid in preventing water from sheet flowing towards the structure and down the adjacent slope to the back of the structure. MBV Engineering, Inc. also proposes adding a storm water inlet and piping system to carry water past the eastern slope to help combat future erosion problems. The location of these items can be seen on sheet S7 in Appendix B.

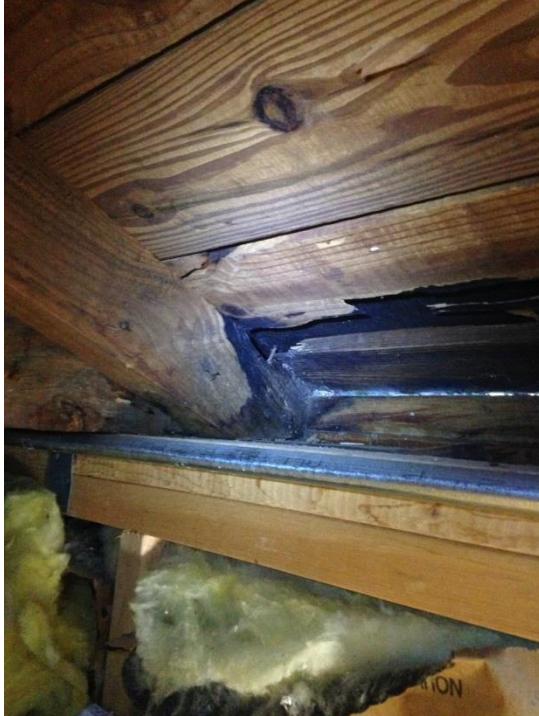
Picture No.: 1	DESCRIPTION: Damaged roof sheathing and member

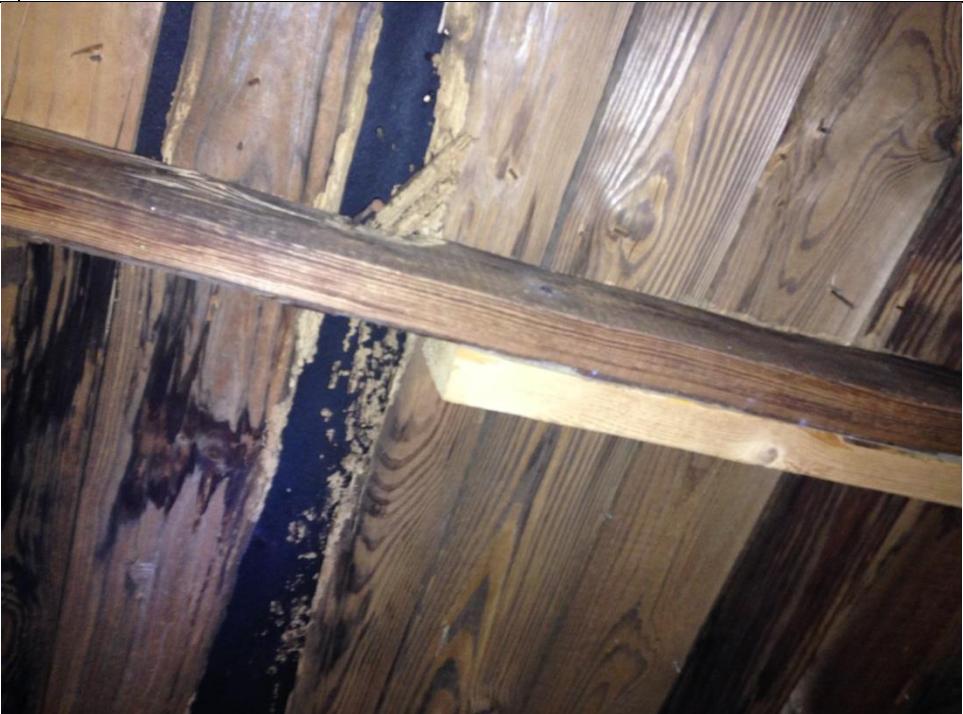
Picture No.: 2	DESCRIPTION: Damaged roof member and sheathing

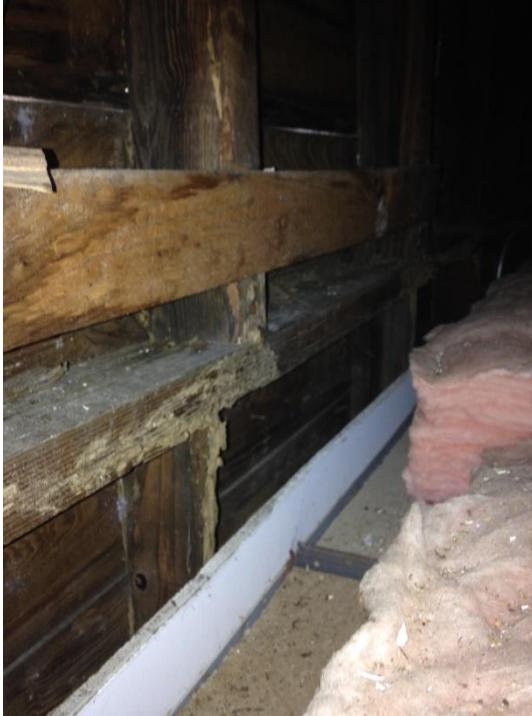
- Multiple areas were found to be missing proper insulation in the frame walls.
- The north gable wall has multiple damaged members, as well as damaged sheathing.

Picture No.: 3	DESCRIPTION: Damaged north gable wall

- The north gable wall shall be repaired and if appropriate retrofitted per the Florida Building Code – Existing Buildings 5th Edition. The sheathing on this gable end has been determined to be of poor condition and will require an entire replacement. An entire rebuild of this wall should be considered.

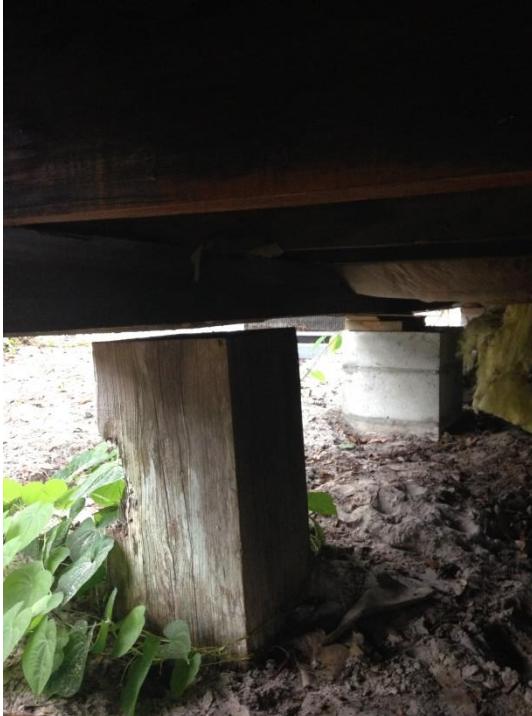
Picture No.: 4	DESCRIPTION: Missing shim at wood pier

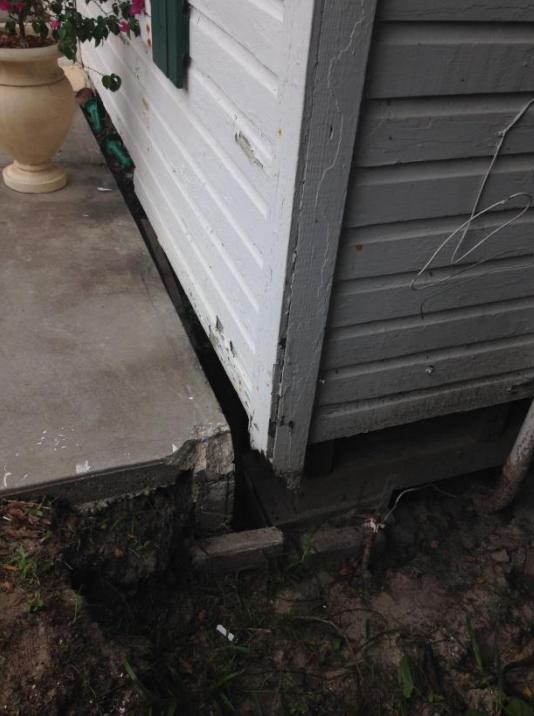
Picture No.: 5	DESCRIPTION: Damaged wall sheathing, signs of erosion and settlement in sidewalk

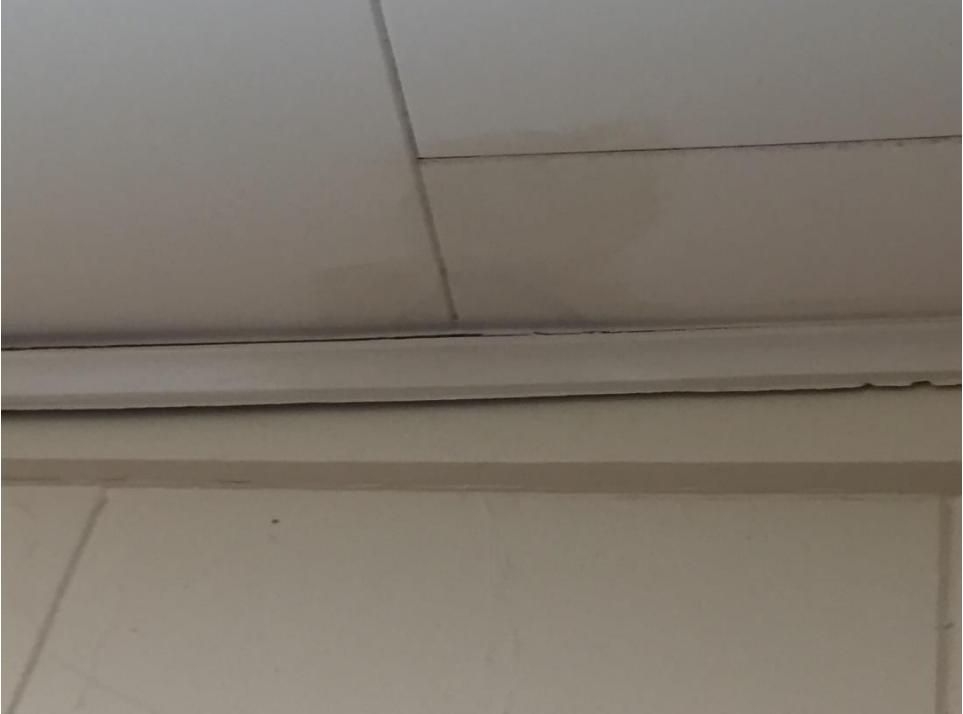
Picture No.: 6	DESCRIPTION: Signs of moisture intrusion

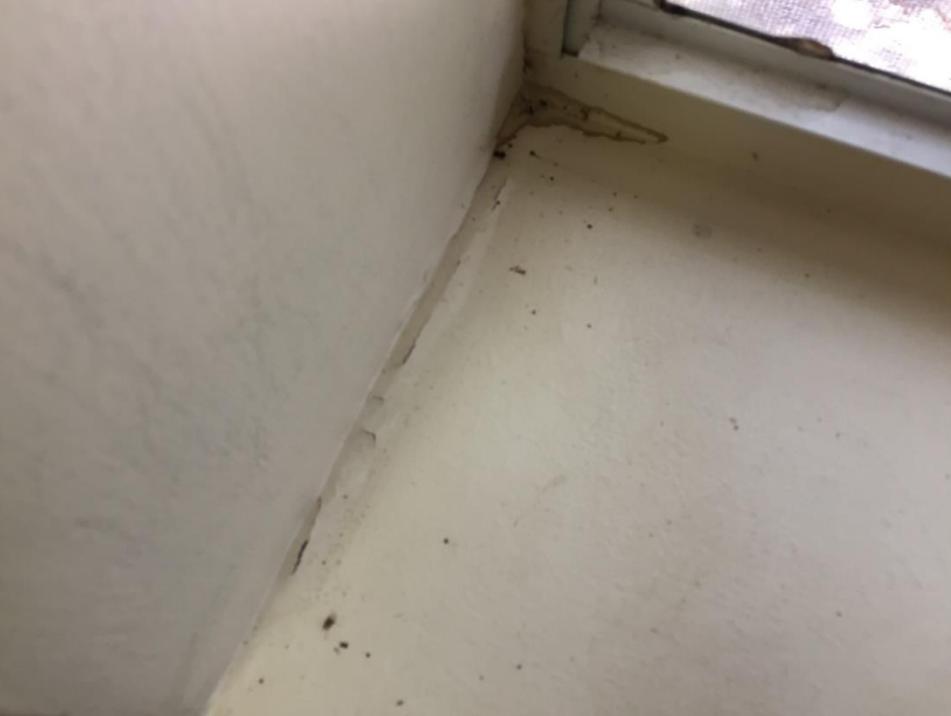
Picture No.: 7	DESCRIPTION: Water stained window sill

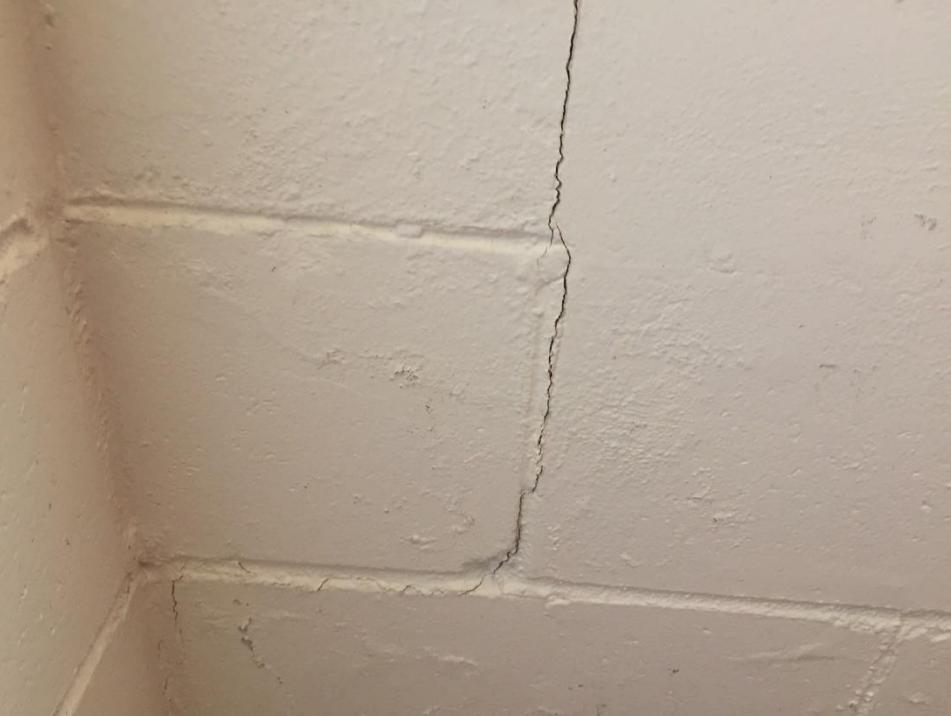
Picture No.: 8	DESCRIPTION: Interior masonry wall crack

- The cracks in the masonry walls shall be patched with appropriate epoxy materials per manufacturer's recommendation based on crack width and depth at each area. Caulking the cracks smaller than 1/8" with an appropriate sealant is very important in reducing potential damage to the structural components and also in preventing moisture from entering the structure.

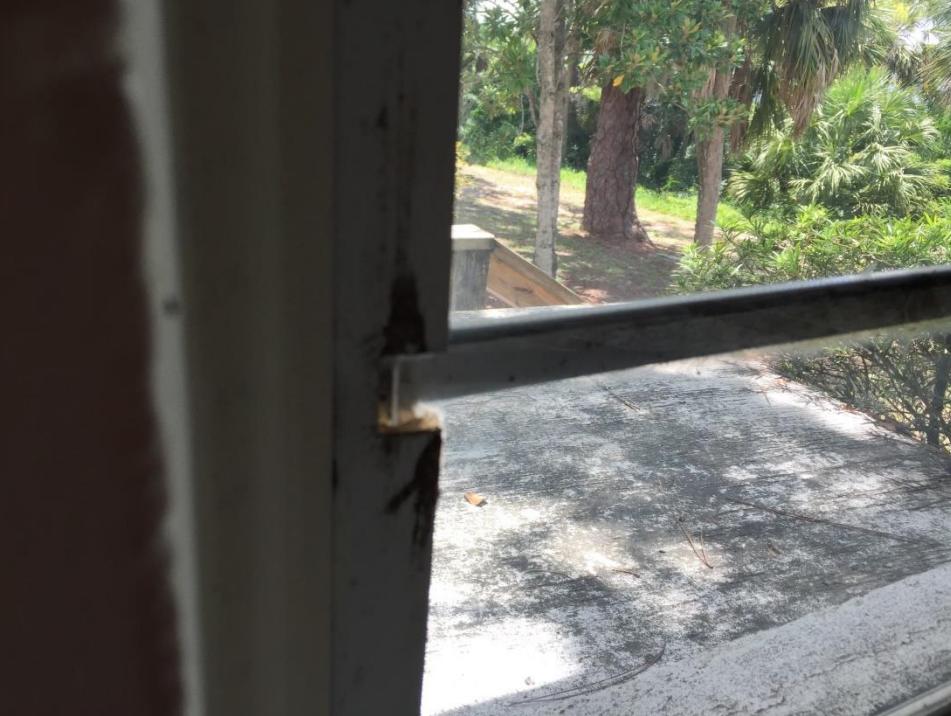
Picture No.: 9	DESCRIPTION: Window broken at muntin

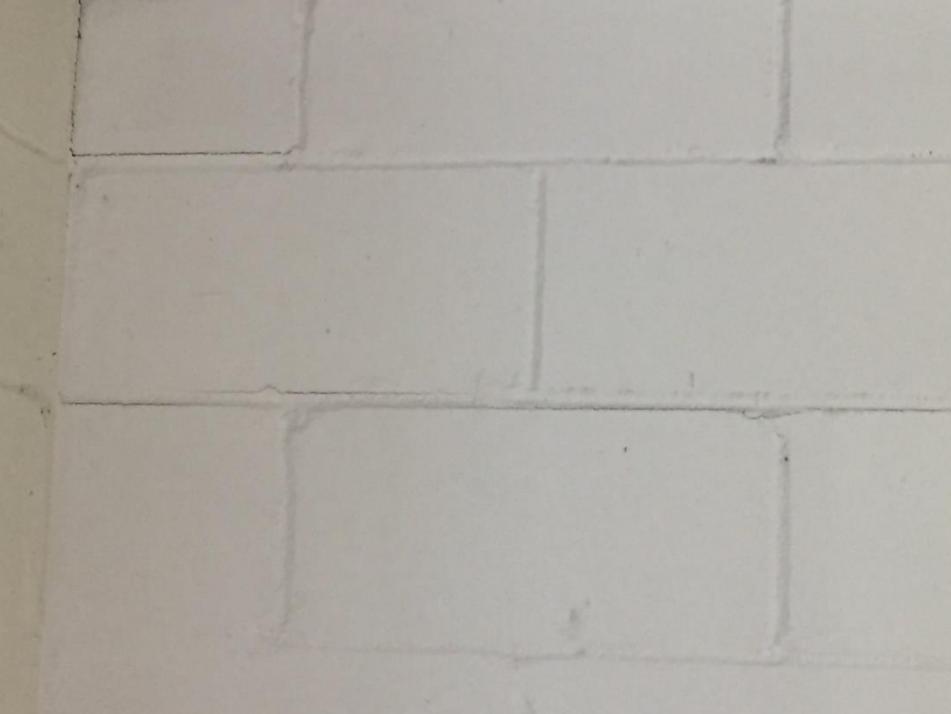
Picture No.: 10	DESCRIPTION: Cracks in basement wall

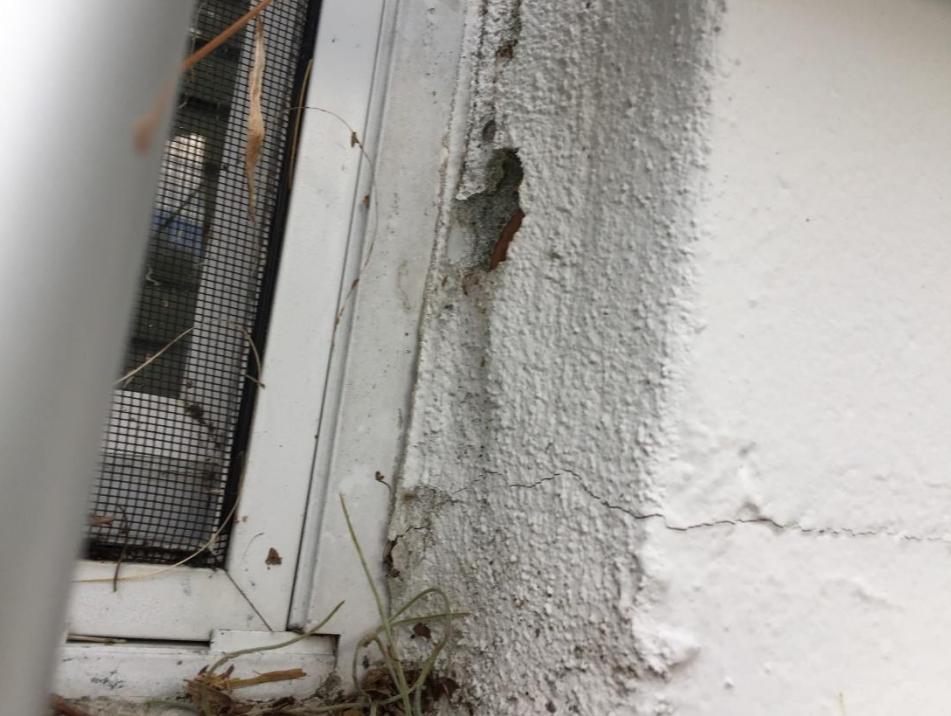
Picture No.: 11	DESCRIPTION: Damaged stucco and peeling sealant

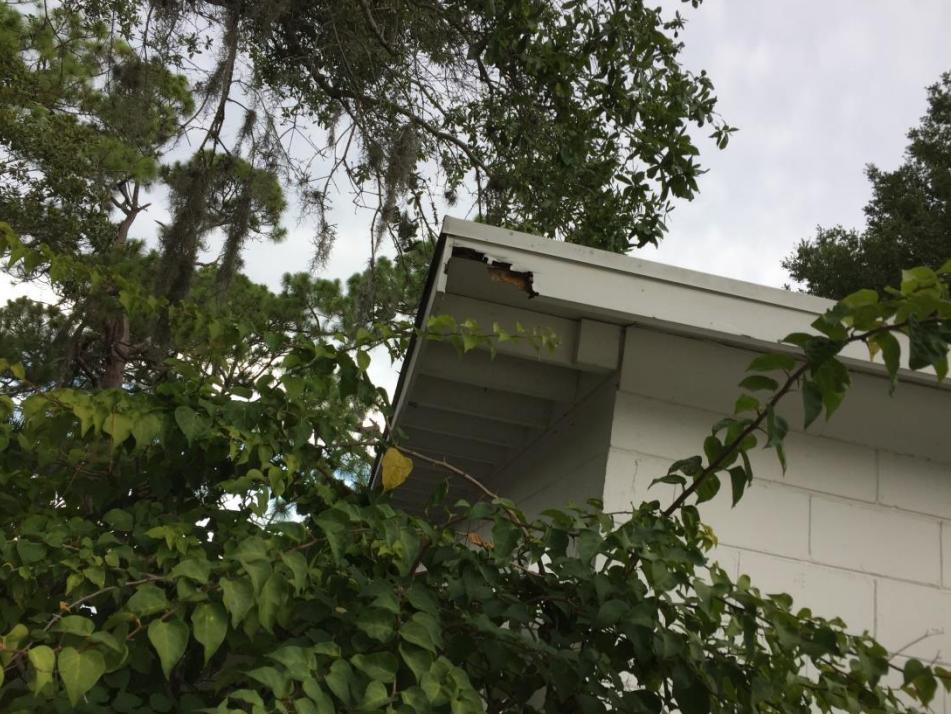
Picture No.: 12	DESCRIPTION: Damaged fascia

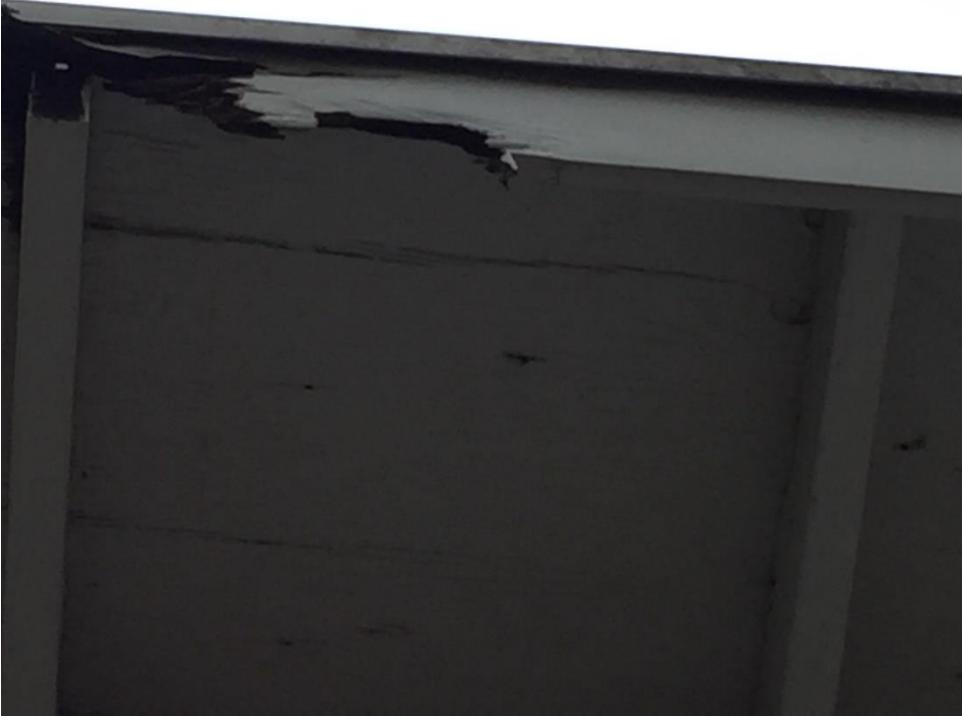
Picture No.: 13	DESCRIPTION: Damaged fascia

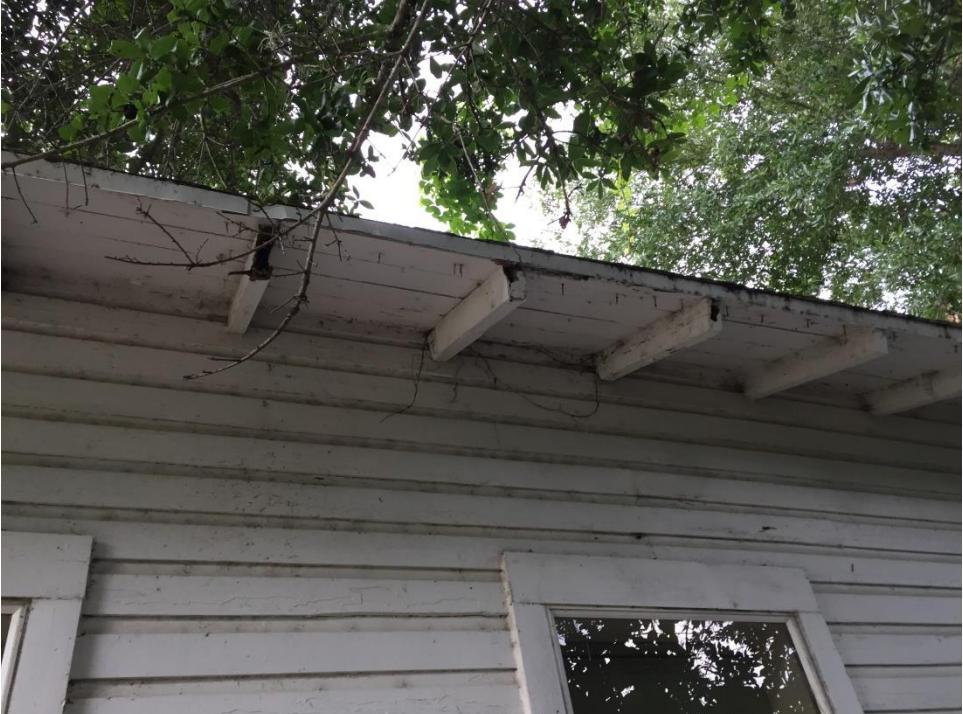
Picture No.: 14	DESCRIPTION: Damaged roof members and sheathing

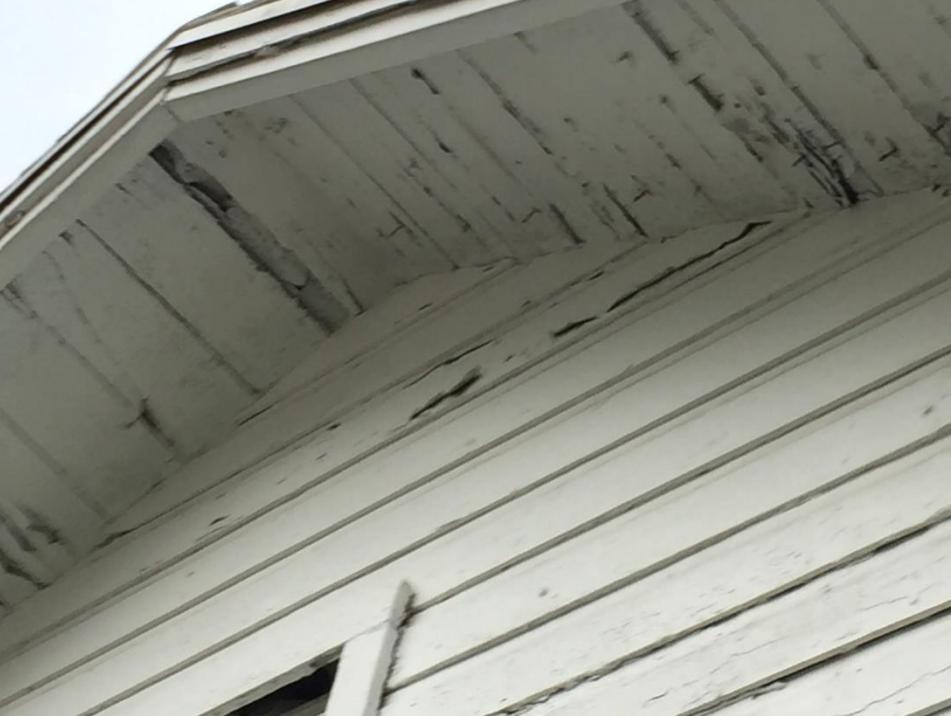
Picture No.: 15	DESCRIPTION: Damaged sheathing, damaged fascia, and peeling paint

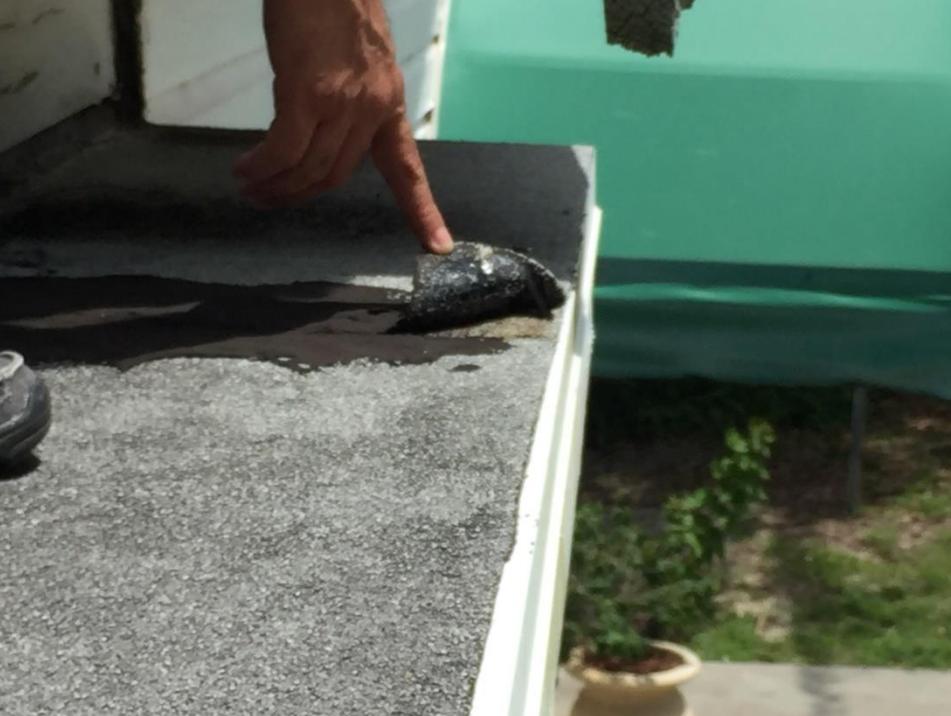
Picture No.: 16	DESCRIPTION: Peeling torch down roof
