RE: Indian River County Utilities Department
South County WTP Floridan Well Rehabilitation Project
Production Well S-4 Condition Assessment
Contract #2016031

TECHNICAL MEMORANDUM

South Oslo Road Water Treatment Plant, Upper Floridan Aquifer Well S4

Date: December 9, 2016

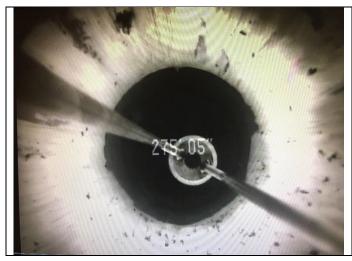
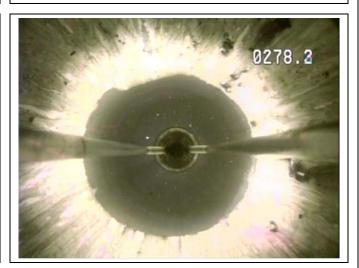
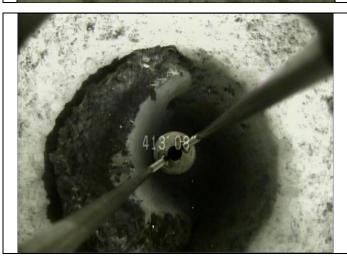
Selected photographs comparing features from the 2016 and 2009 well videos are included as Attachment A. Geophysical logging performed by AWE included caliper, dual induction, gamma ray, and static and dynamic fluid conductivity and flow logs. PDF Copies of the geophysical logs are included as Attachment B.

2009 AMPS Video 2016 AWE Video 0006.6 0028.2 0028.5

2009 AMPS Video 2016 AWE Video UNDER VOLTAGE 0037.3 0045.6 0044.4

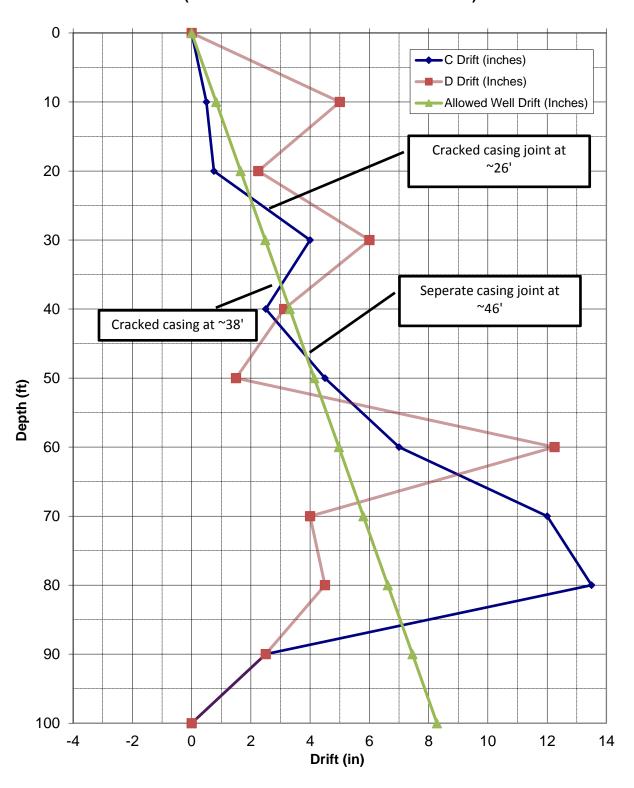
INDIAN RIVER COUNTY UPPER FLORIDAN AQUIFER WELL S4 2004 PLUMBNESS AND ALIGNMENT TEST DATA (DEFLECTION CALCULATED FROM 0 FT.)

- Phase II Report (2005) refers to a plumbness and alignment test (P&A) being performed to determine if the new pump would pass freely to the new pump setting depth of 100 feet BPL. The P&A test descriptions stated there were two locations where the well was not properly aligned and that the pump column pipe became lodged, but "not too tightly" during installation. (Refer to attached 2004 plumbness and alignment test exhibit)

Historically, well pump assemblies have been difficult to extract from well S4 due to an out of plumb PVC well casing.
