TECHNICAL MEMORANDUM

Re: Indian River County, Parks, Recreation & Conservation Department, North County Pool Heat Exchange System UFA Supply Well Sand Investigation, Exploratory Video, Testing, & Recommendations

Date: November 27, 2024

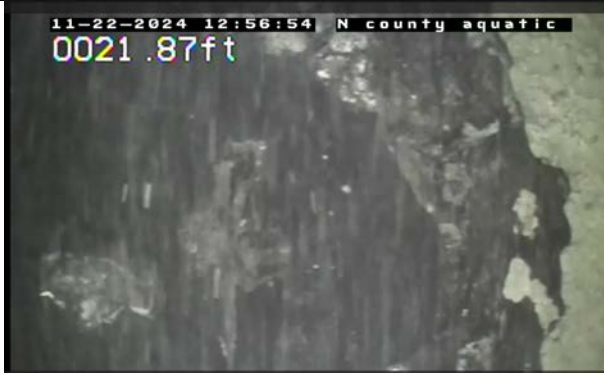
<p>11-22-2024 12:56:54 N county aquatic 0021 .87ft</p>

- **6" Steel casing from 0 to 150 feet.**
 - Visible sediment buildup and scale on the well casing throughout including whole shells visible in places.
 - Sand seen entering the well through visible holes in the casing at 21.85' and 44.21'.

<p>11-22-2024 13:20:47 N county aquatic 0172 .37ft</p>
<p>21.87' - Hole in the well casing.</p>	<p>172.37' - Casing Diameter decreasing from 6-inch to 4-inch casing.</p>

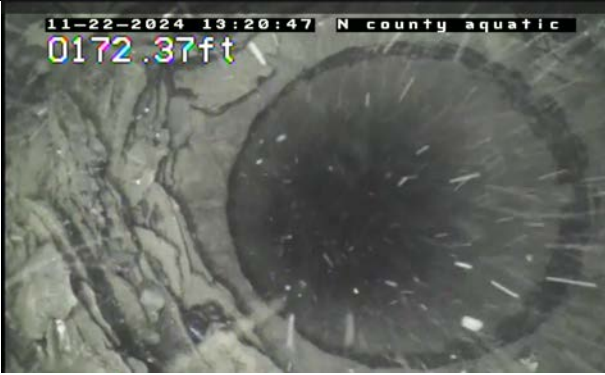
- Casing joints appear to be threaded when visible indicating a driven casing with no cement grout seal behind the casing.
- **173.24' - Transition from a 6-inch steel casing to 4-inch Steel casing.**

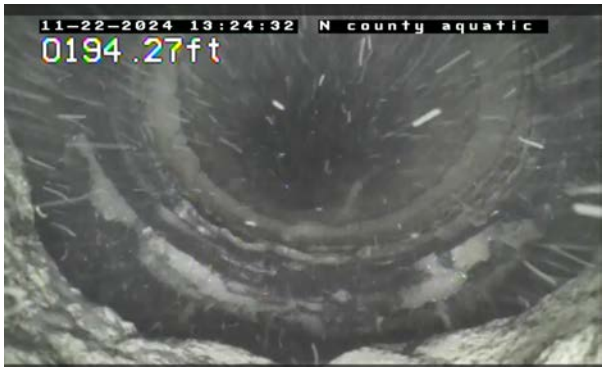
<p>11-22-2024 13:24:32 N county aquatic 0194 .27ft</p>

- 194.28' & 216.31' – Complete separation of the well casing with formation visible at all points between the two section of steel casing.
 - 195.50' - Large hole in the side of the casing.

<p>11-22-2024 13:43:03 N county aquatic 0274 .54ft</p>
<p>194.27' - Separation in the well casing.</p>	<p>274.54' - Large hole in the casing.</p>

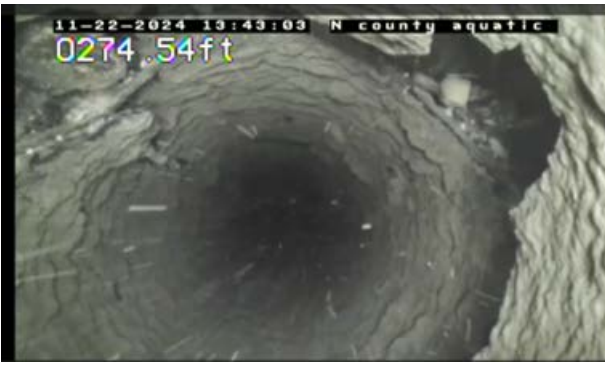
- 275.16' - Major hole in the well casing visible increase in flow and sand entering the well.
 - 283.91' to 289.82' - Major hole in the well casing in this interval with approximately 1/4 of the casing missing.

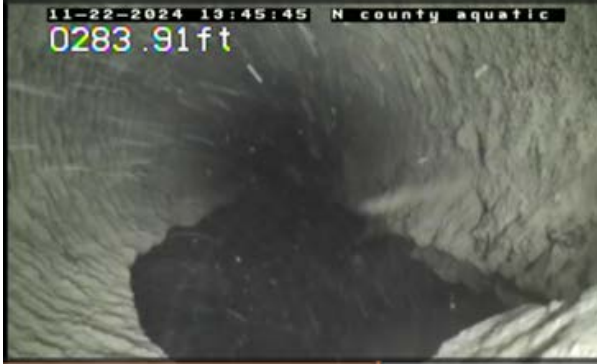
<p>283.91' – Major hole in the casing approximately ¼ of the well casing missing.</p>	<p>322.02' - Base of well casing.</p>

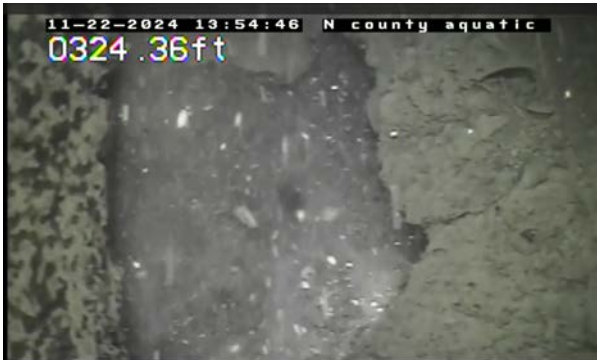
<p>324.36' Hole in casing with large quantities of sand entering the well.</p>	<p>323.90' - Drill pipe left in the well.</p>

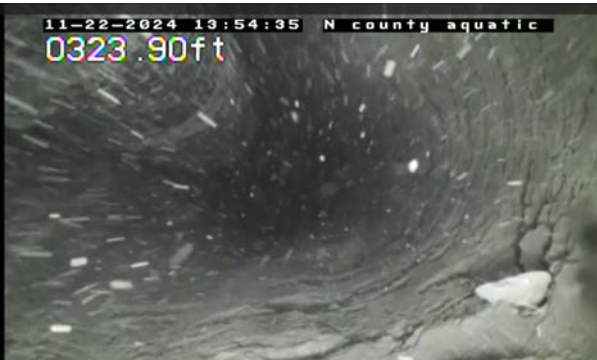
- 322.82' – Base of 4-inch steel casing.
- **Open hole section of the well from 322.82 to a total accessible depth of 346.69 feet.**
 - 324.00' - Start of the observed drill pipe that was left behind in the well extending down to total accessible depth of 346.69'.

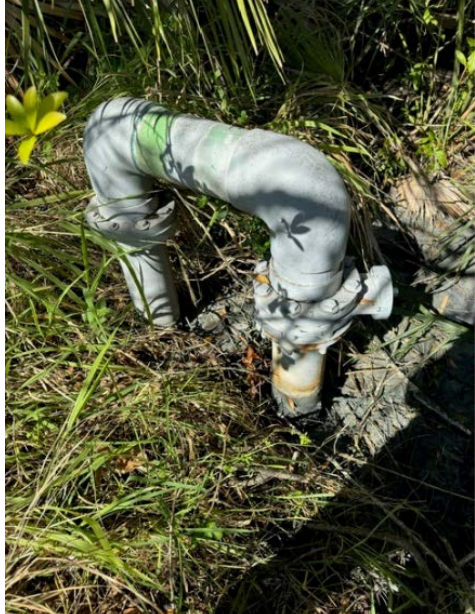
<p>Well Head and discharge piping.</p>	<p>Well site flooded due to damaged casing.</p>

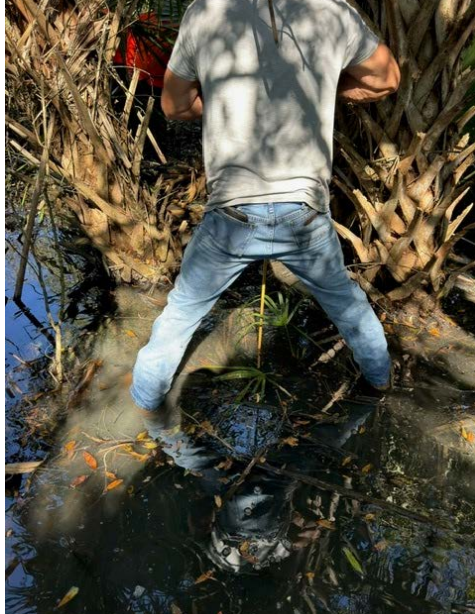
- UFA well location was approximately 100-feet south of the well pump.
 - Supply well was continuously flowing to the ground and flooding the well site due to damaged well casing.

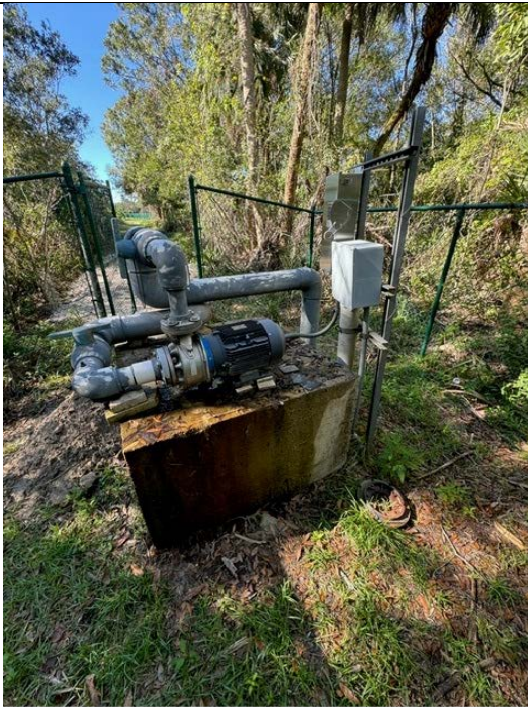
Well Pump - Site location.

- 346.69' - Drill pipe in the well preventing the camera from reaching any deeper.
- **Well Site and Equipment Observations.**
 - UFA Supply well location was not adjacent to the well pump pedestal.

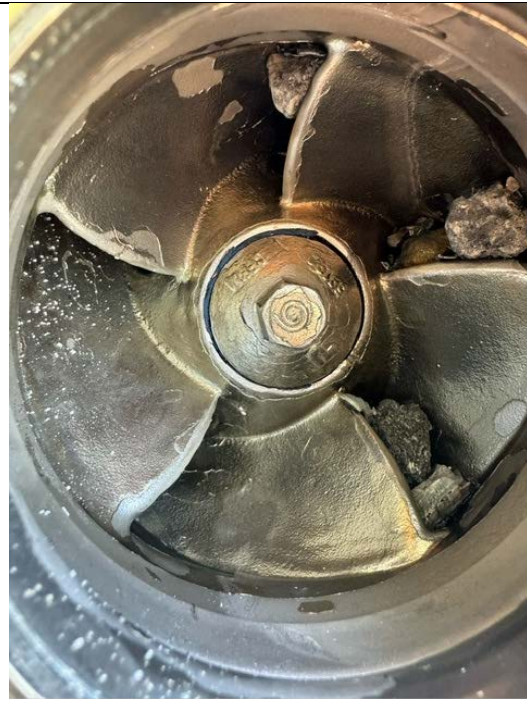
- Well pump impeller was obstructed with large pieces of formation material.

Pump impeller obstructed with large pieces well formation material.
