**Water & Air Research, Inc.  
6821 Southwest Archer Road  
Gainesville, Florida 32608  
Project No. 24-6442**

## **1.0 WINTER BEACH 73RD ST PROPERTY**

The Winter Beach 73rd St Property, Environmental Bond Nomination Number 24, was nominated by a local resident with the anticipated acquisition type of Fee Simple.

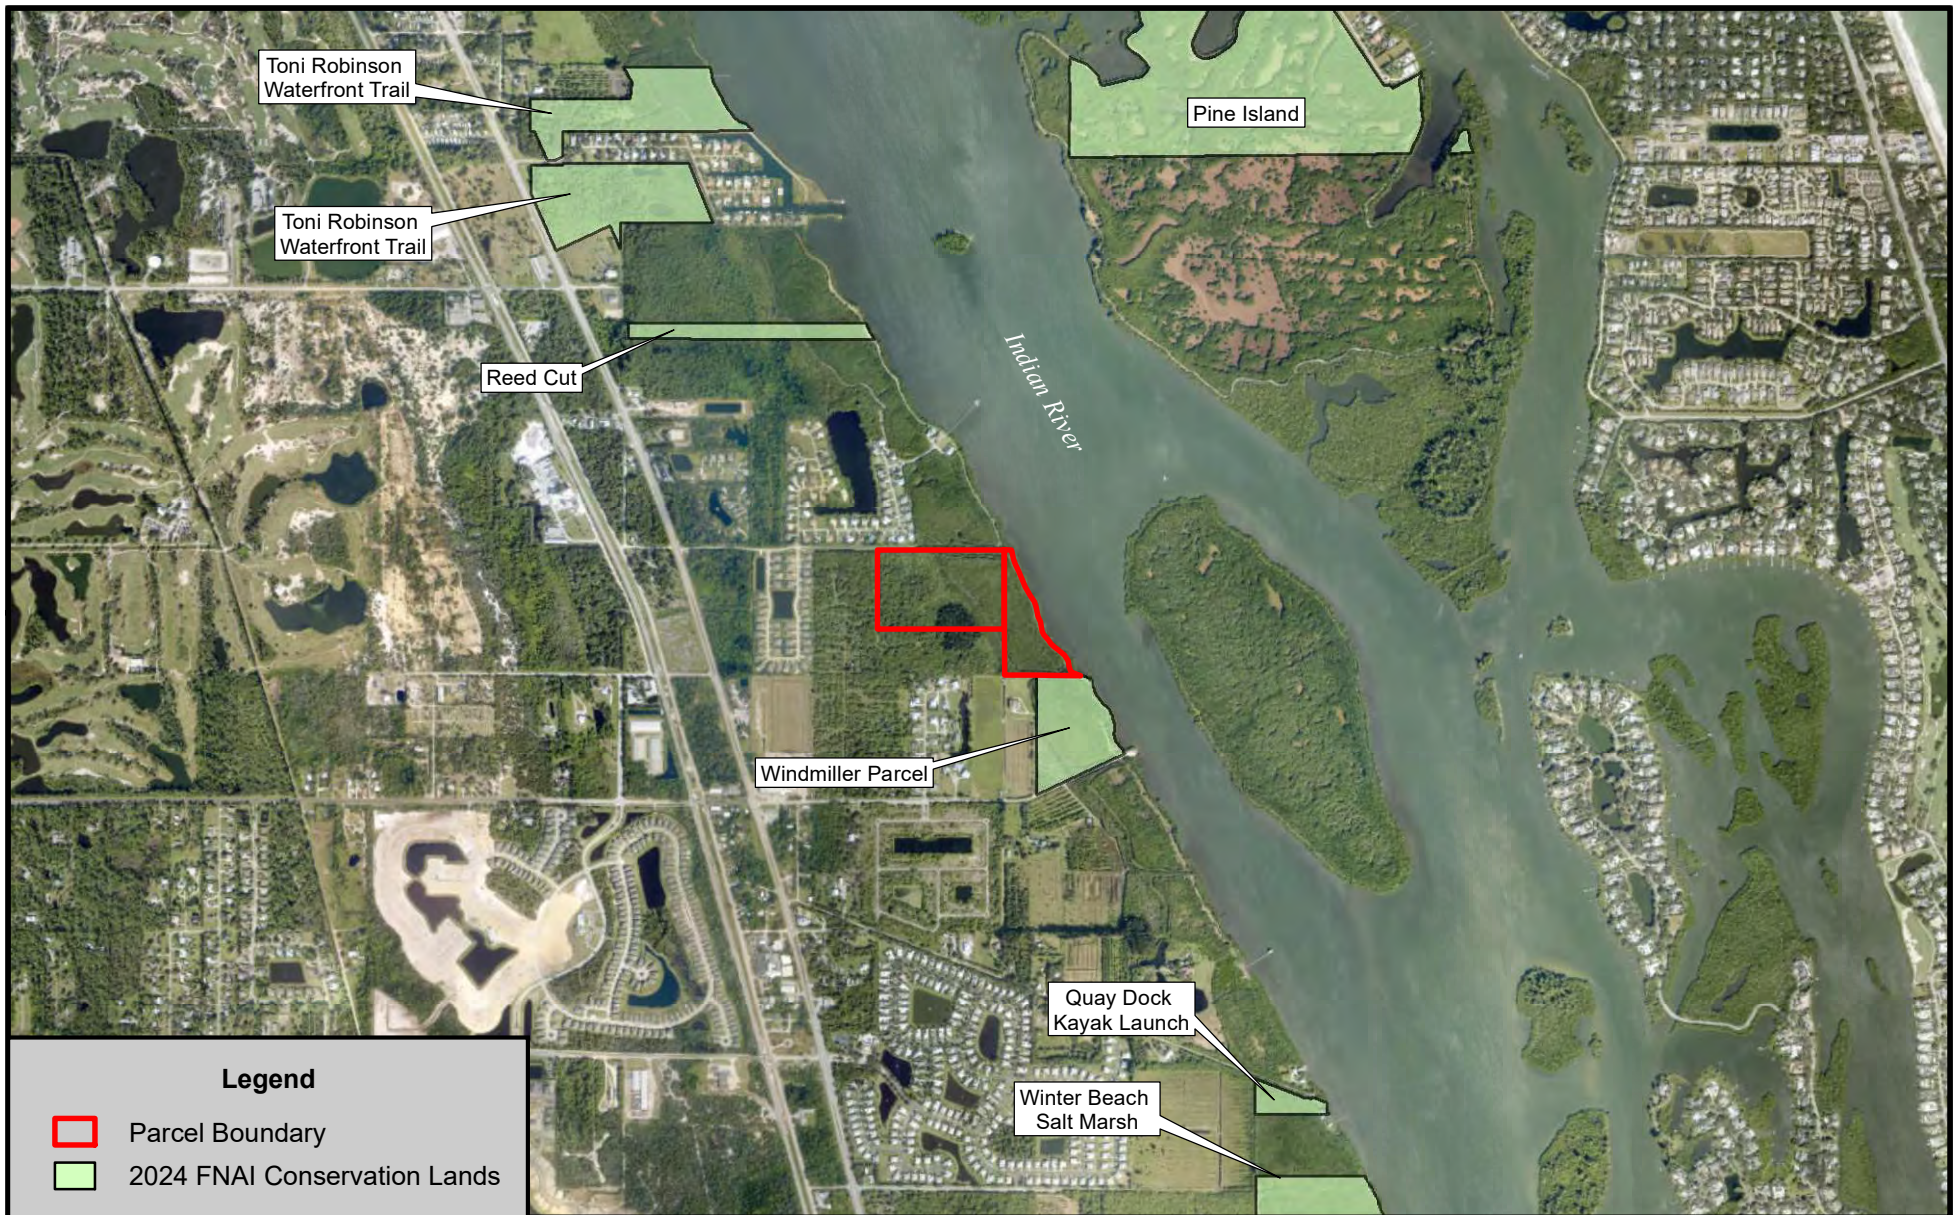
Figure 10.  
The Winter Beach 73rd St. Property  
and the Conserved Lands in the Vicinity  
Indian River County, Florida

The Winter Beach 73rd Street Property is adjacent to the Indian River Lagoon and is one of the unacquired parcels of the Indian River Lagoon Blueway Florida Forever BOT project. This property is contiguous with the 19-acre SJRWMD Windmill Parcel to the south (Figure 10) along with a series of privately owned, undeveloped, mosquito impoundments to the north and south.

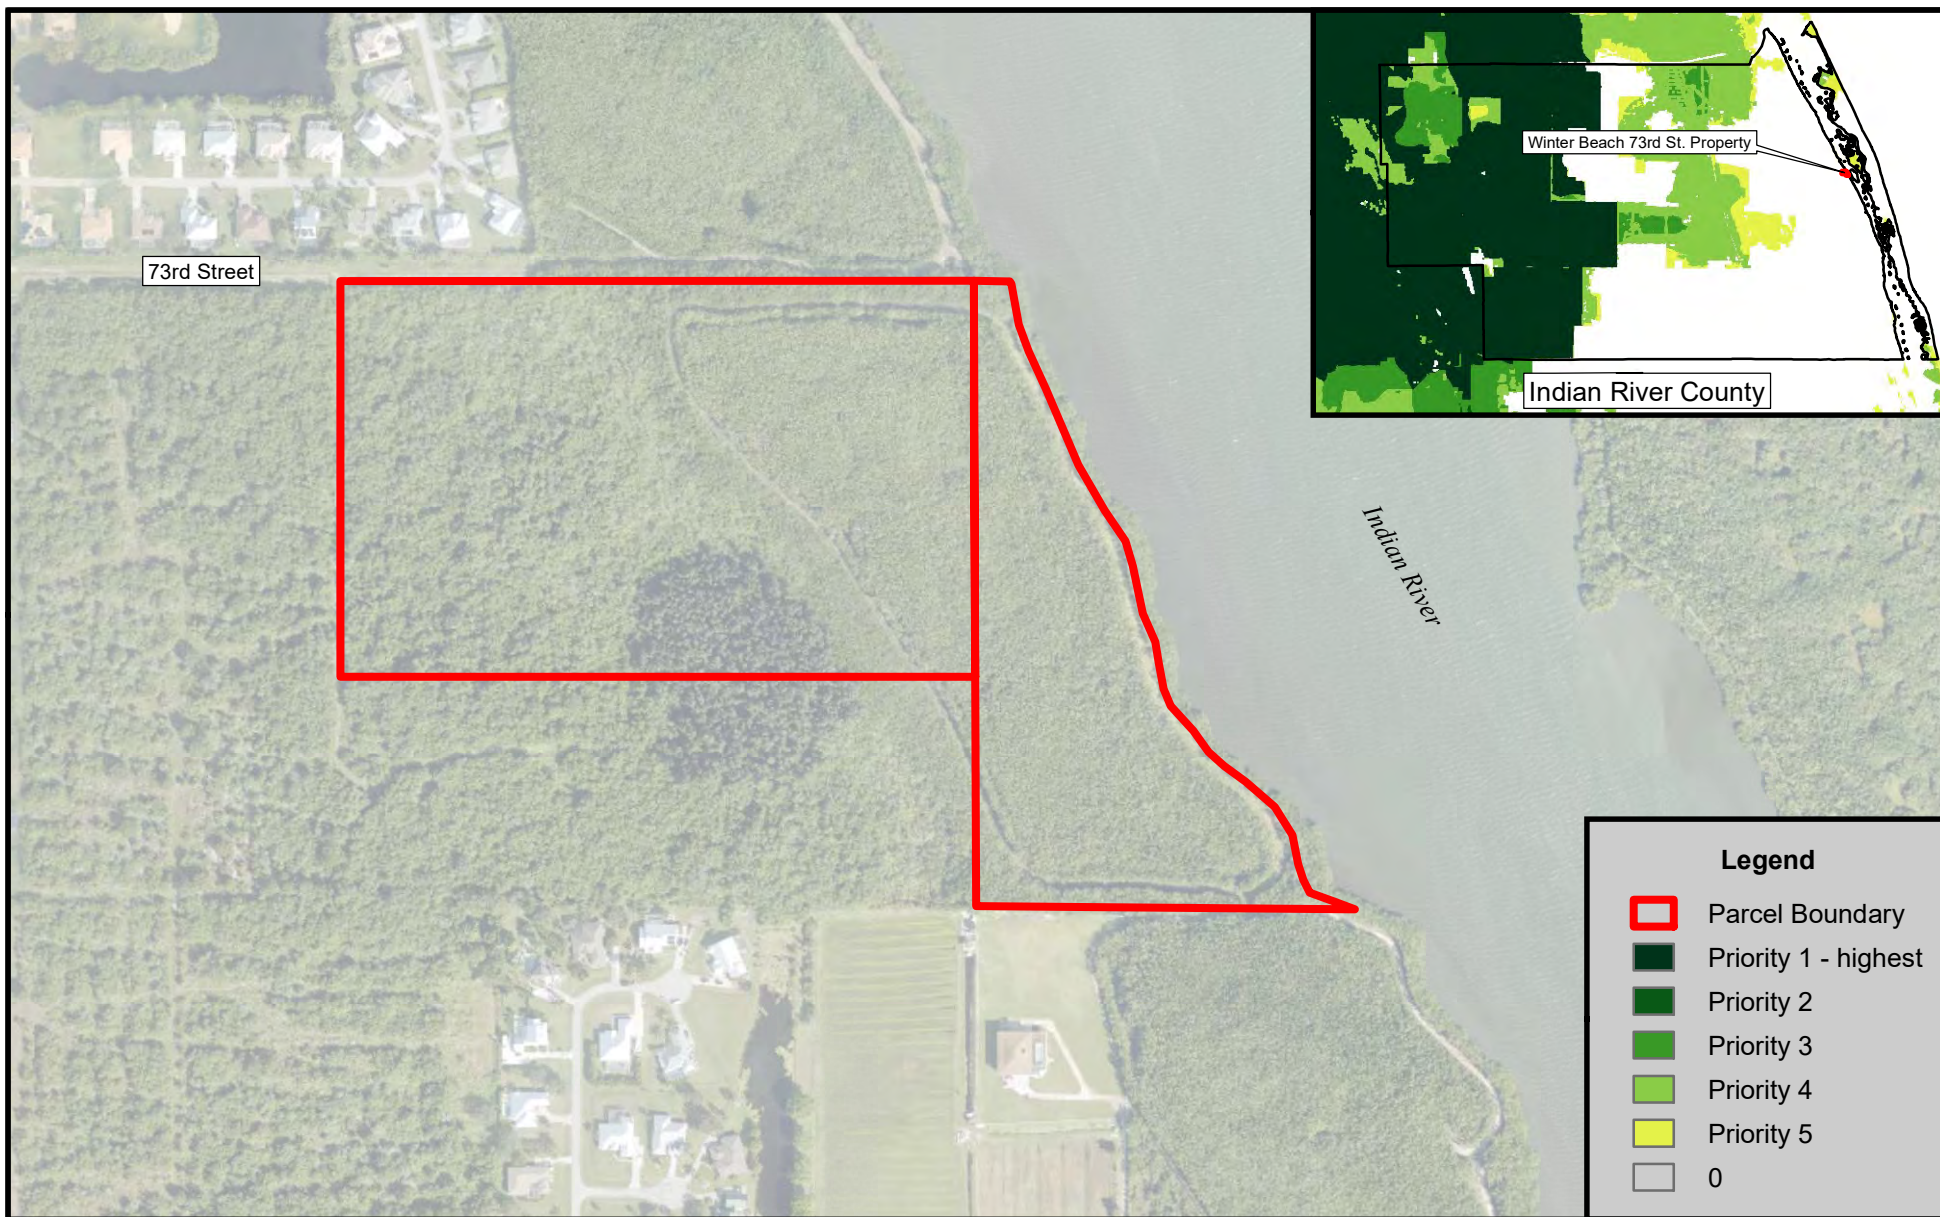
Figure 11.  
The Landscape Resource Priorities Model (CLIP 4.0)  
on the Winter Beach 73rd St. Property  
Indian River County, Florida

Figure 11 shows the CLIP landscape priority ranking for the property. This model combines priorities from the Ecological Greenways and Landscape Integrity Core Data layers. No portion of this property was ranked a priority.

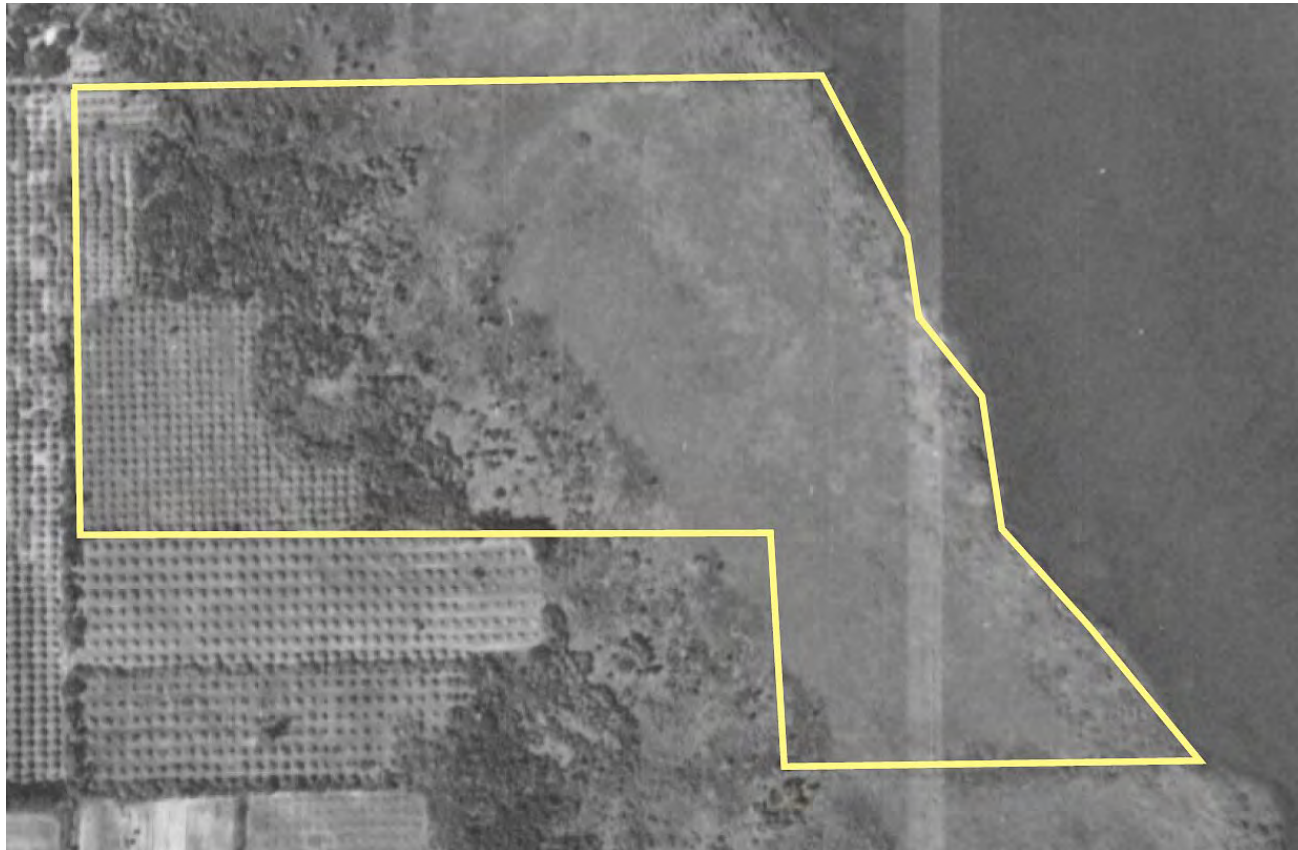
1951 Aerial Photograph

- The natural communities are relatively unchanged from 1943
- The canopy of the central band of mixed forest and pine flatwoods appear denser
- The eastern marsh is still open with a few woody trees or shrubs along the river

- Suppression of the natural fire regime in conjunction with increased citrus groves and agricultural development of the surrounding pinelands could have impacted the historical open nature of the pine flatwoods
- The diagonal ditch is barely visible due to an increase in woody vegetation
- The former bridge that extended east from what is now 69<sup>th</sup> St no longer crosses over to the Hole in the Wall Island

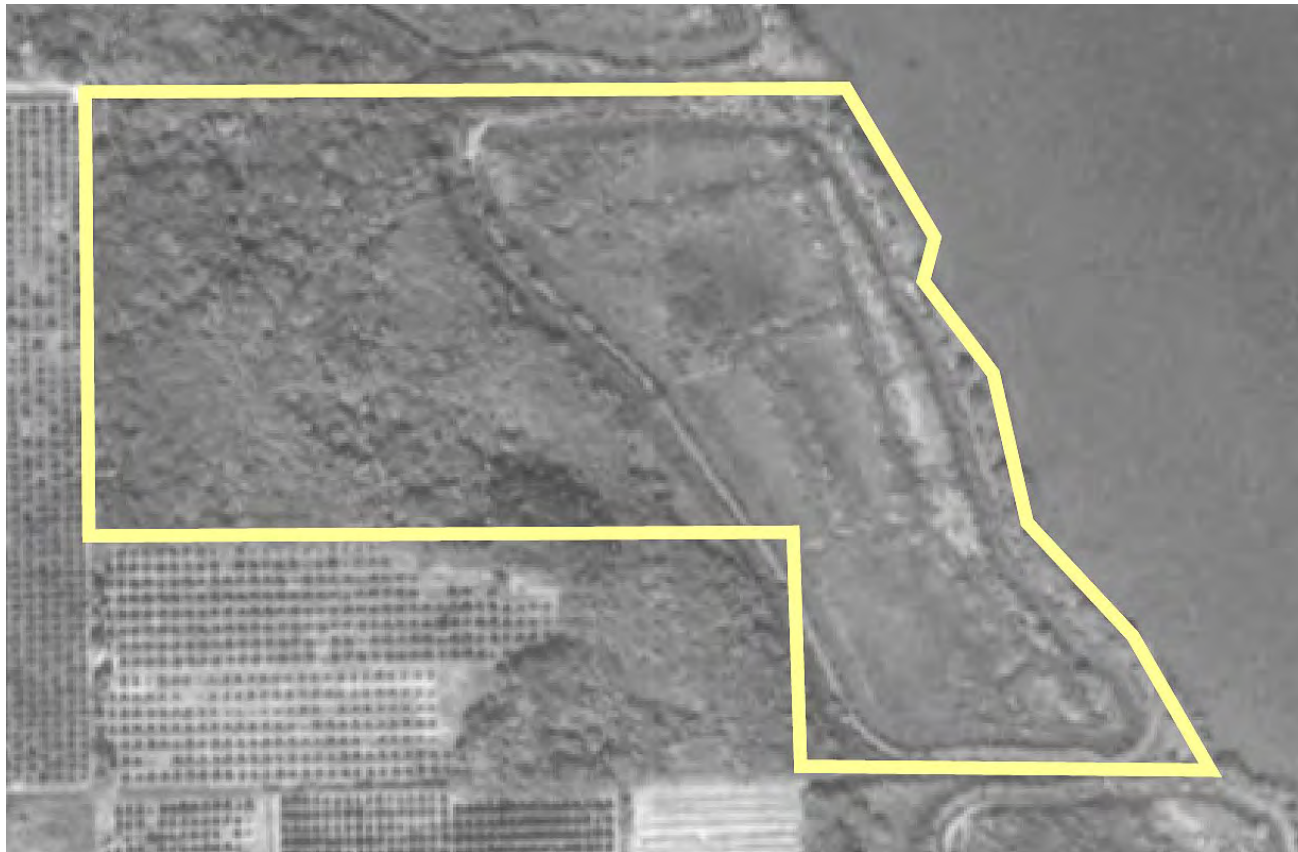
1970 Aerial Photograph

- The citrus grove is gone and the new vegetative aerial signature of the 5.3 acres appears very similar to the mixed forest to the east
- Land disturbances in the mixed hardwoods and pine flatwoods appears to have occurred since 1951, possible timbering
- The dark circular signature near the center of the southern boundary is the start of an infestation of the invasive exotic tree, Australian pine
- The formerly open pine flatwoods on the western half of the site is now forested with hardwoods
- Mangroves have recruited into the formerly open saltmarsh
- The formerly open saltmarsh has a dike and ditch encompassing a mosquito control impoundment
- The construction of mosquito impoundments (during the 1950s and 60s) along the Indian River has occurred throughout the region and adjacent to this site

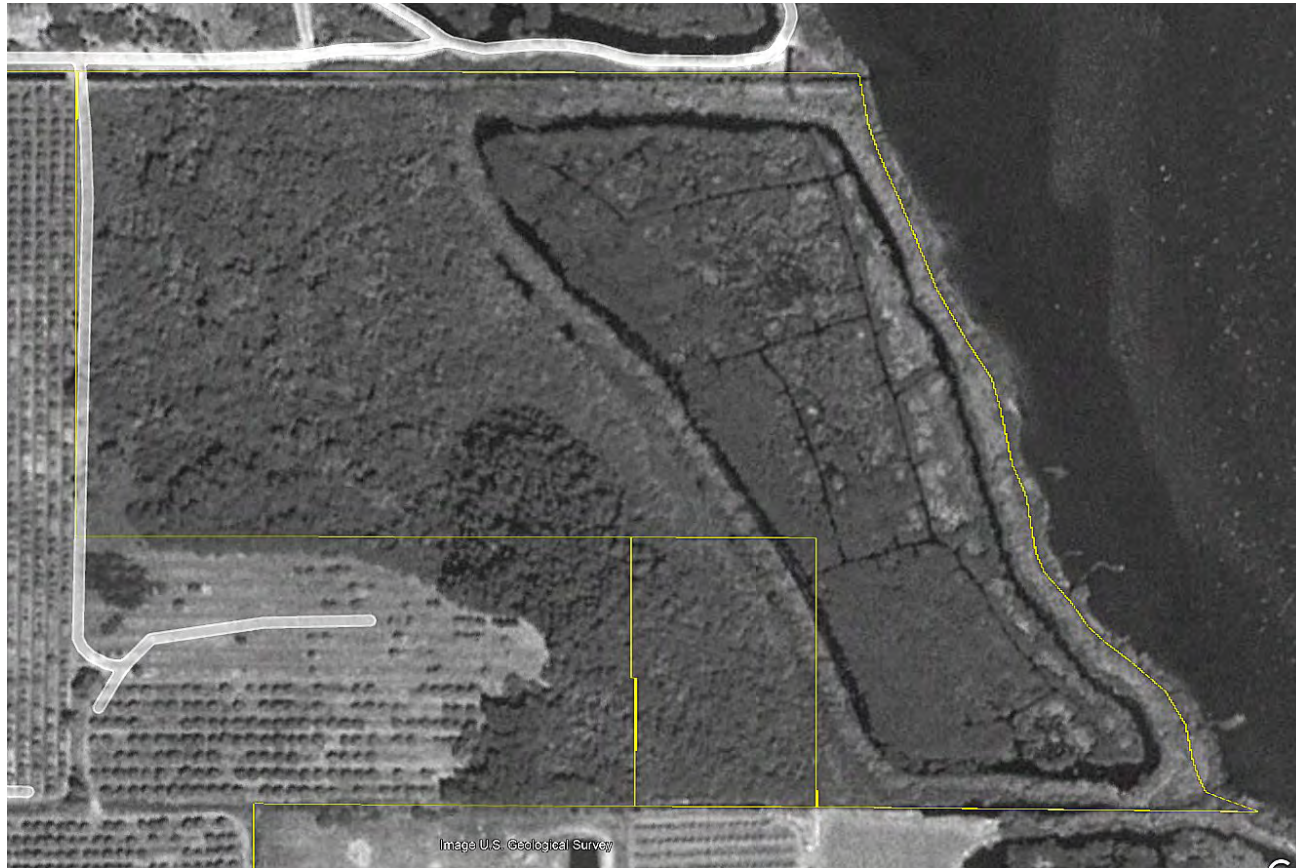
1994 Aerial Photograph

- The entire site has a woody canopy (forested) of various heights, densities, and species
- There is some open water in ditches crossing the mosquito impoundment
- The Australian pine infestation has increased in size and density
- The formerly open saltmarsh appears to be mostly mangrove trees
- A ditch has been excavated along the north and southeast property lines, the ditch along the north boundary is fairly wide and likely doubles as a linear storm retention pond
- 73<sup>rd</sup> St is a dirt path that runs along the western half of the north boundary
- Some oyster bars are visible in the Indian River along the southeastern boundary for the first time (likely visible due to aerial photograph quality and low tide conditions)

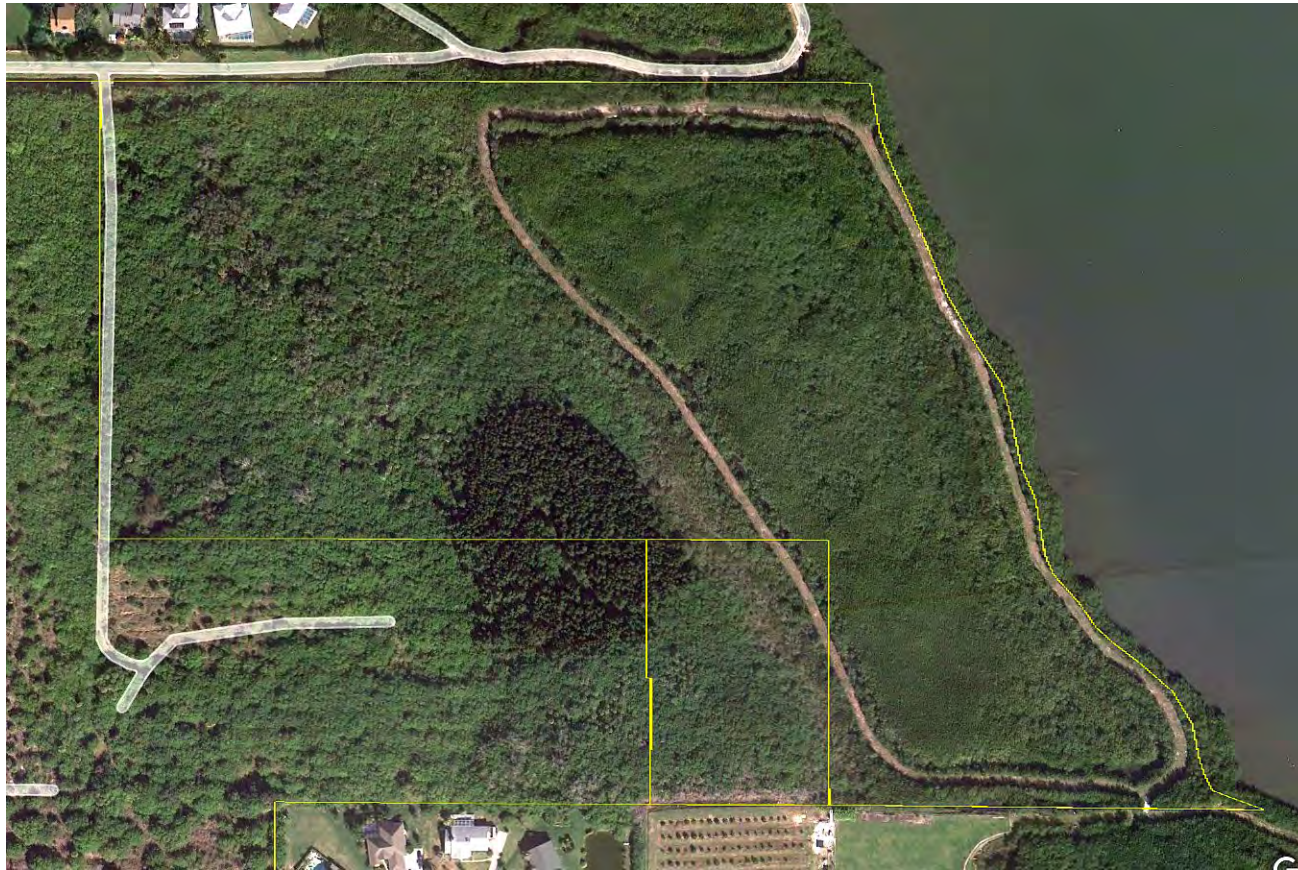
2010 Aerial Photograph

- The Australian pine infestation has grown back in the same area (dark green circular signature), Lidar and other sources don't show any major topography changes in the area and soils are mapped the same as the adjacent areas
- The mixed hardwoods signature includes areas of oak and cabbage palm, deciduous species, and likely some invasive exotic species
- The tree canopy is dense in the mosquito impoundment, and very little open water is visible with most ditches and dikes hidden under canopy
- Oyster bars are visible
- The adjacent offsite former citrus groves are succeeding into forest

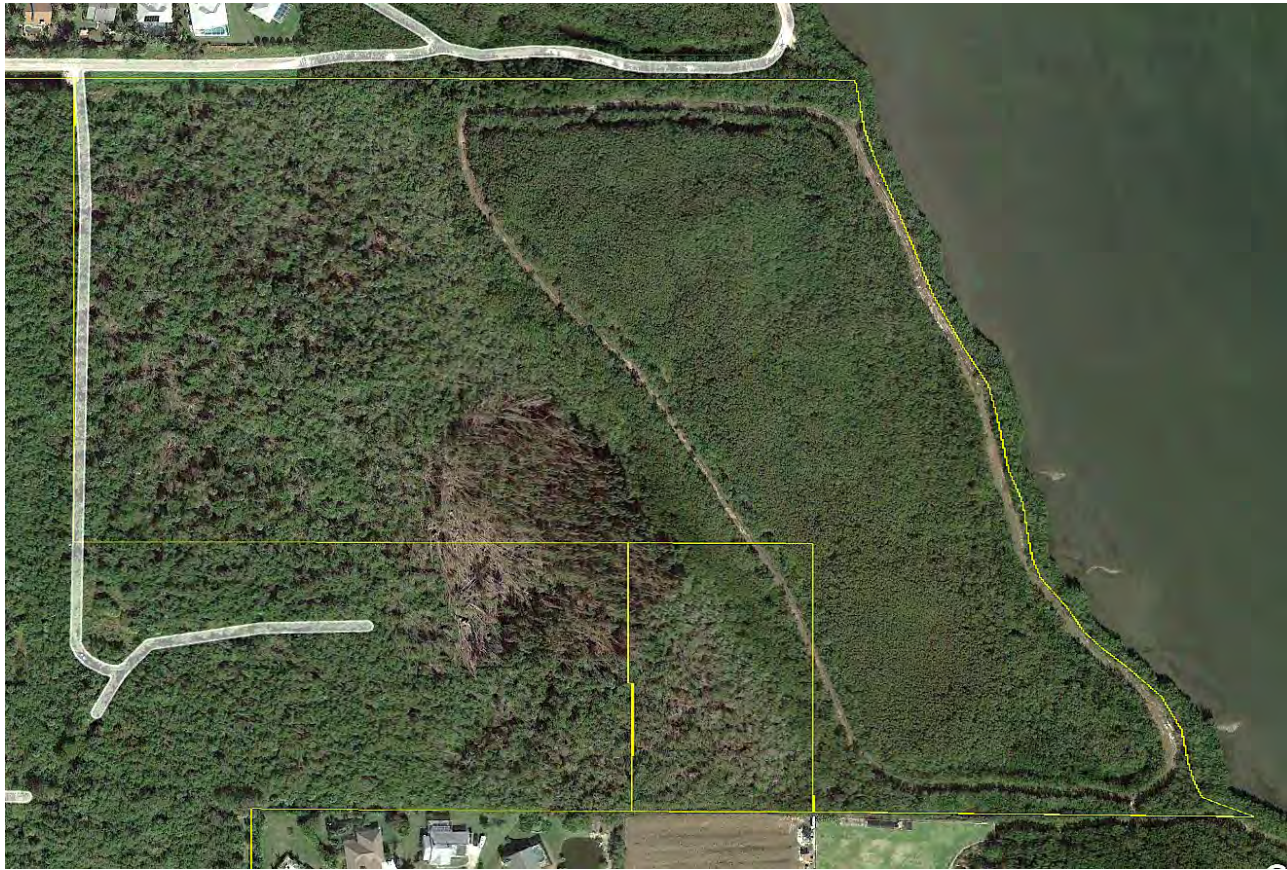
2017 Aerial Photograph

- The Australian pine infestation has been disturbed, many trees have been blown over, as well as scattered Australian pine to the northwest in the mixed hardwood area and possibly other species as well
- The mangrove signature is distinct, and it extends west beyond the mosquito impoundment dike
- The mosquito impoundment dike appears maintained
- Three exposed oyster bars are visible, the same ones first observed in 1994, possibly some other oyster bars (dark areas) are visible in the same area, but beneath the water
- There is no sign there was offsite citrus groves which are now completely forested

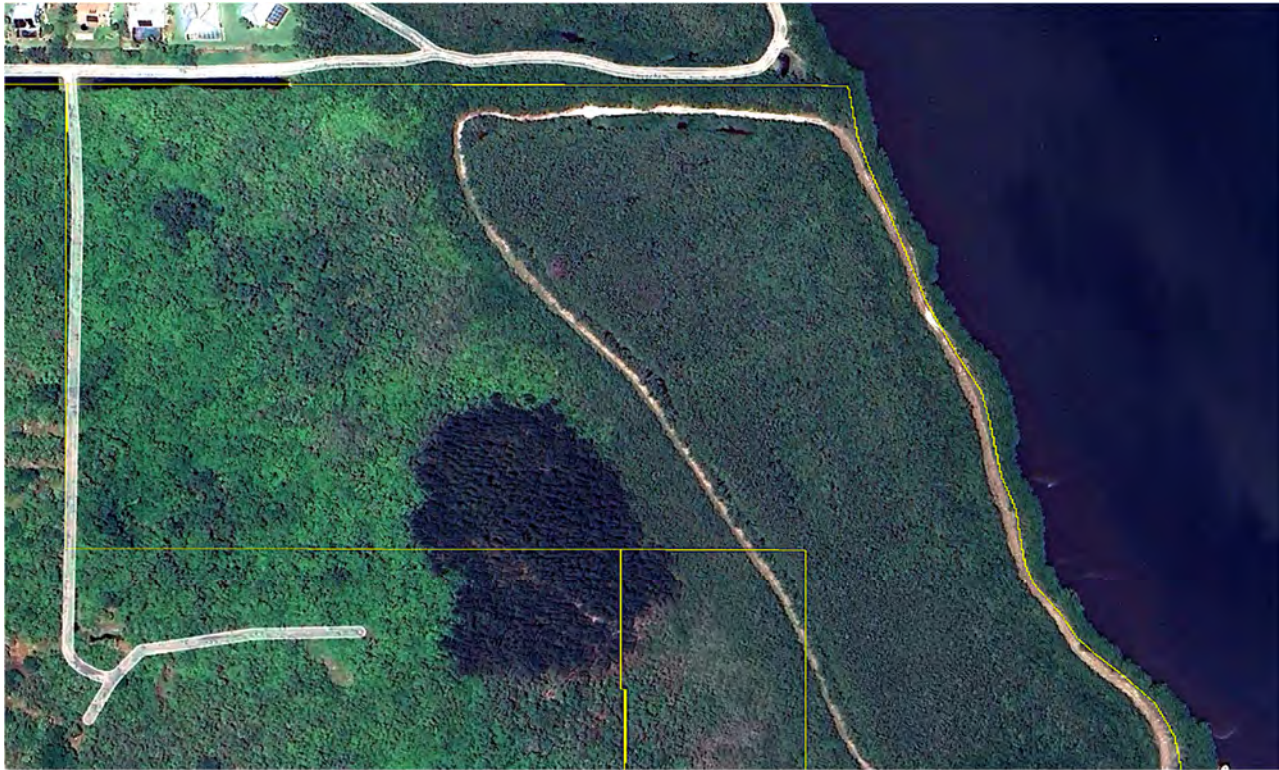
2024 Aerial Photograph

- The Australian pine patch looks intact, slightly larger with no sign of fallen trees
- The current CLC map designation for the invasive exotic Australian pine polygon is Mesic Flatwoods
- What was open pine flatwoods or citrus groves in 1943 is indistinguishable from what was called mixed hardwoods in 1943
- The former offsite citrus groves now have a similar aerial signature
- The saltmarsh, open in 1943, is a mosquito impoundment that is now a closed canopy mangrove swamp forest
- Three exposed oyster bars are visible, they might be slightly reduced in extent than when first observed in 1994
