**Osprey Estates Property**  
**Indian River County Environmental Bond**  
2024

**Water & Air Research, Inc.  
6821 Southwest Archer Road  
Gainesville, Florida 32608  
Project No. 24-6442**

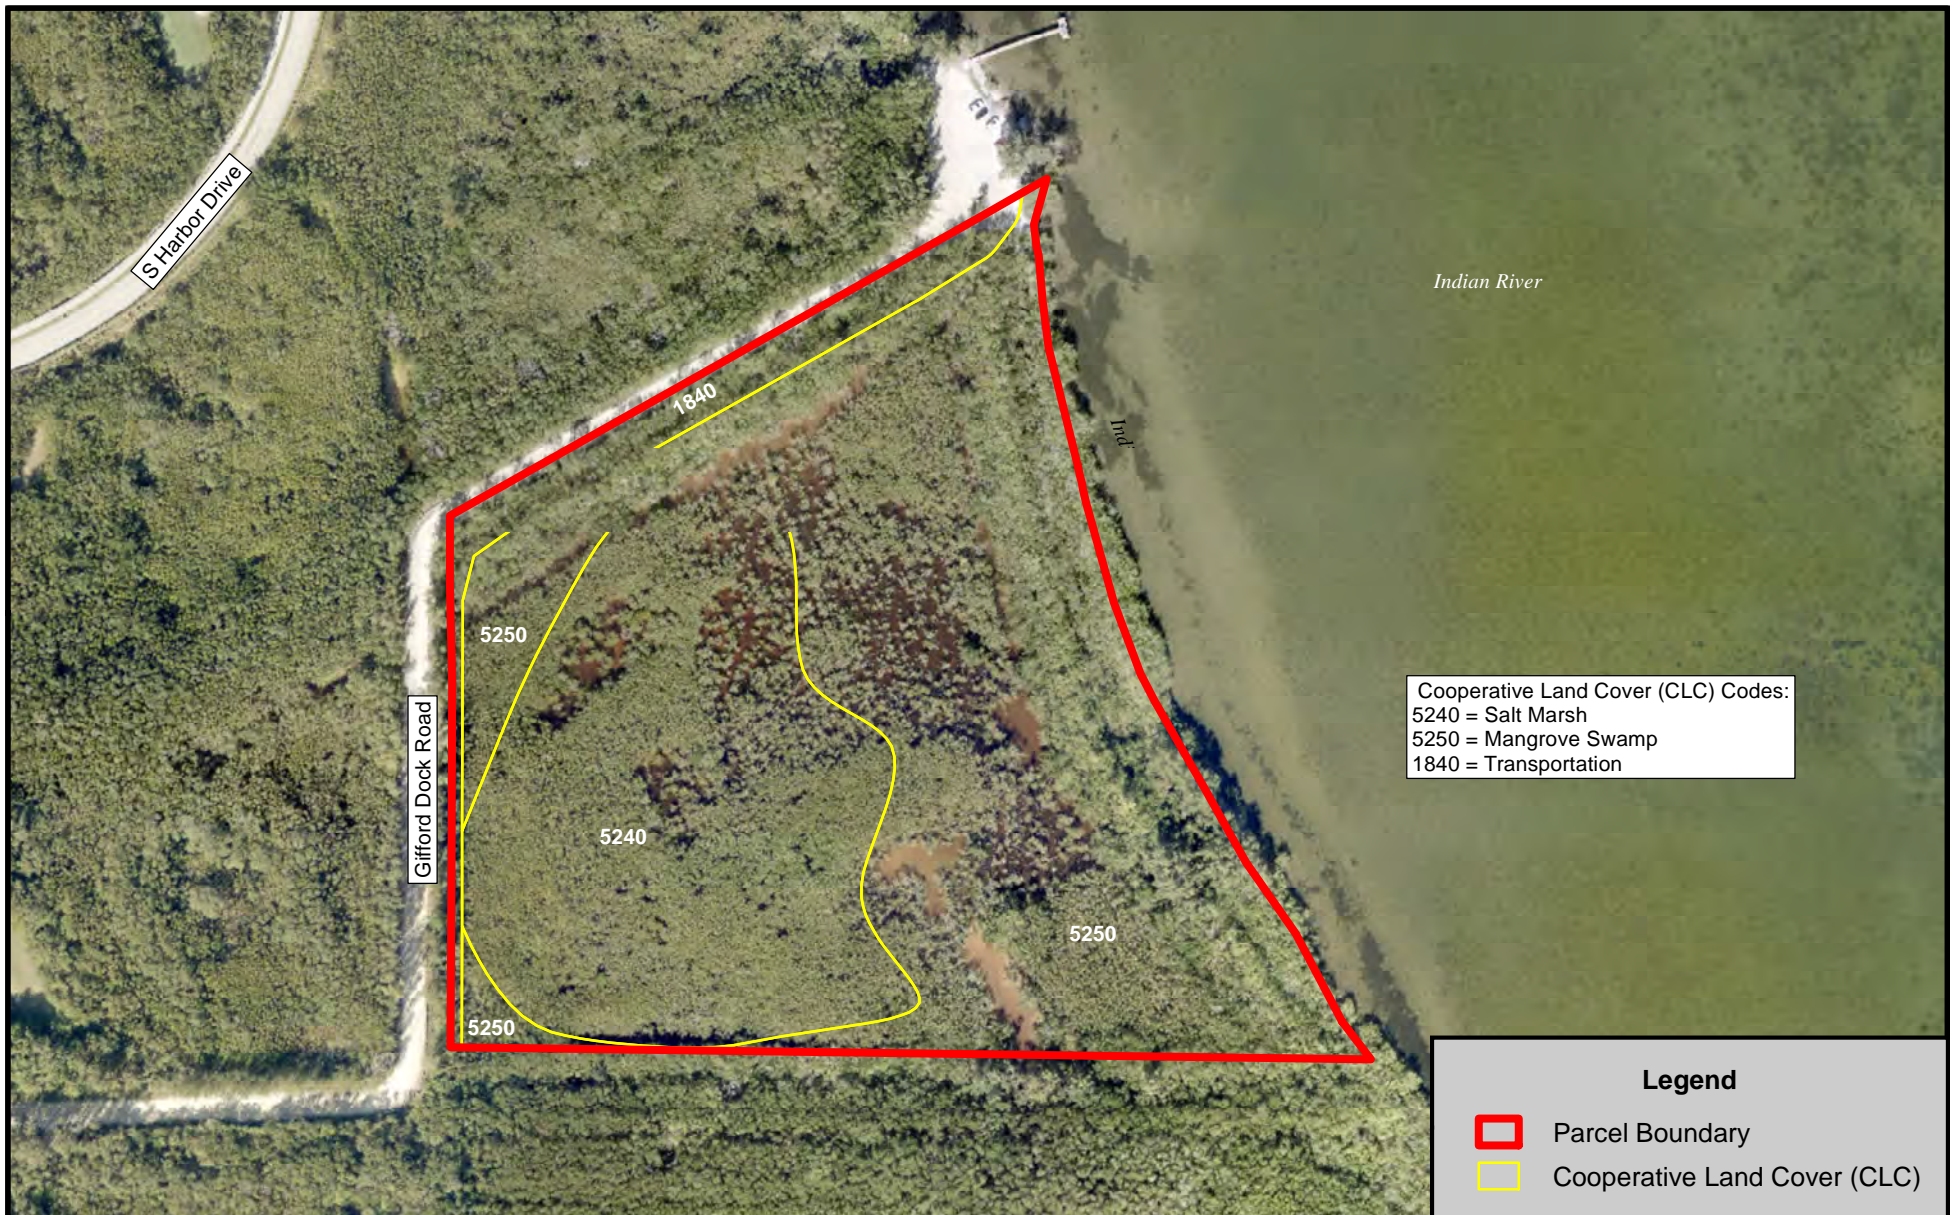
Figure 2.  
The Florida Cooperative Land Cover Map  
on the Osprey Estates Property  
Indian River County, Florida

There were two natural community types, and one altered land use type identified on the property from the 2023 Florida Cooperative Landcover Map (CLC) (Figure 2). Approximately 58 percent of the site consists of mangrove swamp interspersed with openings where there is relic salt marsh totaling less than 35 percent of the site (Table 1). A small area of roadway on the impoundment berm makes up the remainder (<1 percent) of the property. Figure 3 and Table 1 present the acreage of each land use and natural community type on the property.

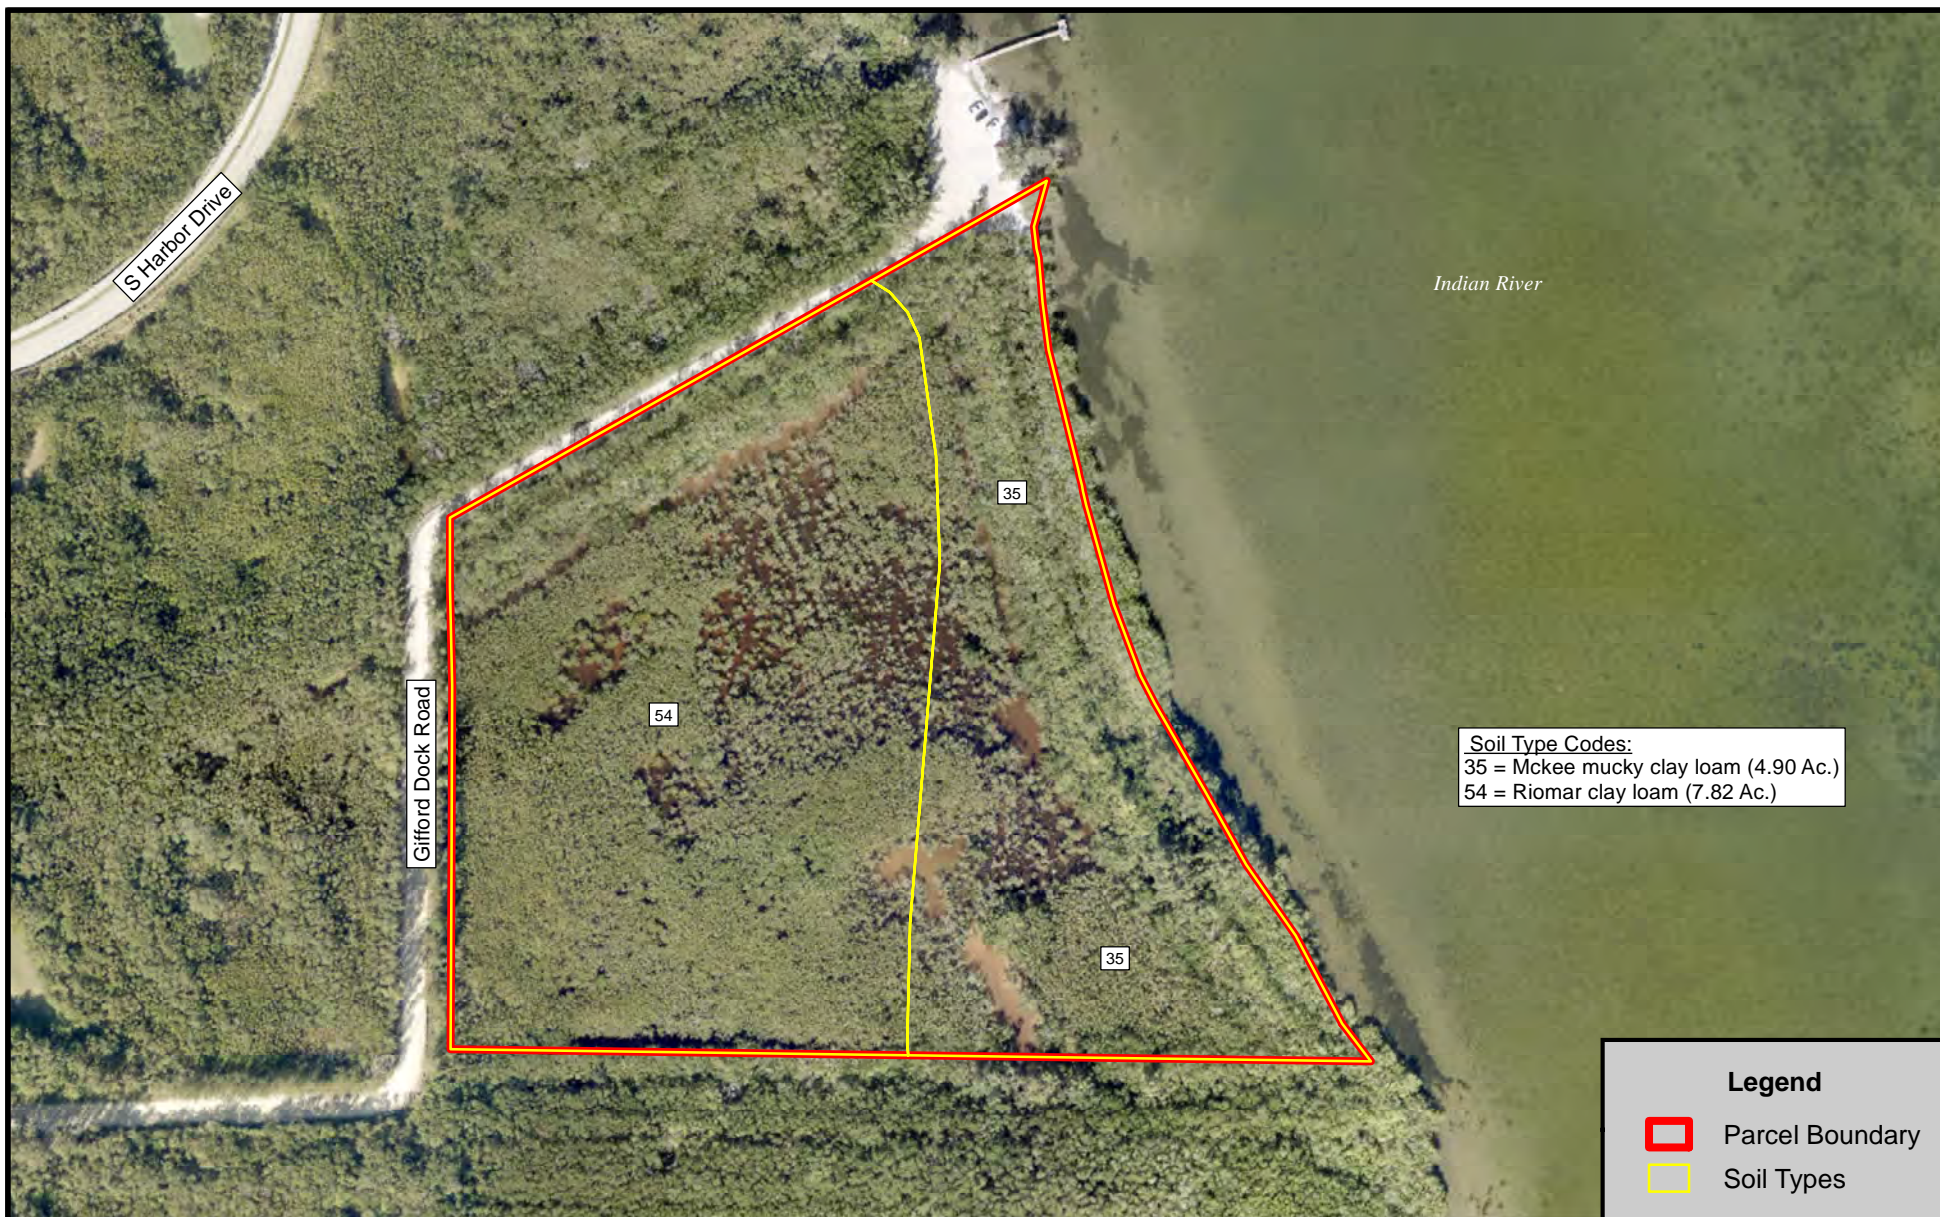
Figure 5.  
 The Soil Types Found on the  
 Osprey Estates Property  
 Indian River County, Florida

The soil types found on the Osprey Estates Property are represented in Figure 5.

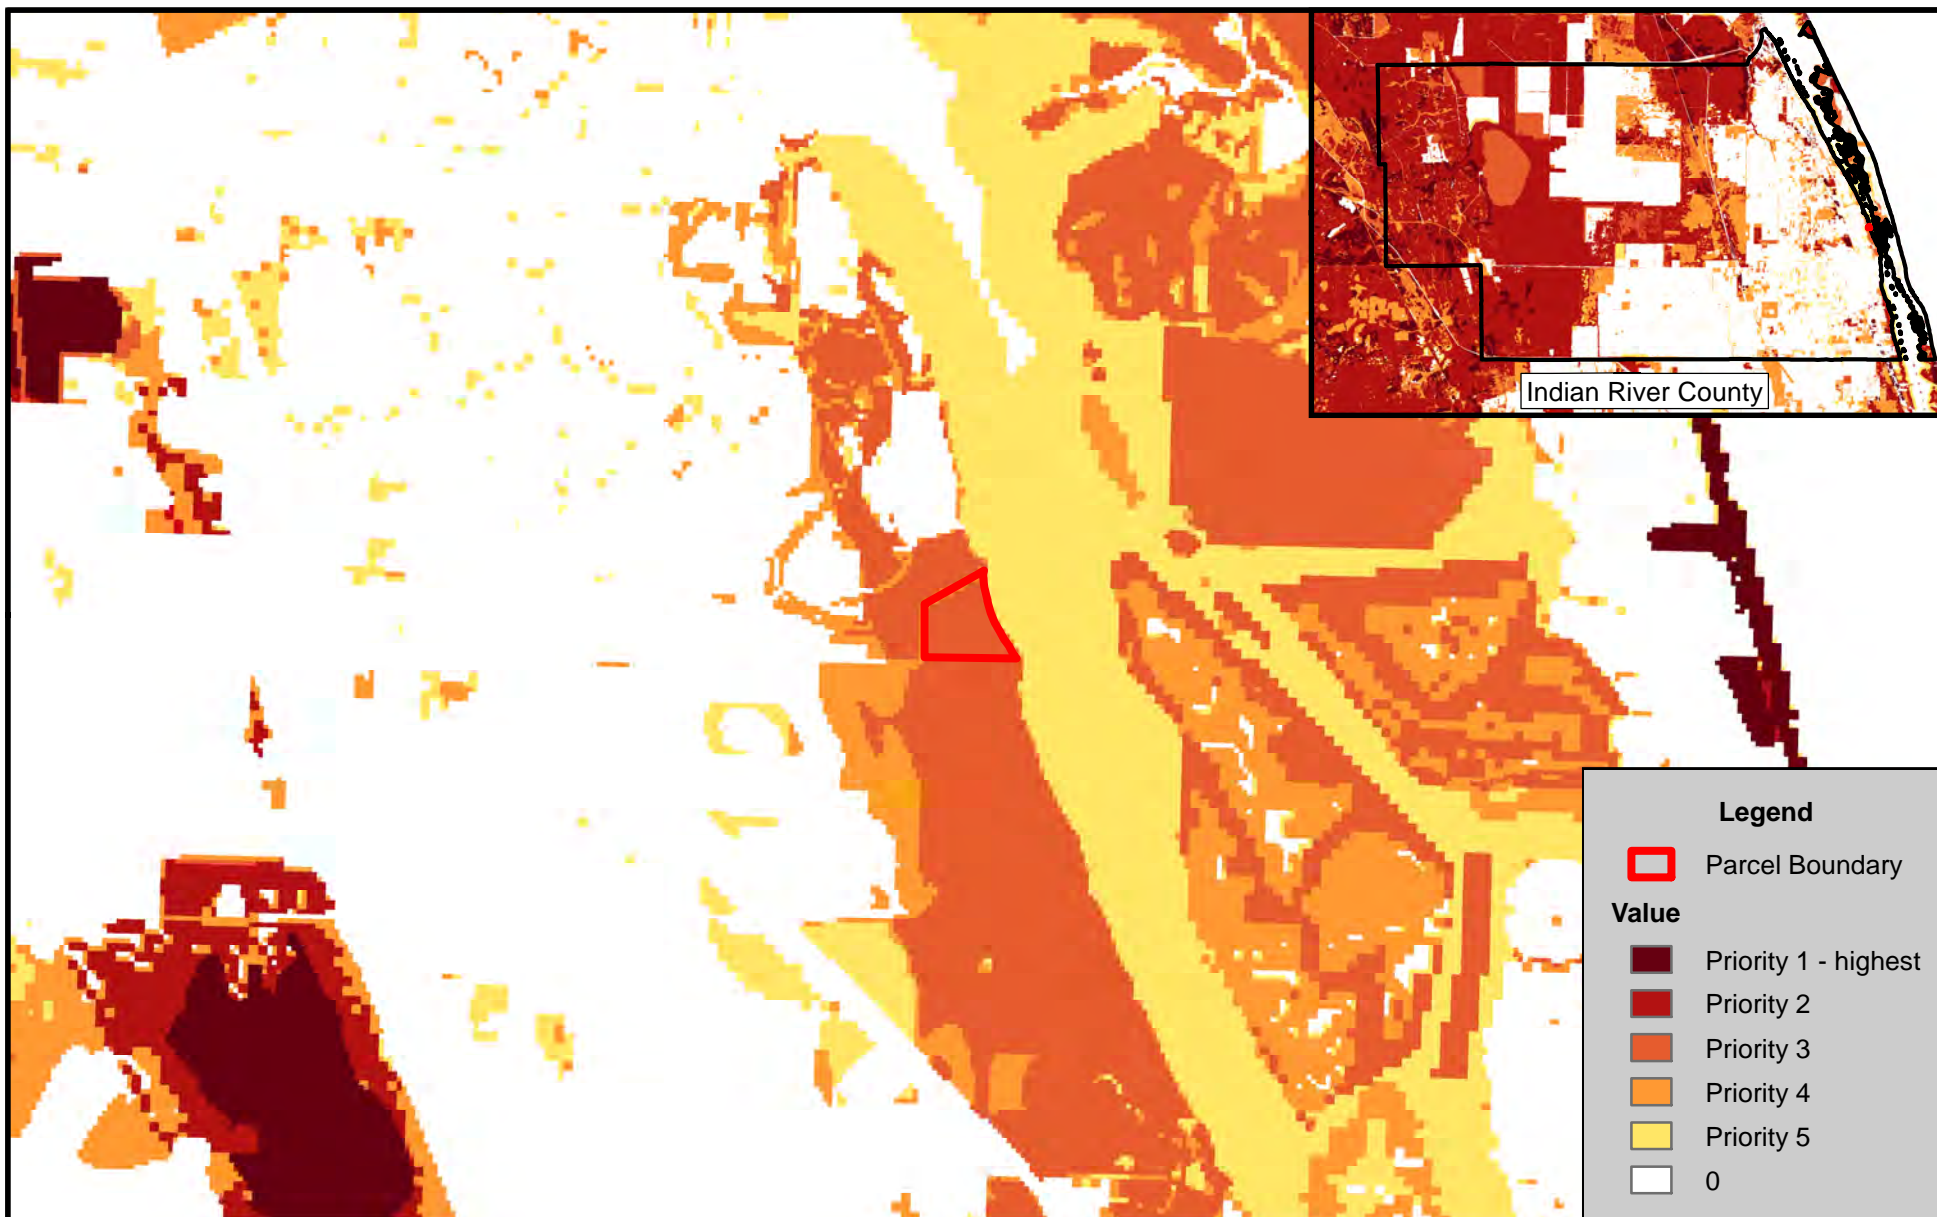
Figure 7.  
The Biodiversity Resource Priorities Model (CLIP 4.0)  
on the Osprey Estates Property  
Indian River County, Florida

Figure 7 shows the Critical Lands and Waters Identification Project (CLIP version 4.0) Biodiversity Resource Priorities model, which combines several conservation priorities models including the Strategic Habitat Conservation Areas for Florida Forever, Vertebrate Richness, Potential Rare Species Habitat, and Priority Natural Communities Core Data layers. The property is mapped as Priority 3 (Priority 1 has the highest conservation priority on a scale from 1 to 5) (Figure 7).

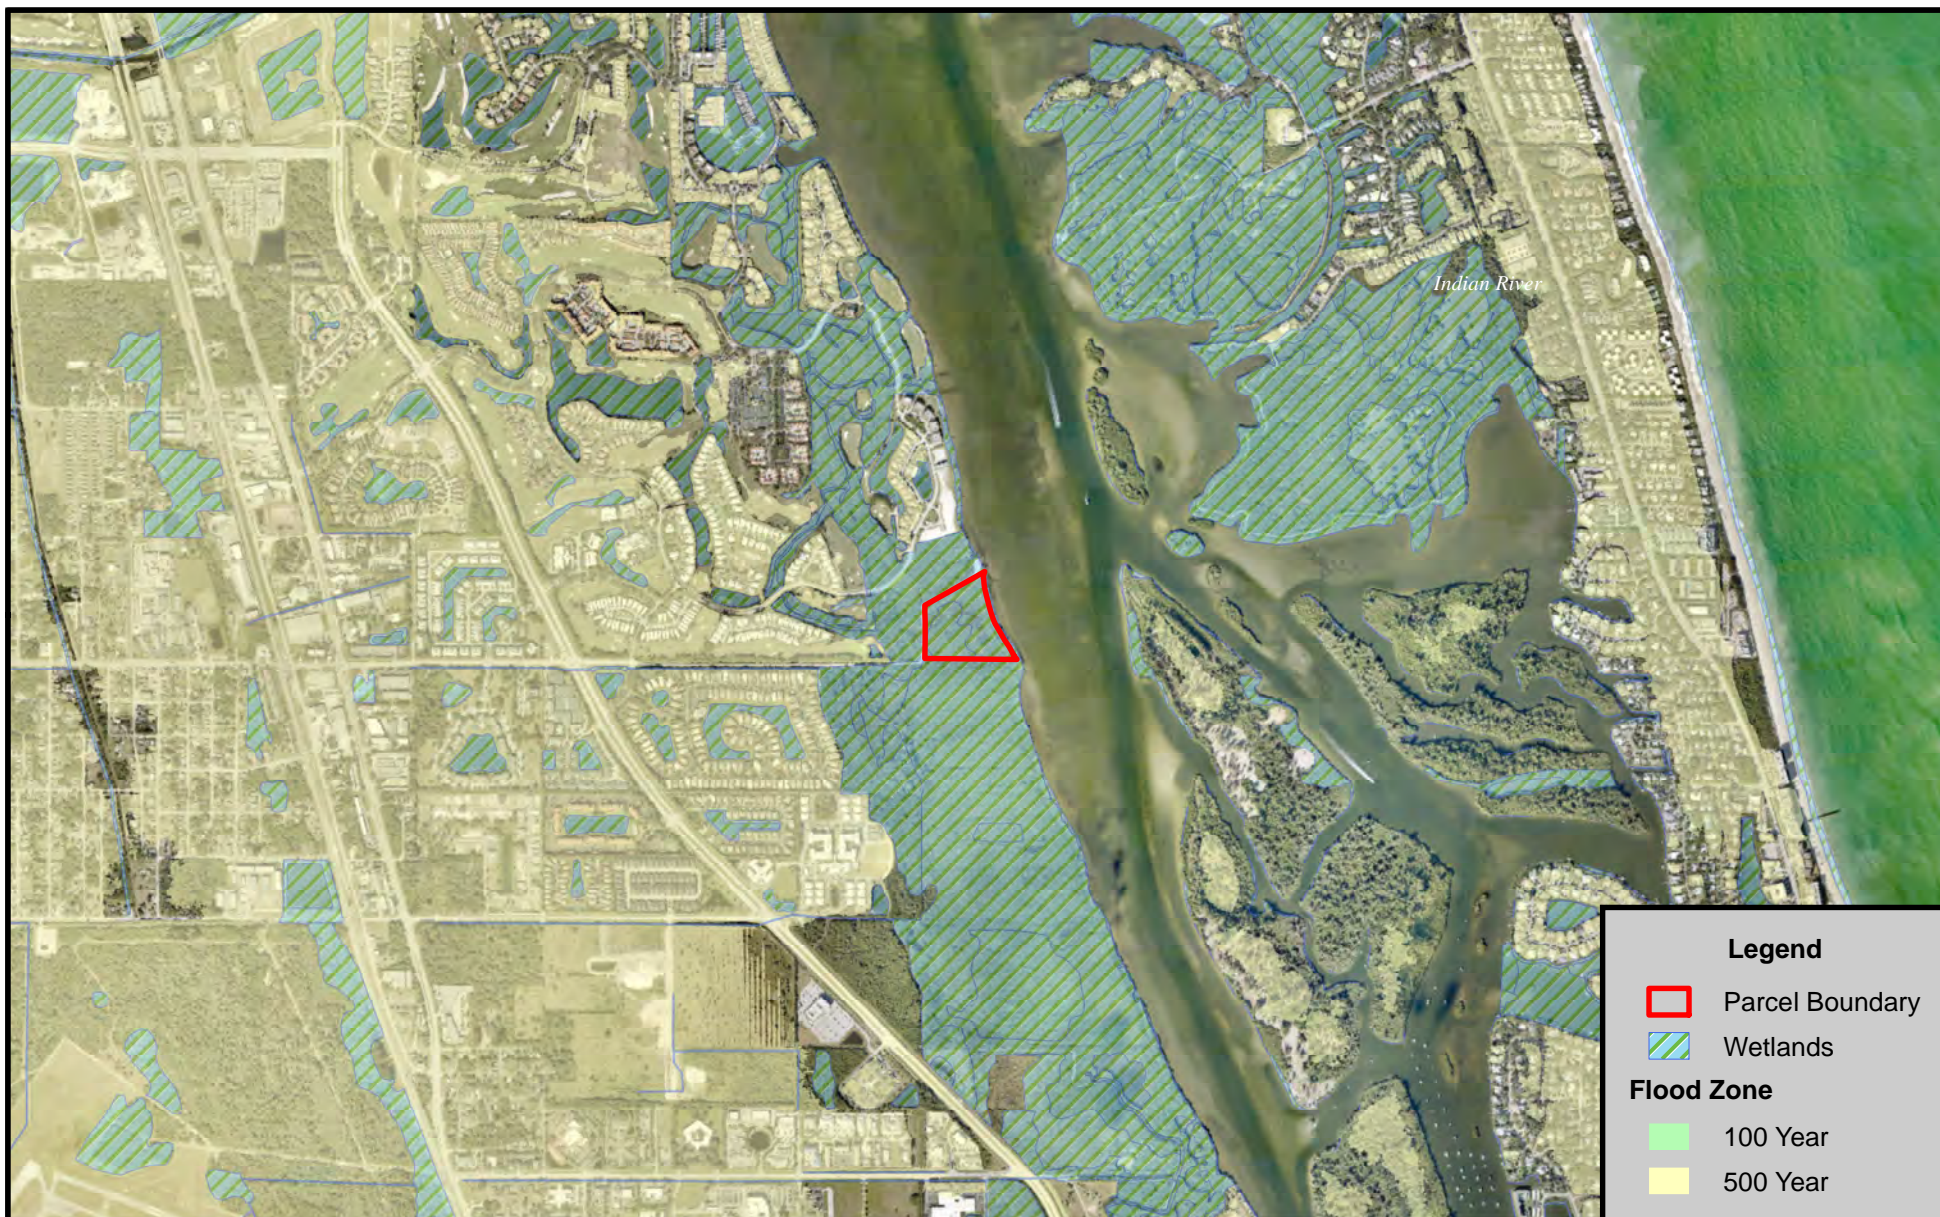
Figure 8.  
The NWI Wetlands and FEMA Flood Zones  
on the Osprey Estates Property  
Indian River County, Florida

Figure 8 shows the wetlands, waterbodies, and flood zones located on the property from the National Wetlands Inventory (NWI) and Federal Emergency Management Agency (FEMA) maps. The NWI map identified 12.7 acres of wetlands, a total of 100 percent of the site was typed as Estuarine and Marine wetlands.

The onsite wetlands appear to be hydrologically isolated from the Indian River. It is not clear if there is a Rotational Impoundment Management Plan or Modified Rotational Impoundment Management currently being administered to the Triangle Impoundment. The onsite wetlands may not be hydrologically connected to the Indian River or adjacent wetlands; however, the site is contiguous with the surrounding areas that are undeveloped and have wetland natural communities.

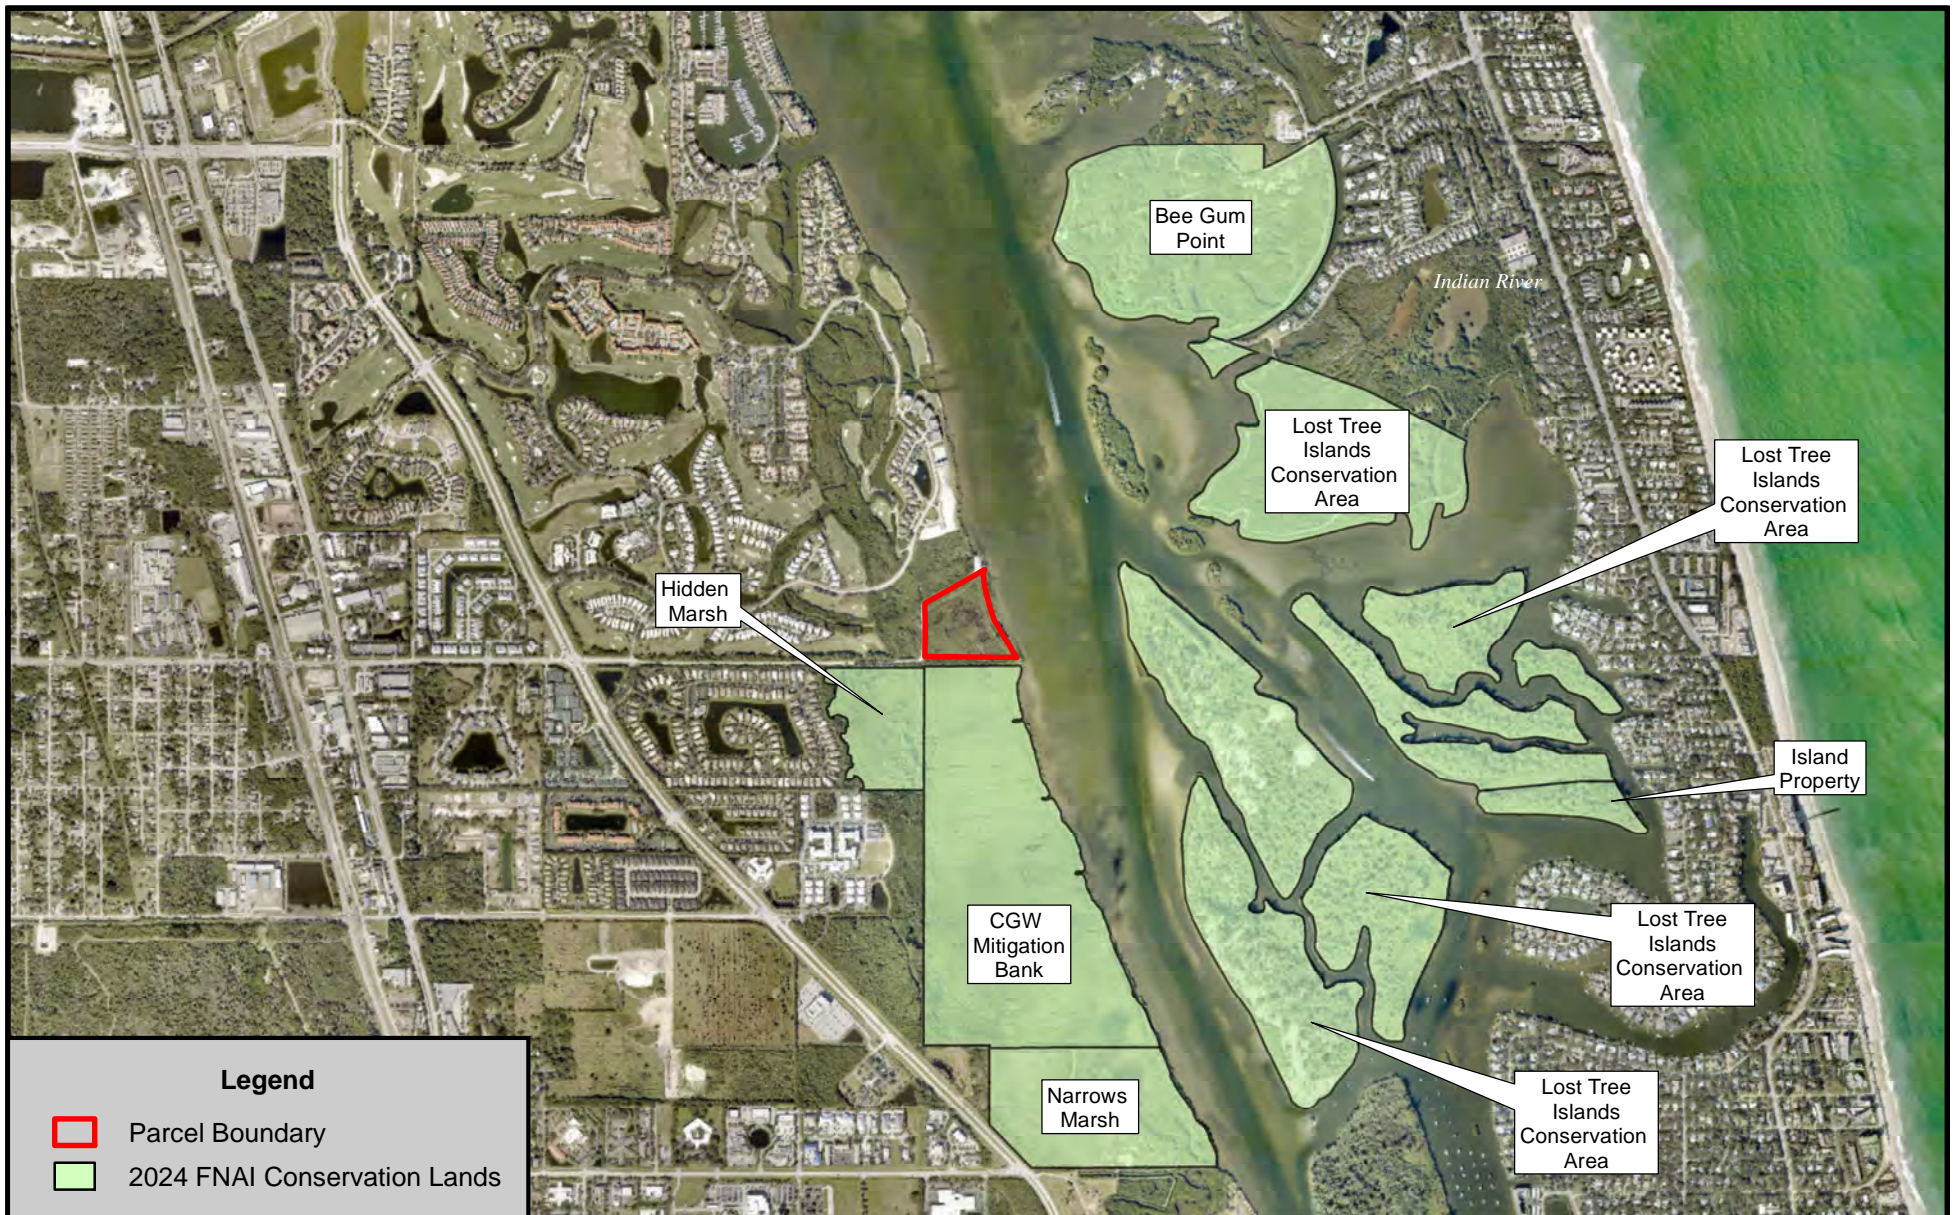
Figure 10.  
The Osprey Estates Property  
and the Conserved Lands in the Vicinity  
Indian River County, Florida

The proposed Osprey Estates Property is contiguous with the CGW Mitigation Bank to the south, which is contiguous with other privately owned conserved properties (Hidden Marsh, Narrows Marsh, Bridgeview) totaling more than 228 acres (Figure 10). East across the Indian River from the parcel is more than 508 acres within the Lost Acres Conservation Area.

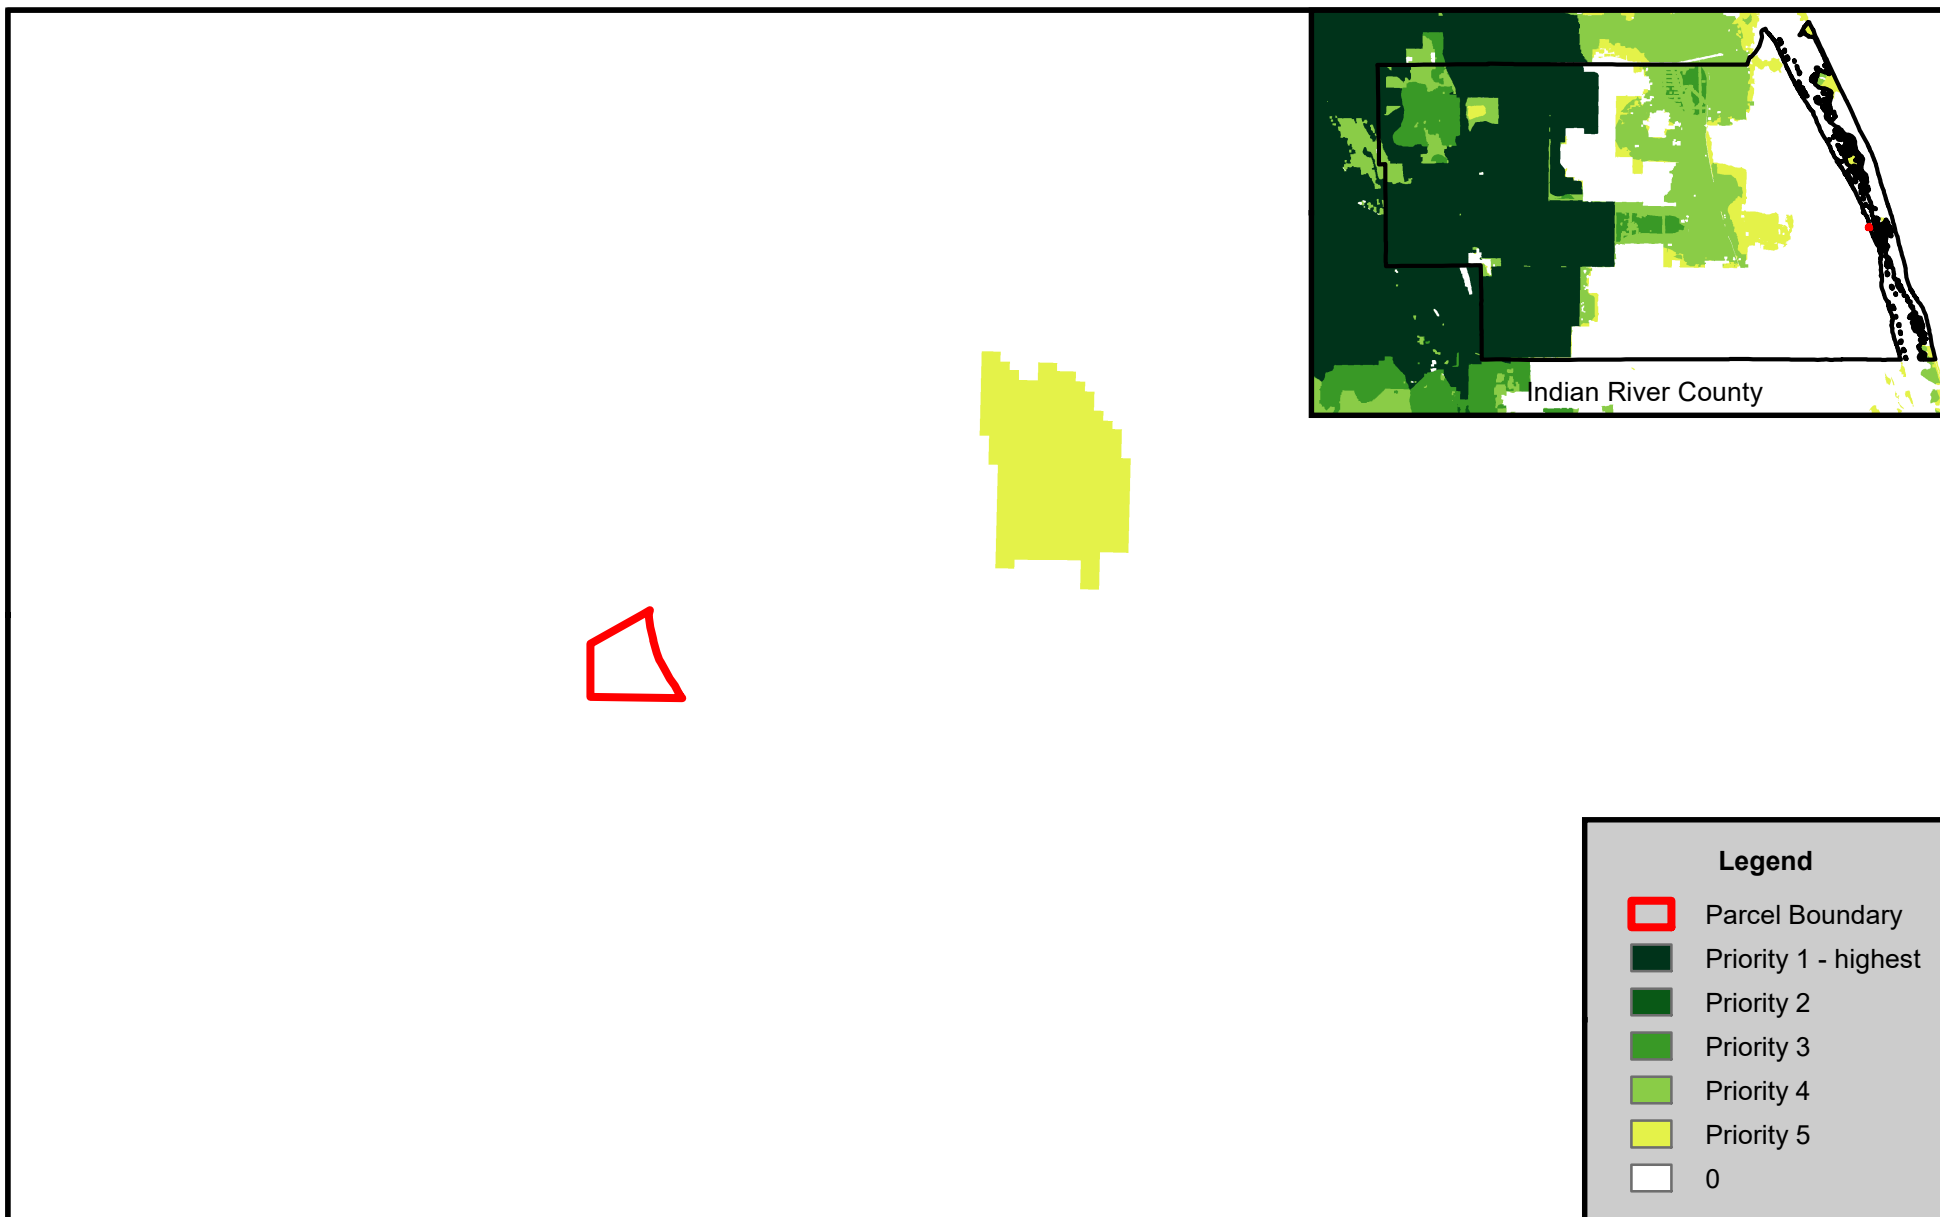
Figure 11.  
The Landscape Resource Priorities Model (CLIP 4.0)  
on the Osprey Estates Property  
Indian River County, Florida

Figure 11 shows the CLIP landscape priority ranking for the property. This model combines priorities from the Ecological Greenways and Landscape Integrity Core Data layers. No portion of this property was ranked a priority.

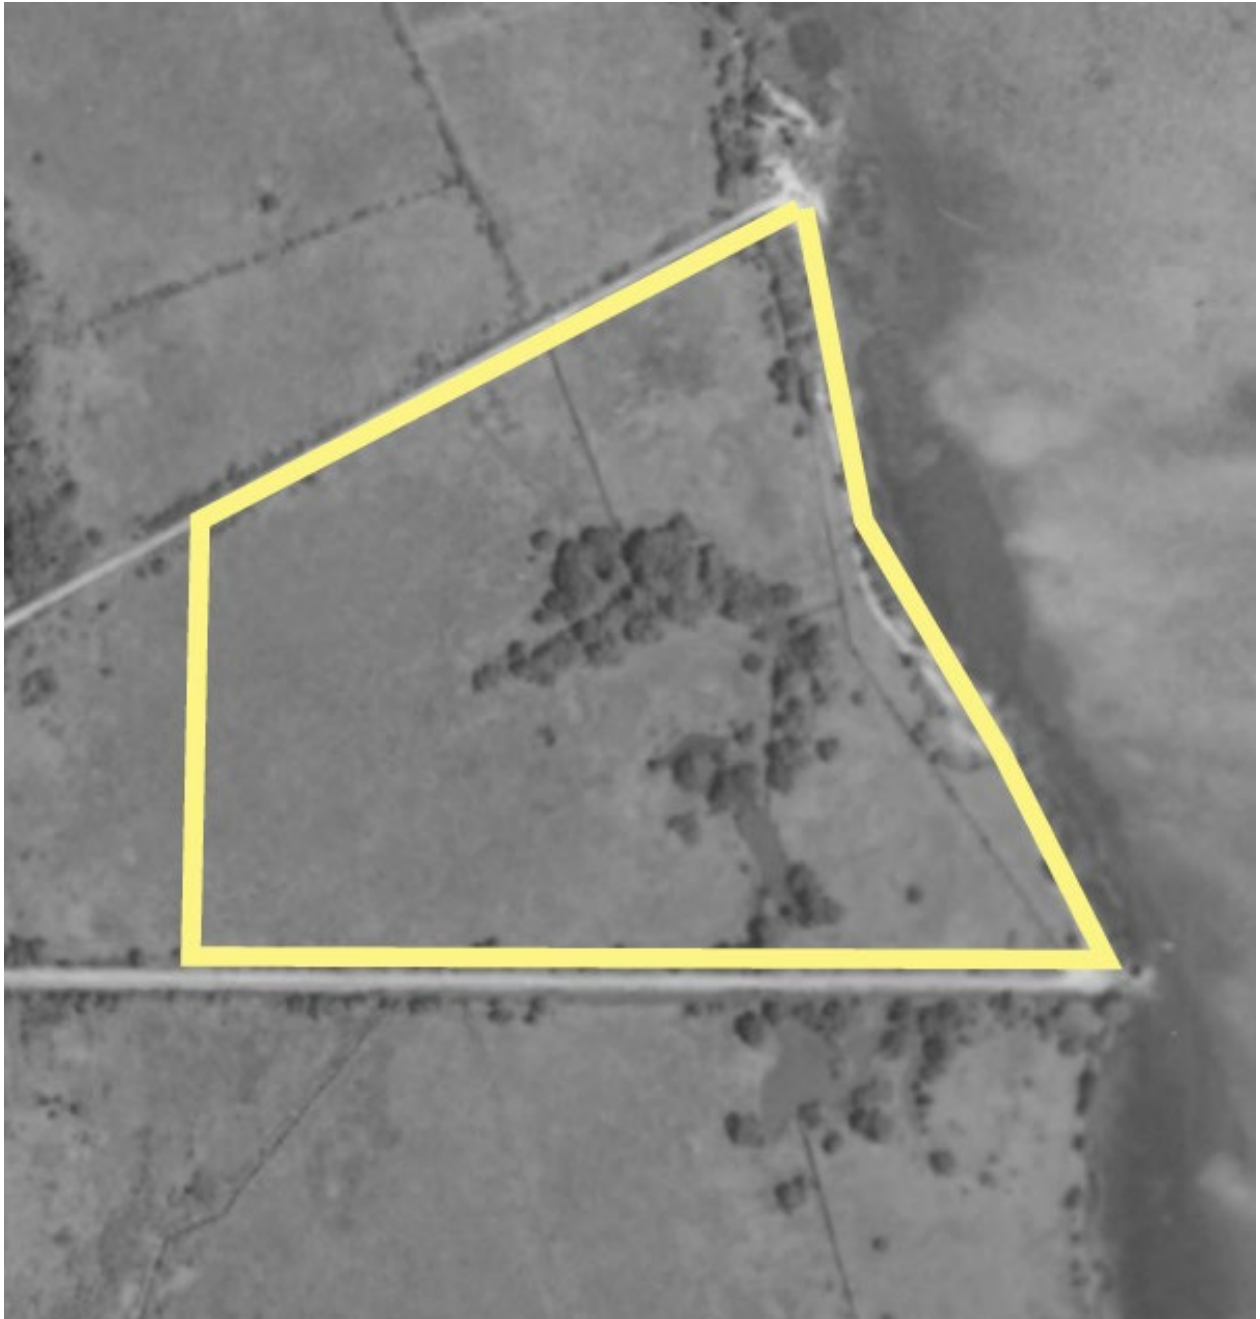
1943 Aerial Photograph

- The site is predominantly saltmarsh dominated by herbaceous species
- there is a small clump of mangroves and possibly Brazilian pepper shrubs (approximately 1/10 of the area) near the center of parcel
- There appears to be two small tidal pools or mudflats near the south-central boundary

- There is a thin ditch that runs staggered through the parcel from north to south and the mangroves appear to be associated with berms from the ditching

- Raised (likely gravel) roads form the southern and northern boundaries and are likely on berms from the start of the construction of the mosquito impoundment
- There appears to be a small berm along a portion of the riverfront

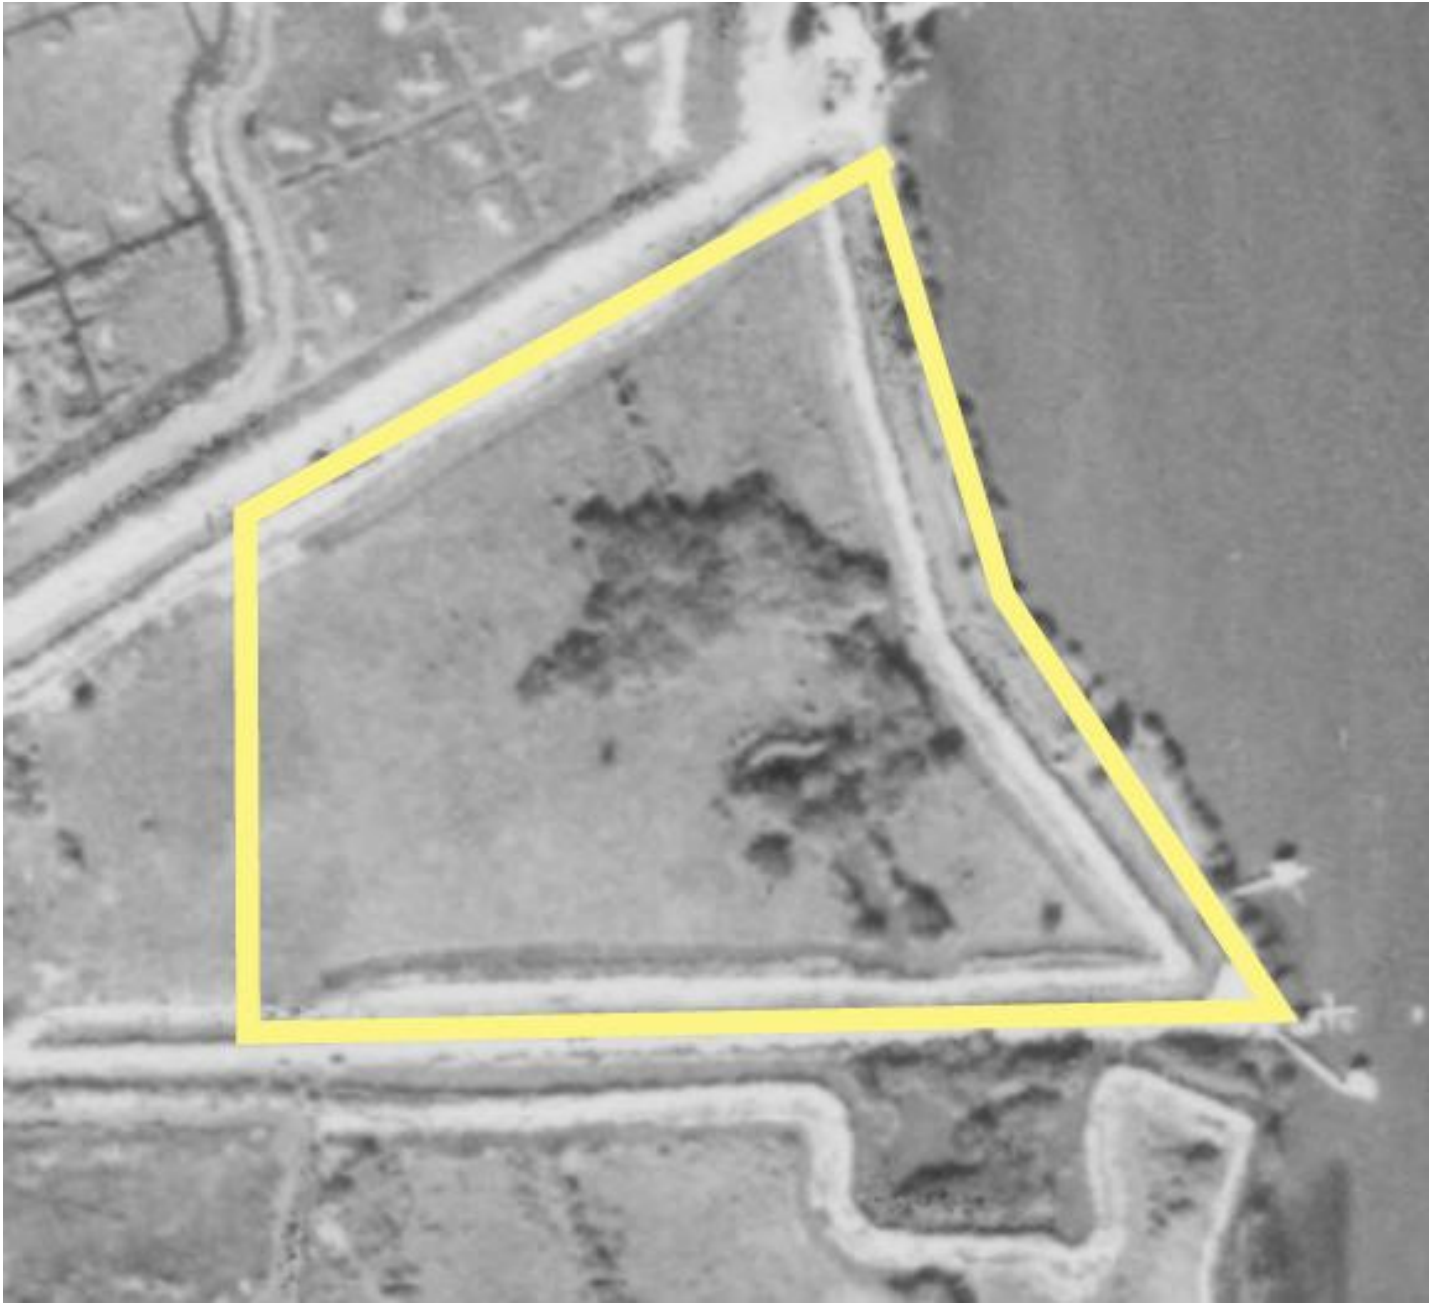
1957 Aerial Photograph

- The north and south boundary roads have been widened and there appears to be a parallel ditch and berm
- A ditch and berm now run along the eastern boundary inland and parallel to the river shore, effectively closing the impoundment from tidal flushing
- Salt marsh is still the most dominant natural community though the mangroves and shrubs have increased slightly from the 1943 aerial
- Two or three docks have been installed at the terminus of the southern boundary road
- The narrow interior ditches are not as obvious
- There are three tidal pools or mudflats apparent within the impoundment berms

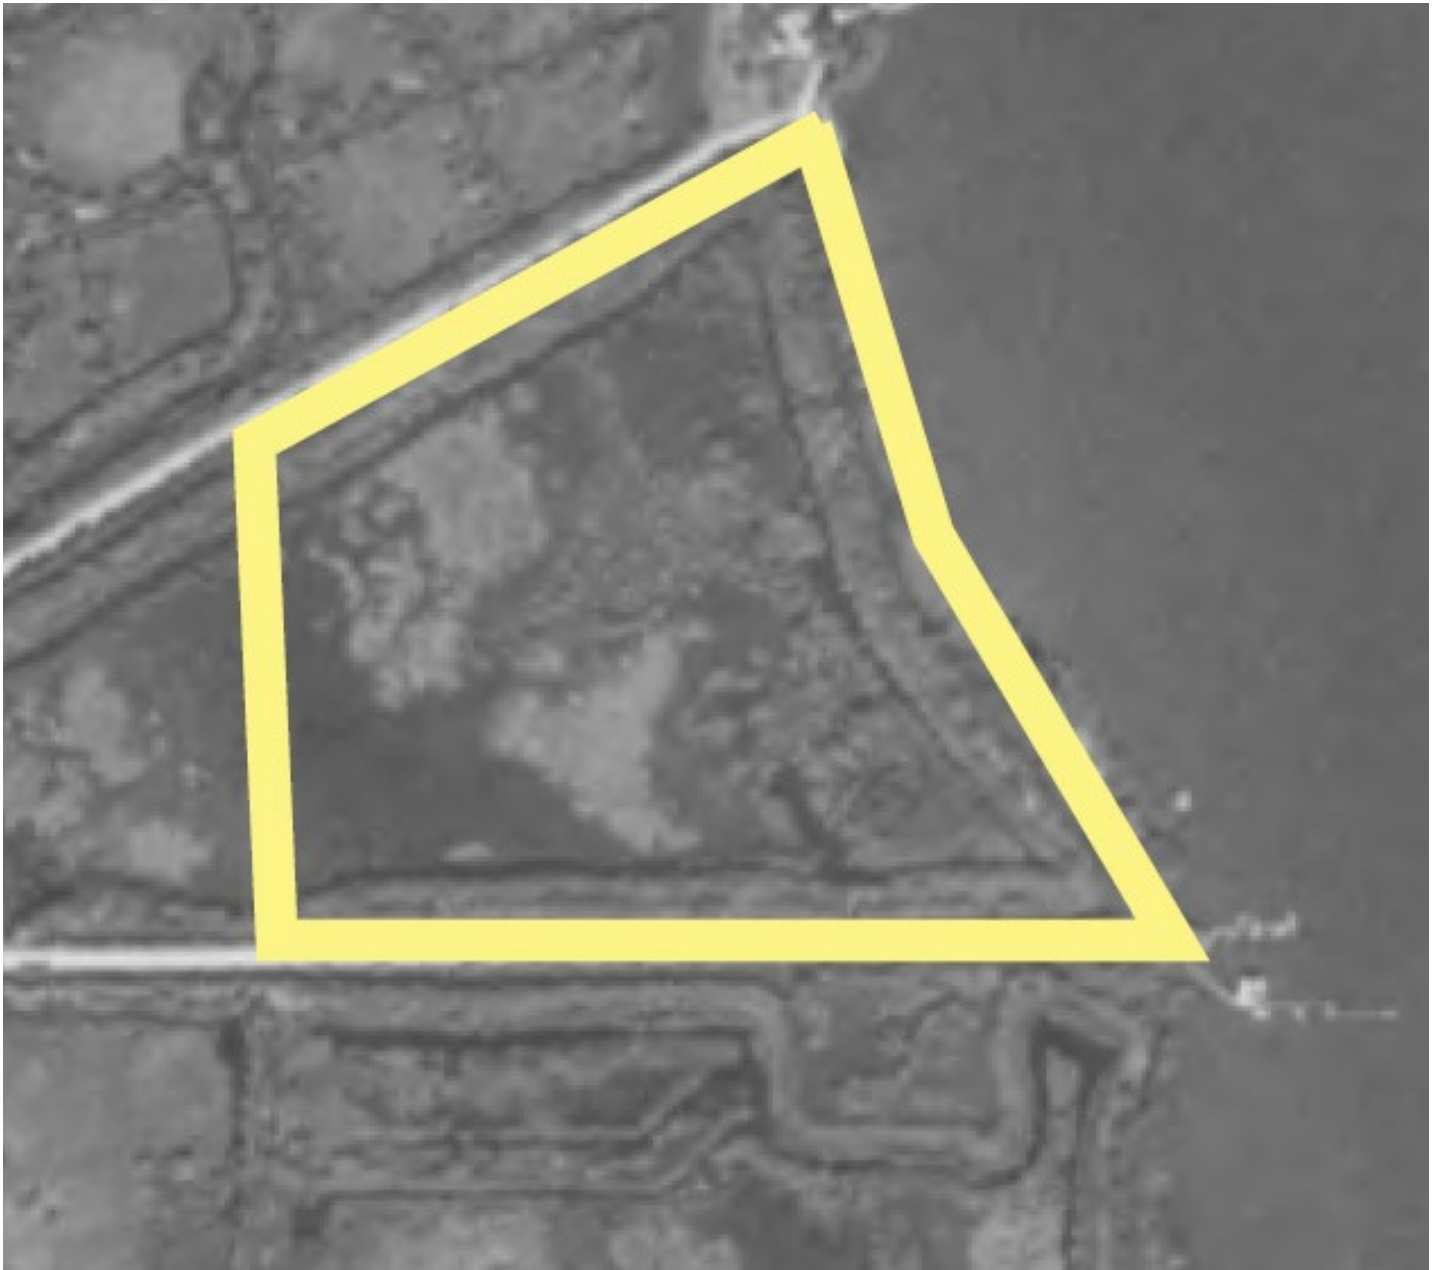
1970 Aerial Photograph

- Only a small amount ( $<1/4$ ) of the salt marsh is evident, the remainder of the site appears flooded with a slight increase in shrubs

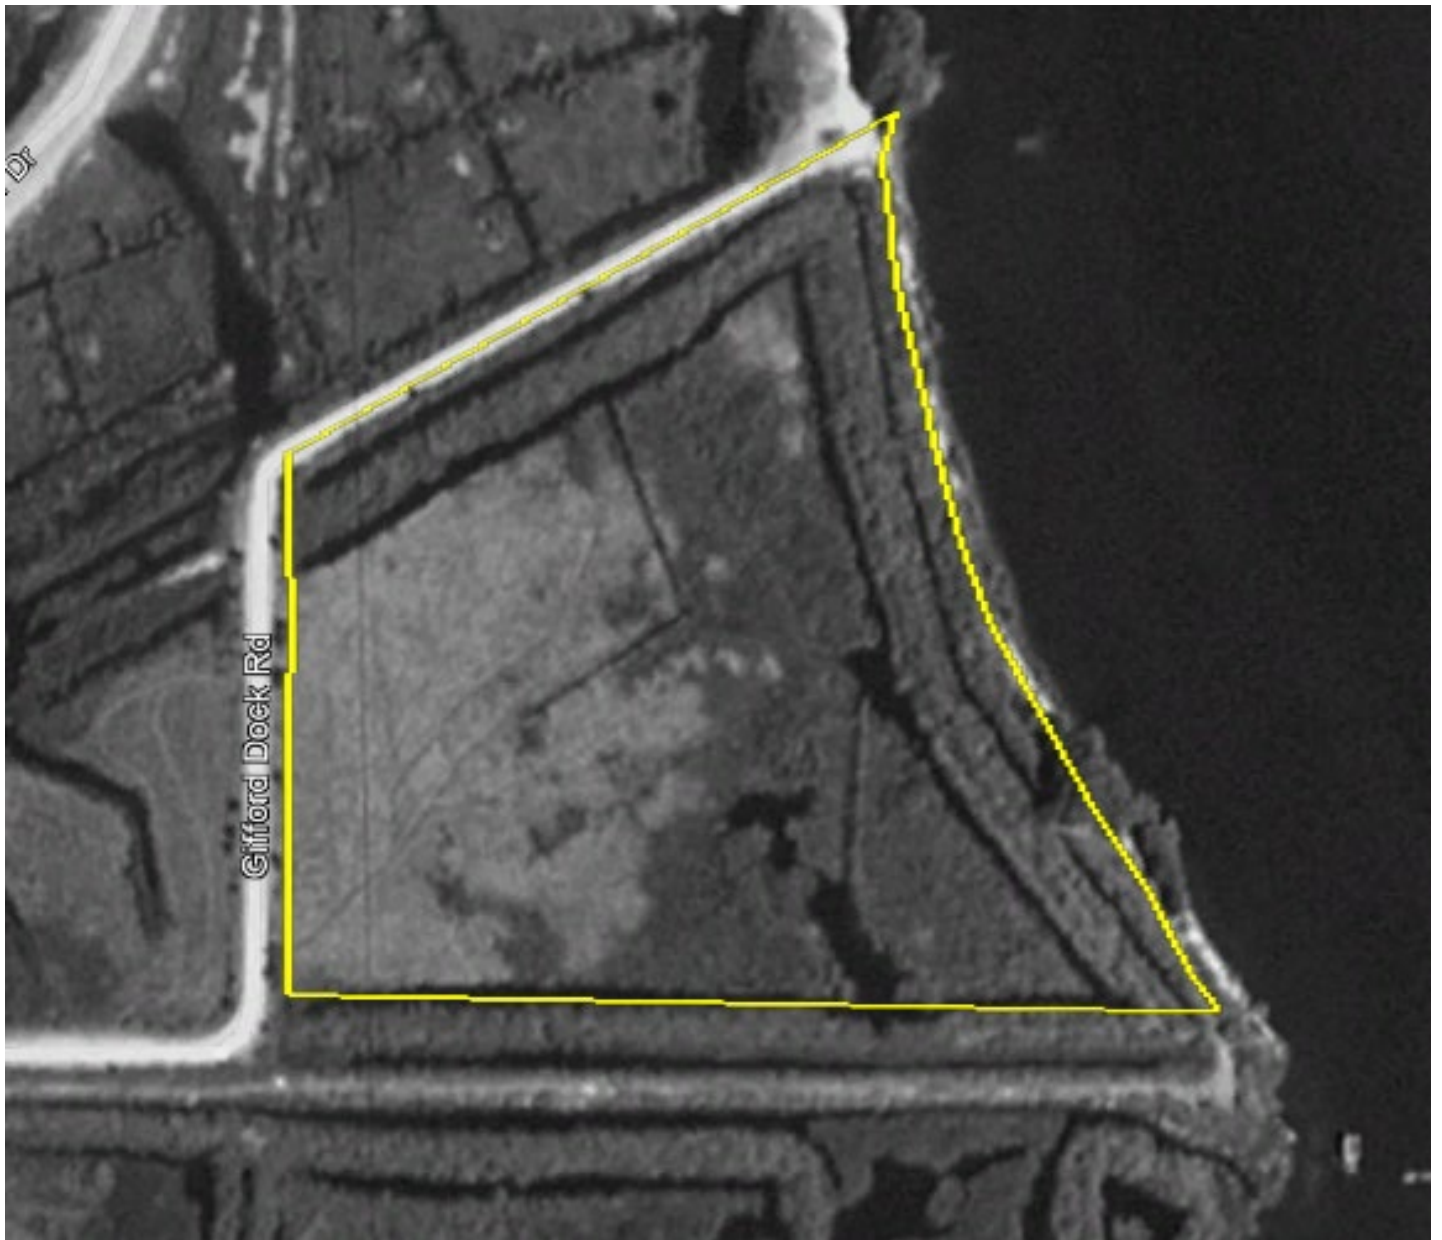
1994 Aerial Photograph

- Gifford Dock Rd now forms the west and boundaries of the property
- Salt marsh appears to have increased slightly from the 1970 photo and covers approximately 1/3 of the parcel concentrated on the west side
- The mangrove shrubs have increased slightly but look shorter than the 1943 aerial
- The berms are now covered in shrubs
- The ditches are flooded as are the three tidal pools, the pools are all connected by a series of ditches, and this may be a result of Open Marsh Water Management Mosquito control techniques
- There appears to be a new narrow ditch that extends into the salt marsh habitat
- The docks at the end of the southern road are no longer apparent and the road appears to have been closed and only a ditch and forested berm remain
