**Osprey Estates Property**  
**Indian River County Environmental Bond**  
2024

**Water & Air Research, Inc.  
6821 Southwest Archer Road  
Gainesville, Florida 32608  
Project No. 24-6442**

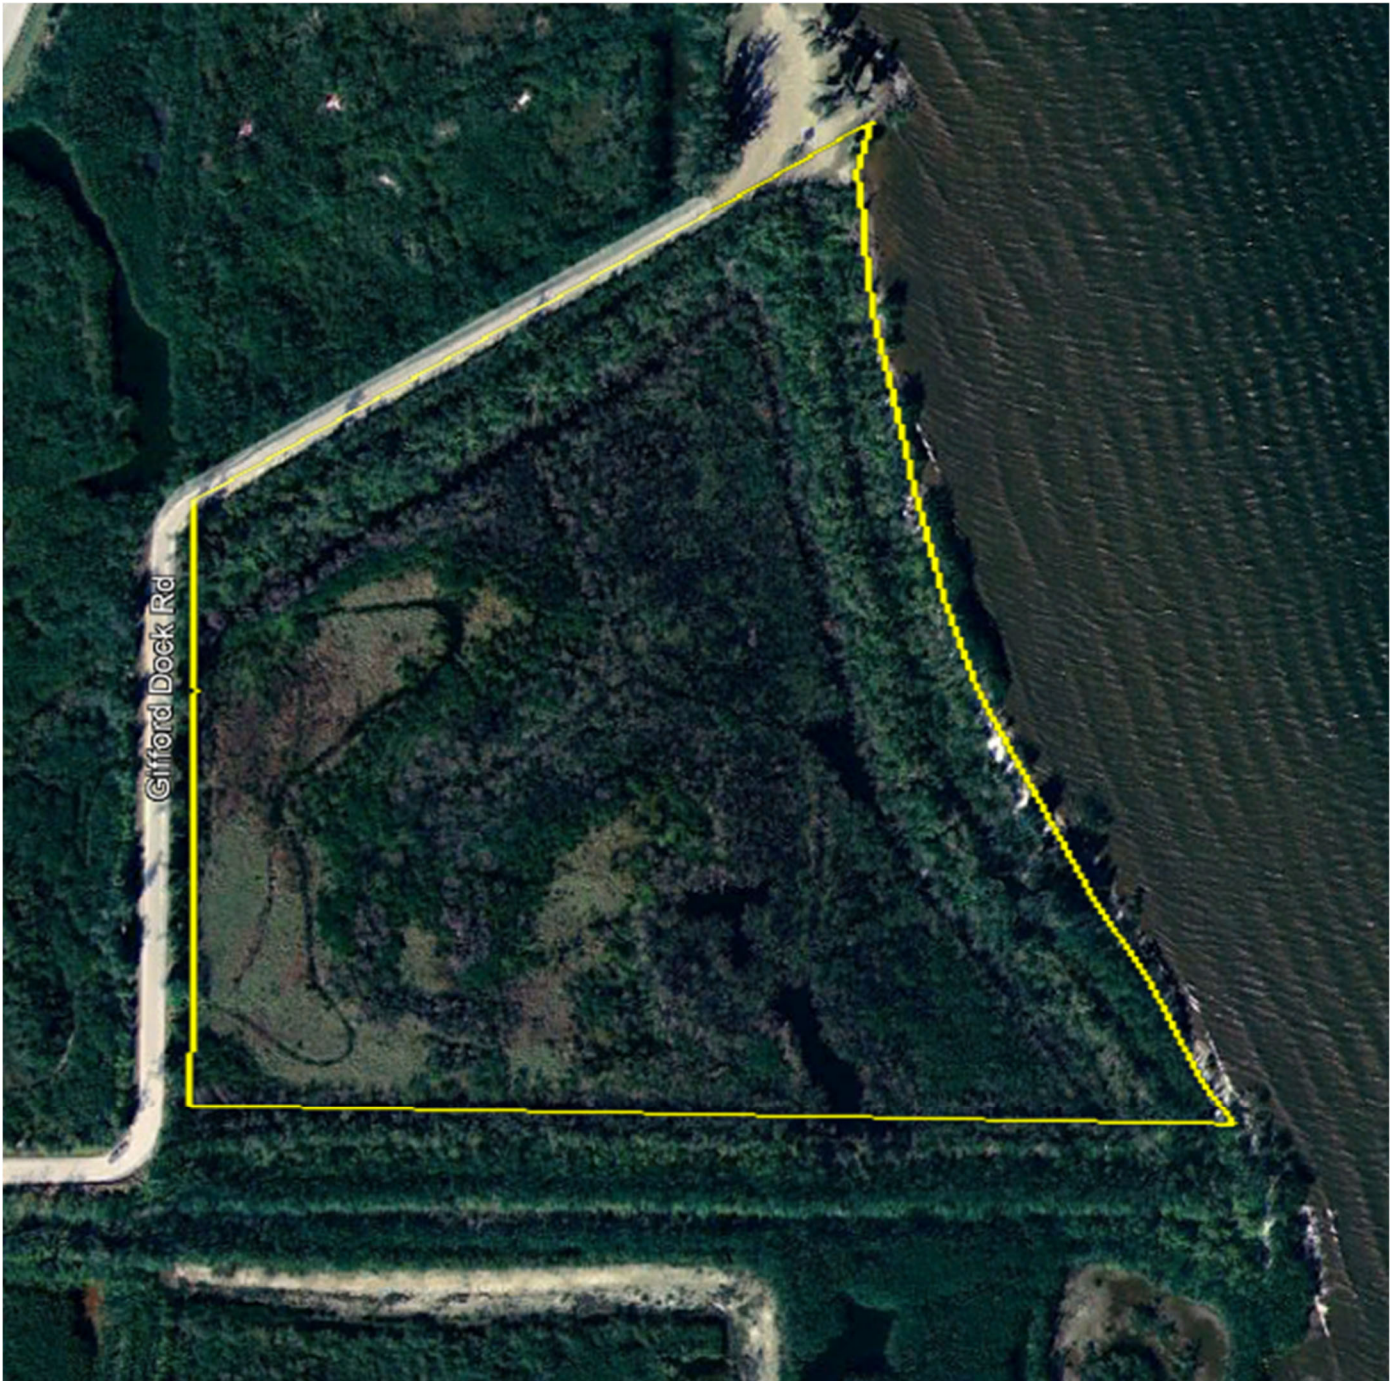
2005 Aerial Photograph

- Only 1/10 of the site is covered in salt marsh
- The shrubs in the impoundment interior have a different signature than the shrubs along the berms (possibly mangroves versus Brazilian pepper)
- There are new sinuous ditches in the remaining salt marsh

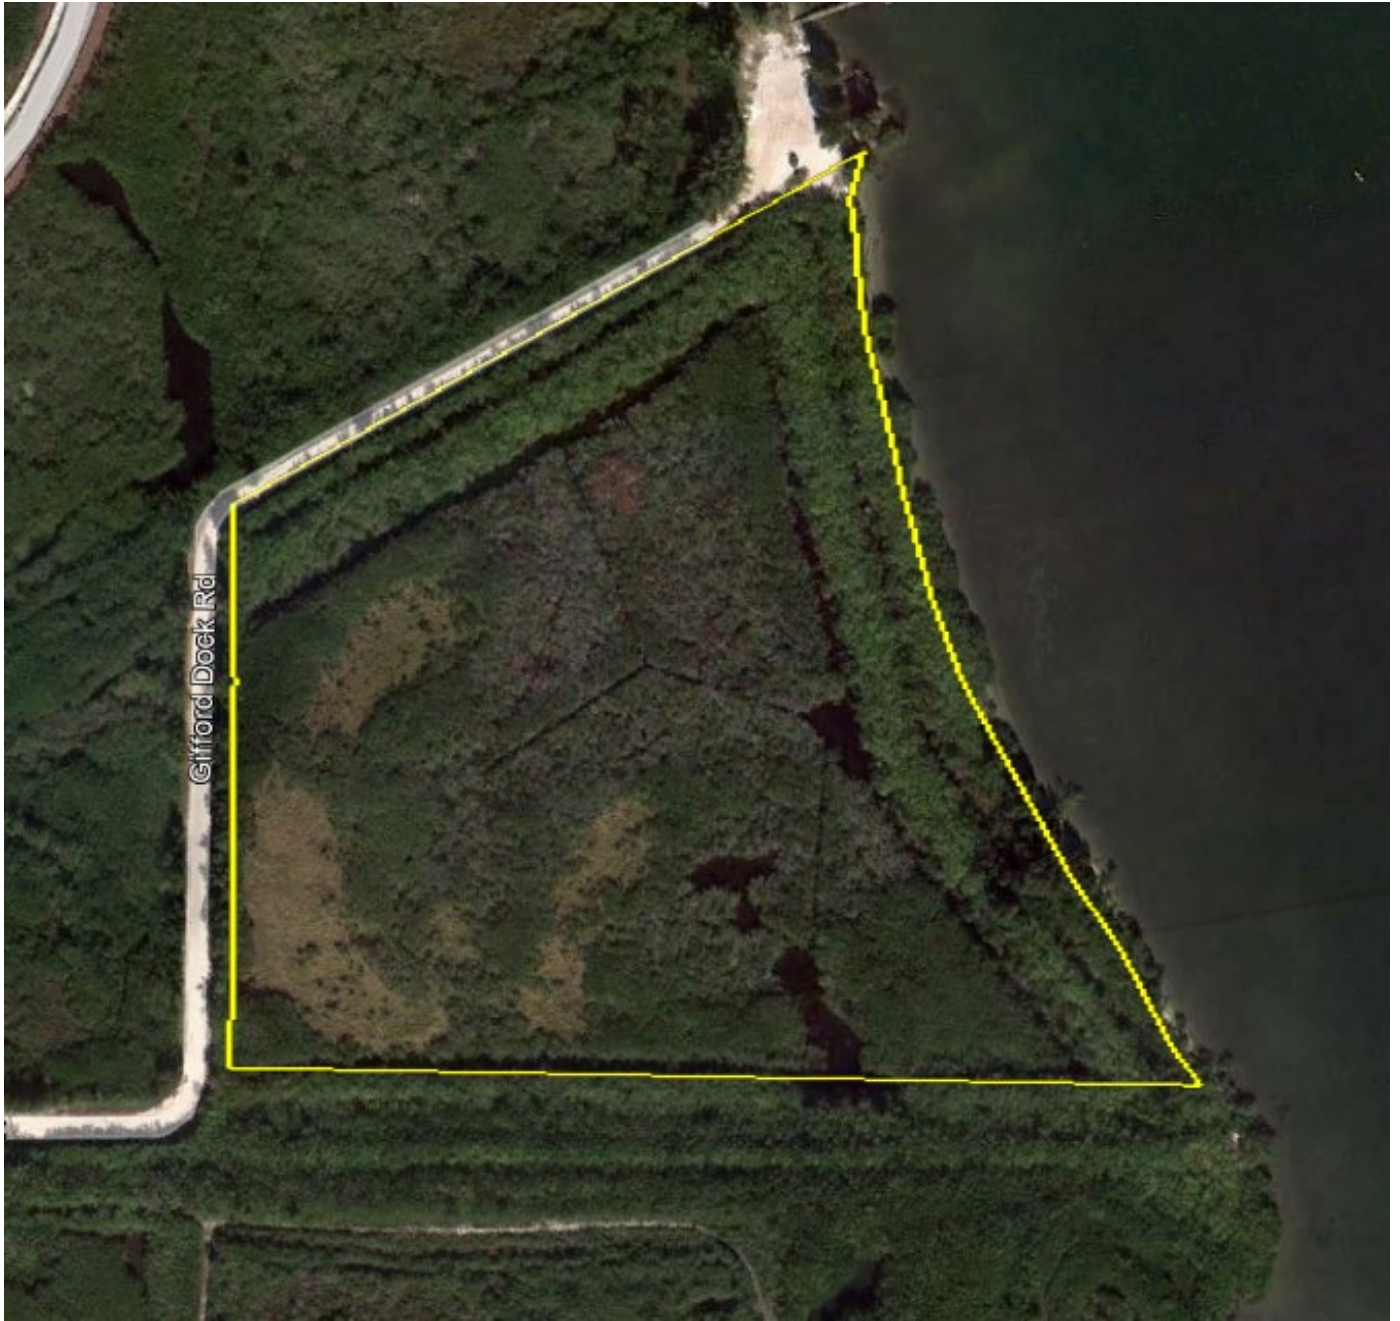
2010 Aerial Photograph

- Approximately 1/10 of the site is still covered in salt marsh
- The ditches and three tidal pools are inundated
- The dock at the end of Gifford Dock Rd is apparent
