**INDIAN RIVER COUNTY, FL
SECTOR 3 BEACH & DUNE RESTORATION PROJECT**

**STORM DAMAGE REPORT:
HURRICANES IAN & NICOLE**

March 2023

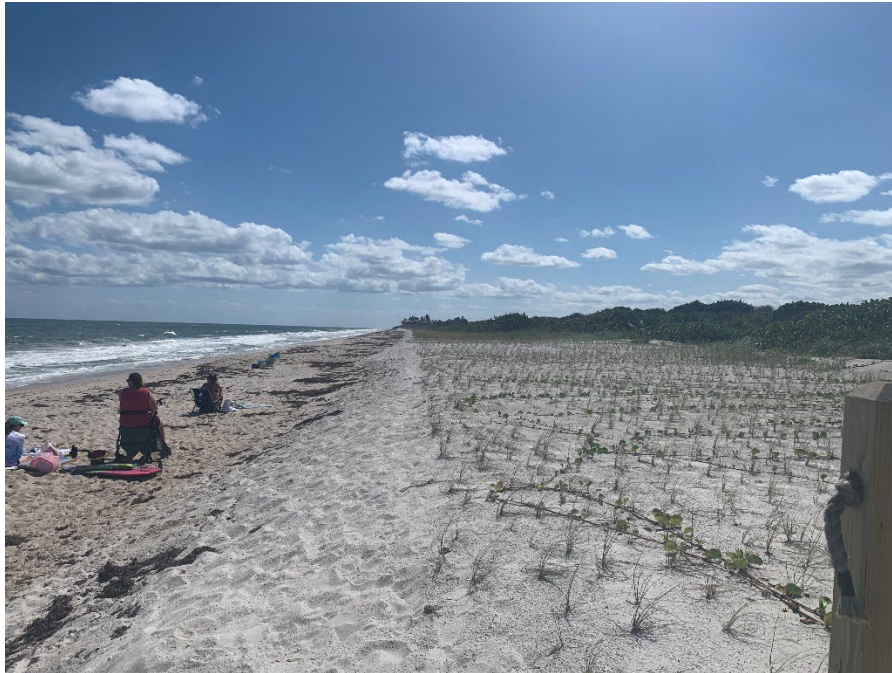
Figure 15. Newly planted sea oats as part of the Sector 3 Beach and Dune Restoration Project.

Indian River County has proactively managed the Sector 3 dune system since the first major restoration project. For each subsequent dune restoration event, including the Sector 3 Phase 1 and 2 Projects constructed in 2021/22, dune vegetation was installed along the newly created habitat (Figure 15).

The dune vegetation along the Sector 3 shoreline is in need of rehabilitation due to impacts from Hurricanes Ian and Nicole. The dune system provides valuable protection to coastal infrastructure in addition to serving as habitat. Based upon an analysis of the pre- and post-storm landward vegetation extents, there was an average overall cross-shore loss of vegetation of 21 ft. Utilizing dune retreat at each profile within the project area and the average loss of vegetated dune area, approximately 728,633 dune plants are required to fully replant the dune system.

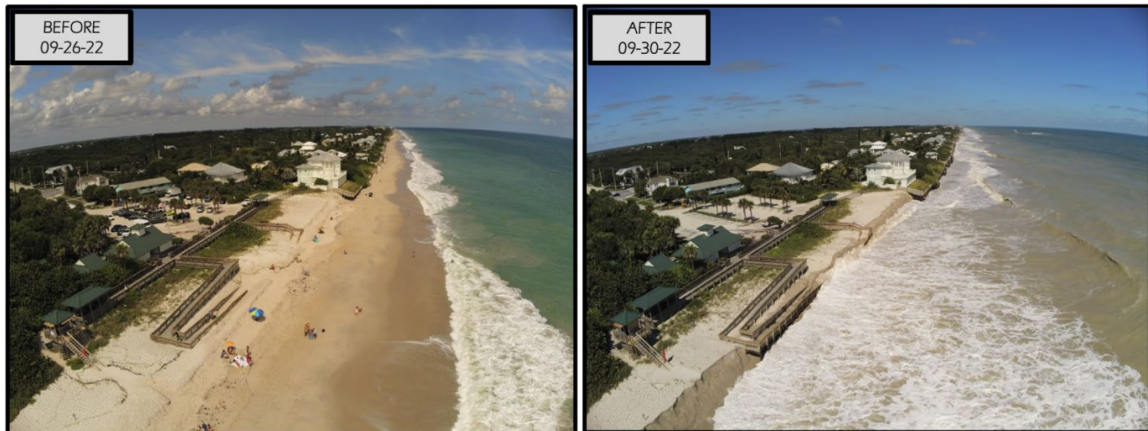
Wabasso Beach Park Looking North

Hurricane Ian Before and After

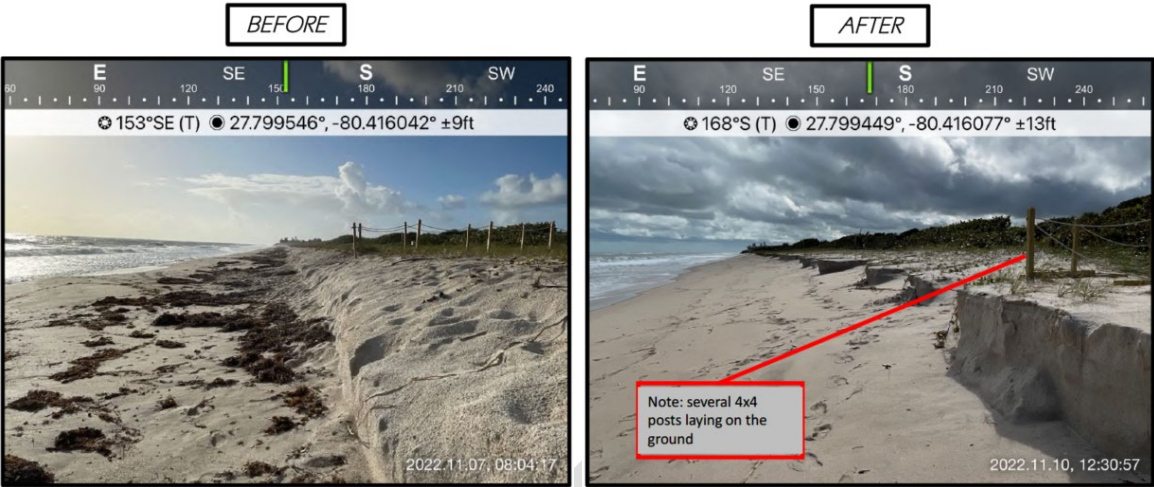
Treasure Shores Beach Park Looking South

Hurricane Nicole Before and After

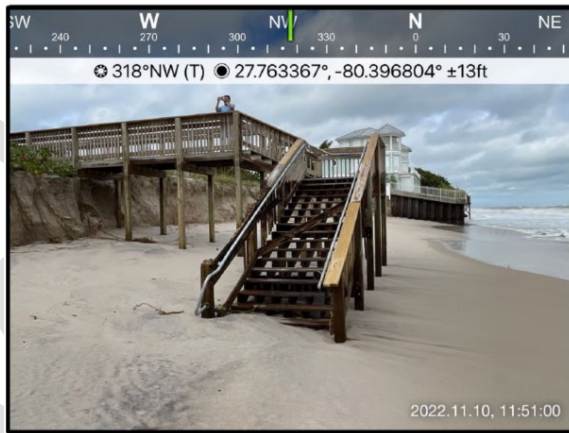
Wabasso Beach Park Looking North

BEFORE

AFTER

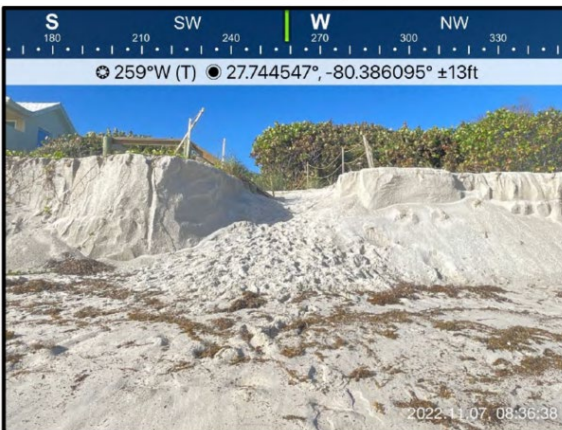
Seagrape Trail Beach Access Looking West

BEFORE

AFTER
