**INDIAN RIVER COUNTY, FL
SECTOR 3 BEACH & DUNE RESTORATION PROJECT**

**STORM DAMAGE REPORT:
HURRICANES IAN & NICOLE**

March 2023

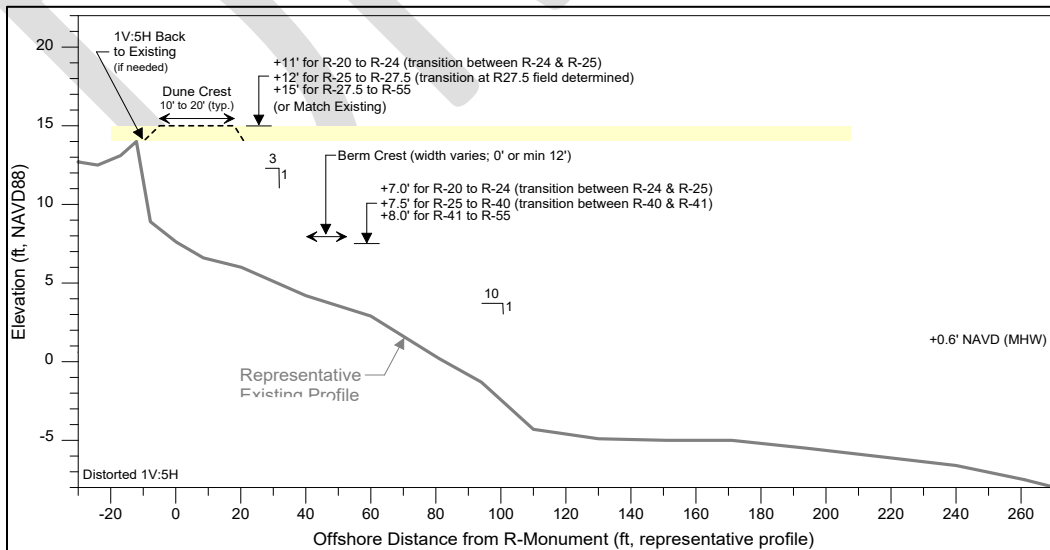
Figure 2. Typical Beach Fill Construction Template.

Figure 2 depicts the typical design construction template for the beach restoration project. The key elements of the 2021-2022 project design, as permitted, include sand placement for:

- a) restoration of the beach berm from R-20 to R-51.3 from the toe of the restored dune extending seaward at a 1V:10H slope to match the existing grade,
- b) restoration of the beach berm from R-51.3 to R-55 from the toe of the restored dune extending seaward at a 1V:10H slope with no material placed seaward of the MHW line,
- c) restoration of the dune from R-20 to R-55 to include:
 - a dune crest elevation of +11.0 feet NAVD88 from R-20 to R-24 that tapered up to a +12.0 feet NAVD88 dune crest elevation from R-25 to R-27 that tapered up to a +15.0 feet NAVD88 dune crest elevation from R-28 to R-55 – with native dune vegetation planted on the restored dune crest,
 - a landward slope on the restored dune backslope at 1V:5H – where applicable, and
 - a seaward slope on the restored dune face at 1V:3H from the dune crest to the seaward toe of the restored dune.

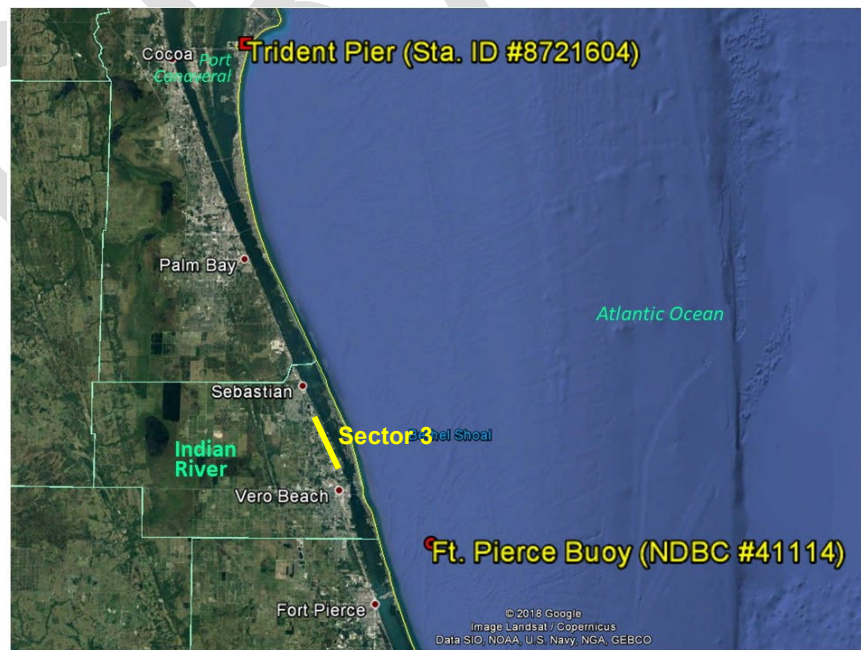
Figure 5. Oceanographic Data Collection Stations near Indian River County.

Figure 5 displays the location of oceanographic data collection stations in the vicinity of Indian River County. The wave climate offshore of Indian River County is assumed to be representative of data collected by an offshore waverider buoy, Station 41114 – Fort Pierce, FL (134), published by the National Data Buoy Center (NOAA, 2022a). The buoy is located about 5 nautical miles offshore of the Indian River County / St. Lucie County line, in a water depth of approximately 53 ft. Data collection from the buoy includes significant wave height, wave period, wave direction, and other standard oceanographic and meteorological data.

Water levels near the coast of Indian River County are assumed to be representative of data collected by a tidal station located in the Trident Basin of the interior of Port Canaveral; Trident Pier, FL – Station ID: 8721604 (NOAA, 2022b). The station is located about 35 nautical miles north of the northern Indian River County boundary. It is noted that the tide gage is not located on the open Atlantic Ocean coast. Rather, the station is somewhat sheltered and does not experience the dynamic storm surge (including wave setup) that occurs on the open coast.

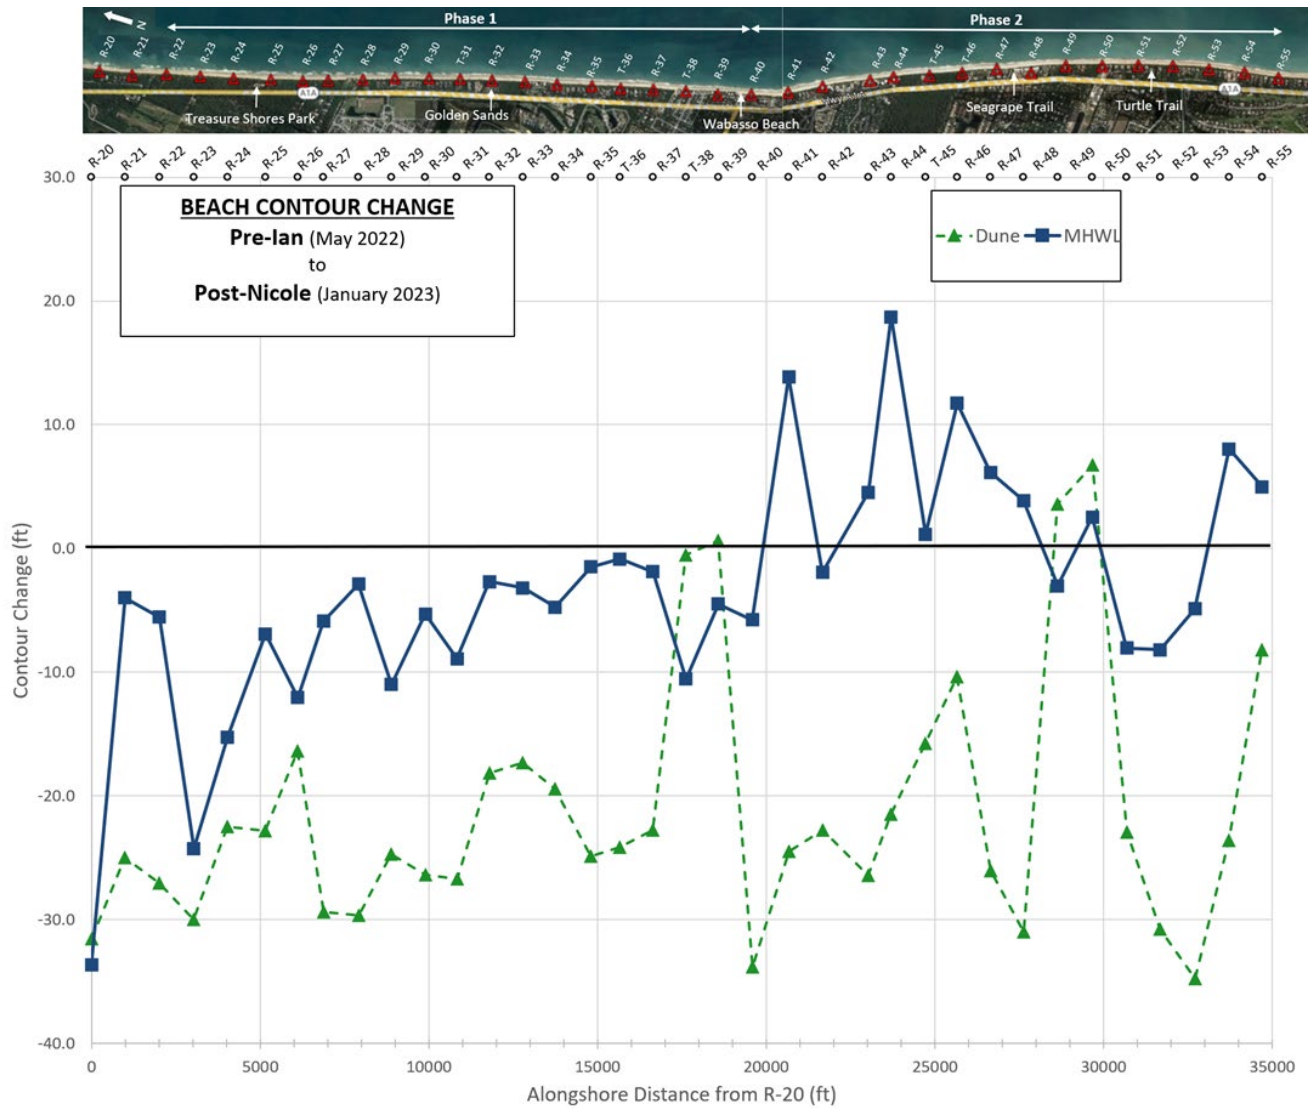
Figure 11. Shoreline and Dune Position Change.

The results of the contour change analysis are summarized in **Table 4** and **Figure 11**. The MHW shoreline experienced an average landward retreat of -3.4 ft between the pre- and post-storm surveys. The greatest retreat, averaging -16.9 ft, occurred along the northern portion of the project between R-20 and R-23. This area also experienced significant deflation of the beach berm, with profile lowering by as much as 3 to 4 ft. The dune position experienced an average landward retreat of -21.1 ft, with at least -30 ft of dune retreat experienced at six monuments throughout the Sector (R-20, R-23, R-40, R-48, R-52, and R-53). These dune impacts are not expected to recover naturally based upon environmental conditions and have diminished the storm protection provided by the dune to upland infrastructure.

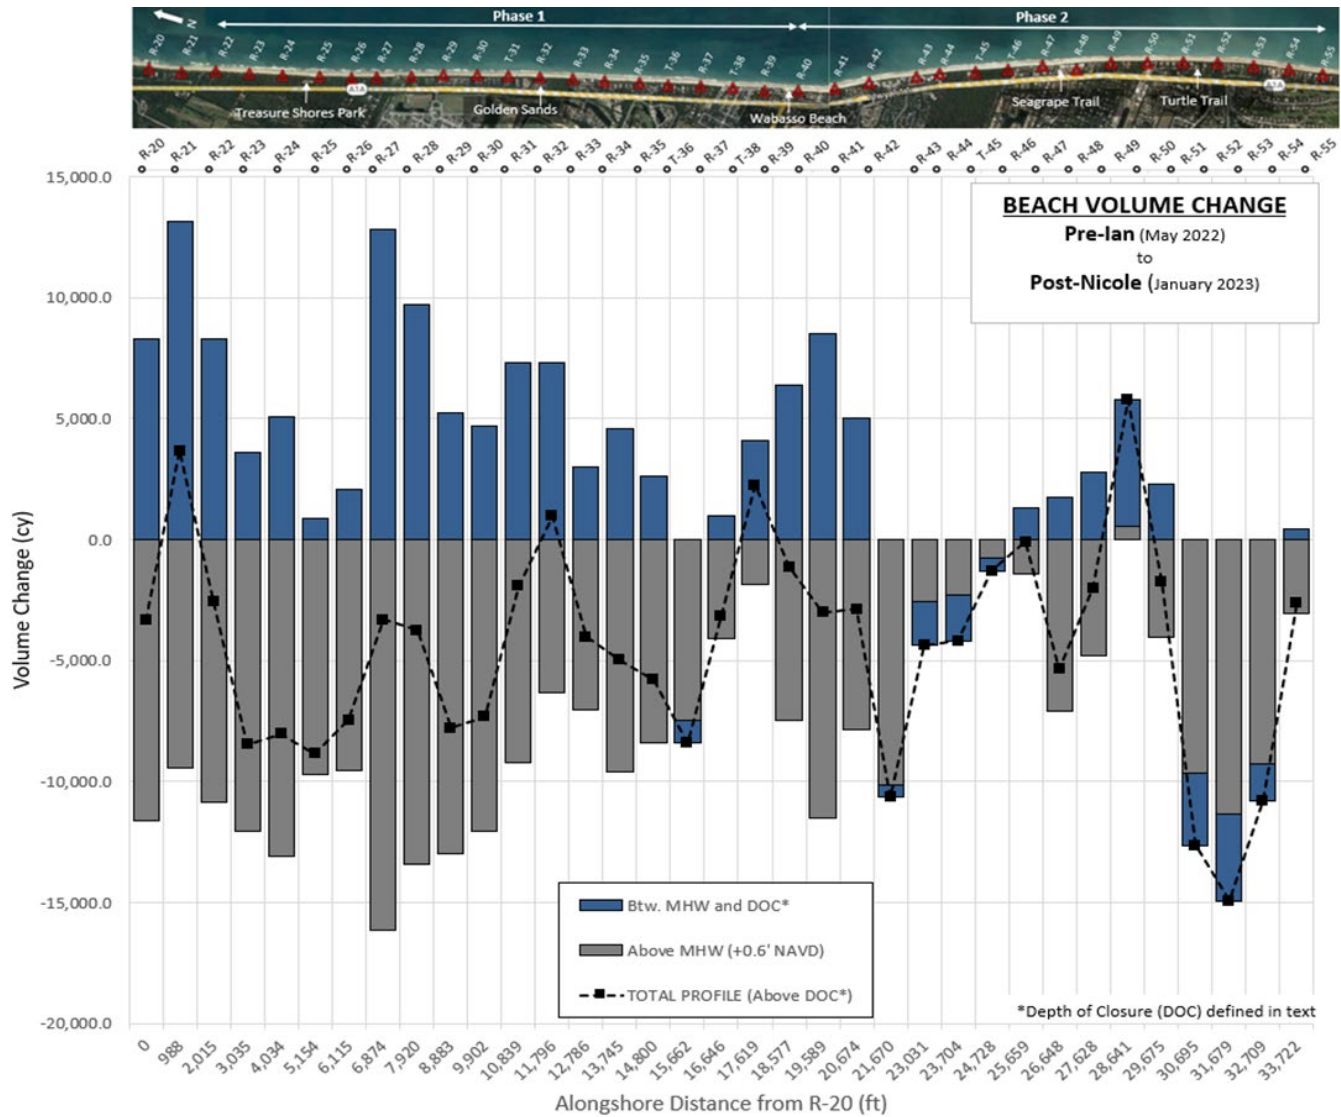
Figure 12. Beach Volume Change.

After removing the background change (-61,500 cy) from the measured change (-154,300 cy), there is a difference of -92,800 cy. As such, it is estimated that the Sector 3 engineered beach fill project lost -92,800 cy of sand above the depth of closure directly attributed to the impacts of Hurricanes Ian and Nicole. Using the prorated distribution percentages described above, it is estimated that Hurricane Ian contributed to a volume loss of approximately -20,416 cy, and Hurricane Nicole contributed to a loss of -72,384 cy.

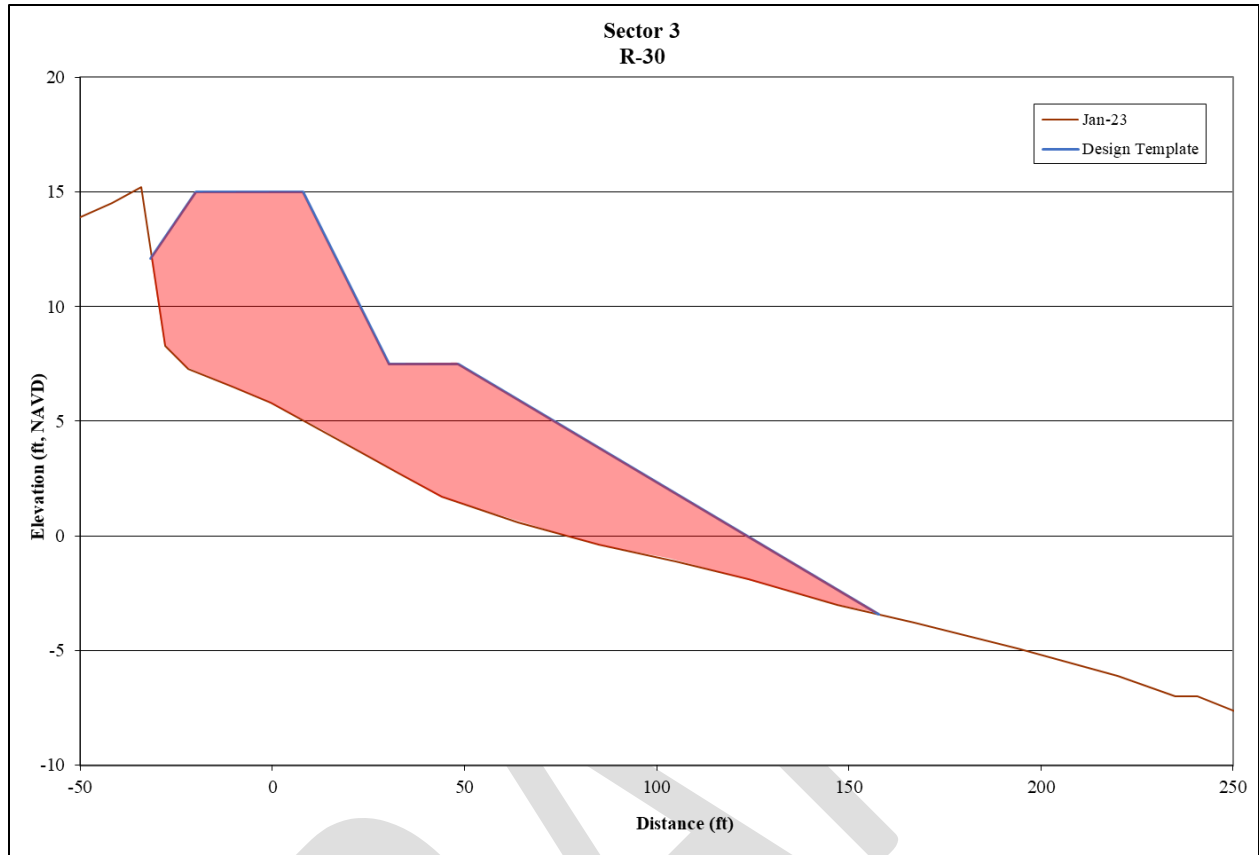
Figure 14. Volume Lost under Design Template.

Although FEMA only considers losses within the active beach profile from the landward limit of the dune to the depth of closure, it is important to note the impacts to the design/construction template due to the passage of Hurricanes Ian and Nicole. When comparing the post-Nicole profile to the permitted design and construction template, the Sector 3 project area lost 399,500 cy from the design profile, which equates to 72% of the volume placed during the most recent project. These impacts have greatly reduced the storm protection benefit provided by the design profile to neighboring upland infrastructure. **Table 8** summarizes losses observed at each R-monument along the Sector 3 shoreline. Overall, R-30 lost much of its design template and experienced the greatest erosion out of the Sector 3 project area. **Figure 14** depicts the loss of protective dune and beach width following the passage of both storms. As can be seen in the plot, much of the newly constructed dune is no longer present with the post-storm profile.

Additionally, construction costs to replace the volume lost under the design template are presented herein as the losses experienced within the dunes and upper contours of the dry beach are not expected to recover naturally (**Table 10**). As such, the estimated cost to repair the damages to the construction template from both storms is \$26,610,292.55 with 10% added for contingency. This methodology will return the project area to its intended storm protection.
