**INDIAN RIVER COUNTY, FL
SECTOR 5 BEACH & DUNE RESTORATION PROJECT**

**STORM DAMAGE REPORT:
HURRICANES IAN & NICOLE**

April 2023

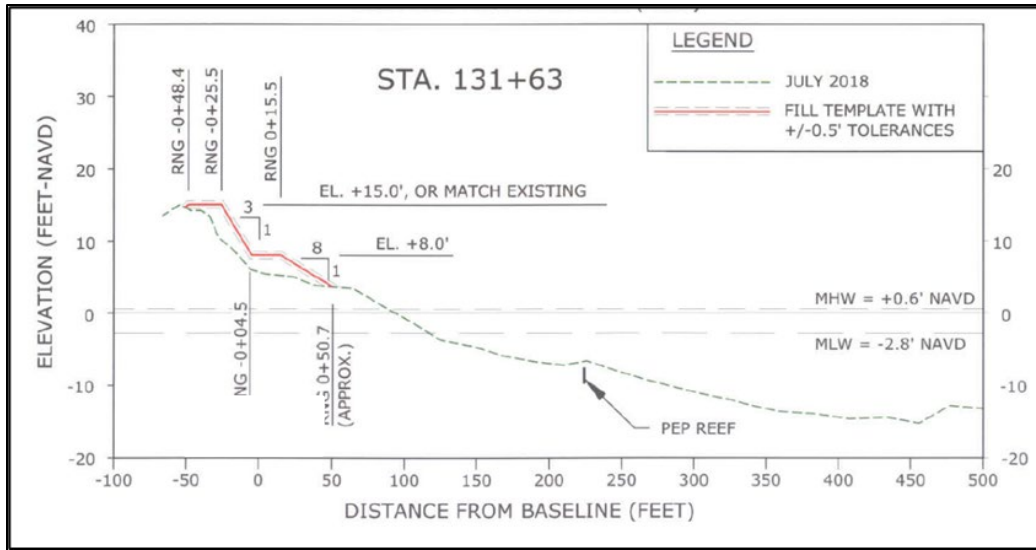
Figure 2. Typical Beach Fill Construction Template.

Figure 2 depicts the typical design construction template for the beach and dune restoration project. The design intent of the project was to replace sand lost due to Hurricane Matthew, Hurricane Irma, Hurricane Dorian, and to replace background erosion losses since 2015. The key elements of the project design, as permitted, are as follows:

- a. restoration of the beach berm from R-70 to R-86 from the toe of the restored dune extending seaward at a 1V:10H slope to match the existing grade,
- b. restoration of the dune from R-70 to R-86 to include:
 - a dune crest elevation of +15.0 feet NAVD88 from R-70 to R-82 that tapered down to a +13.0 feet NAVD88 dune crest elevation from R-83 to R-86 – with native dune vegetation planted on the restored dune crest,
 - a landward slope on the restored dune backslope at 1V:5H – where applicable, and
 - a seaward slope on the restored dune face at 1V:3H from the dune crest to the seaward toe of the restored dune.

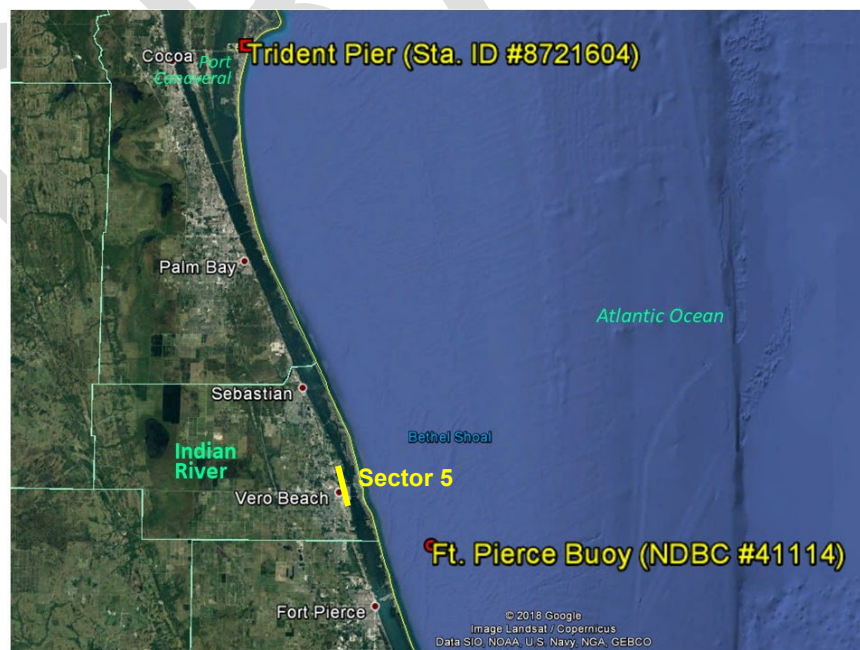
Figure 5. Oceanographic Data Collection Stations near Indian River County.

Figure 5 displays the location of oceanographic data collection stations in the vicinity of Indian River County. The wave climate offshore of Indian River County is assumed to be representative of data collected by an offshore waverider buoy, Station 41114 – Fort Pierce, FL (134), published by the National Data Buoy Center (NOAA, 2022a). The buoy is located about 5 nautical miles offshore of the Indian River County / St. Lucie County line, in a water depth of approximately 53 ft. Data collection from the buoy includes significant wave height, wave period, wave direction, and other standard oceanographic and meteorological data.

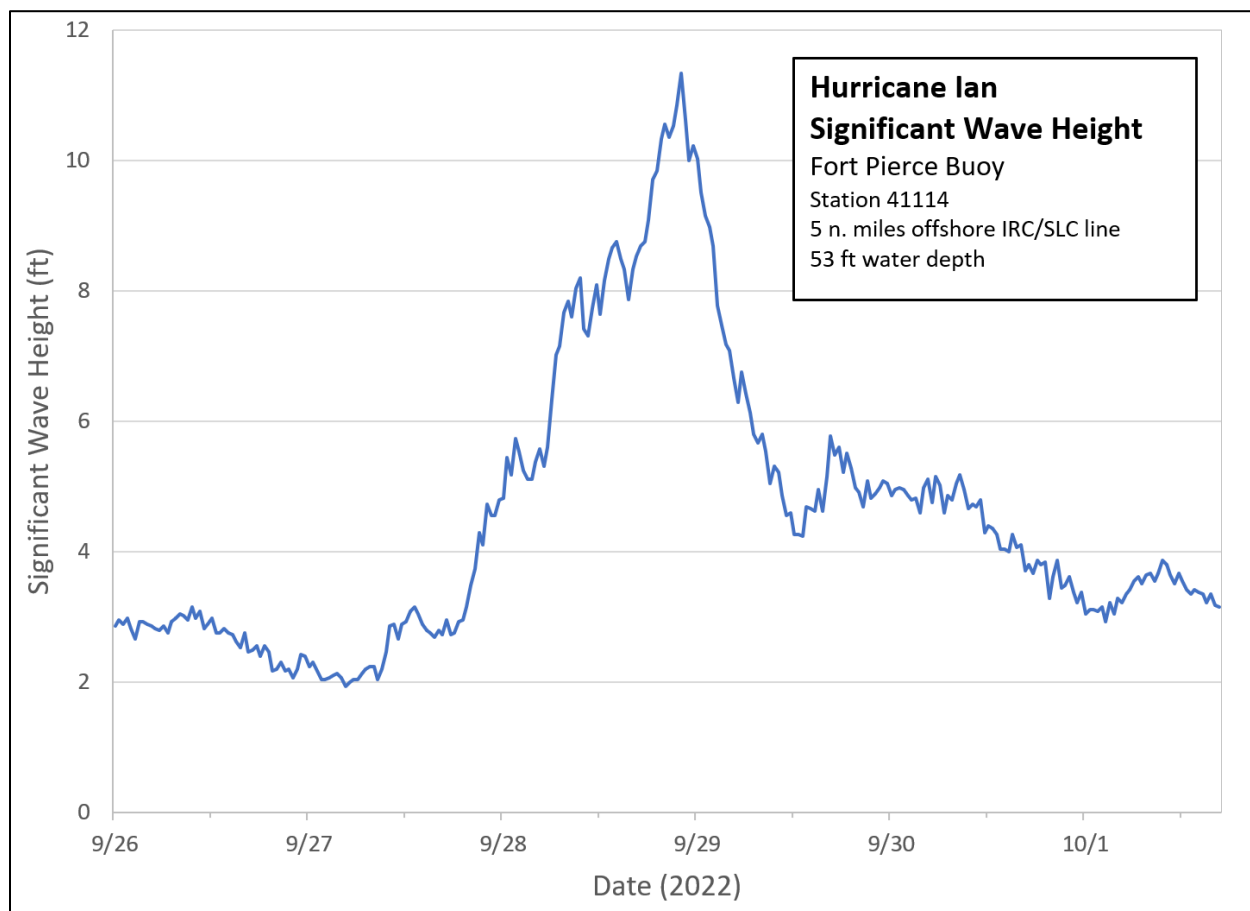
Figure 6. Significant Wave Heights Measured during Hurricane Ian.

Figure 6 displays the time series of significant wave height measured at the Fort Pierce Buoy as Hurricane Ian impacted the area. The significant wave heights reported at the buoy are an average of the largest 1/3rd of all wave heights during a 20-minute sampling period (thus, there were waves that passed the buoy during the 20-minute period that were larger than the reported height). Significant wave heights peaked at approximately 11 ft in the morning of September 29, as the storm passed offshore of the County.

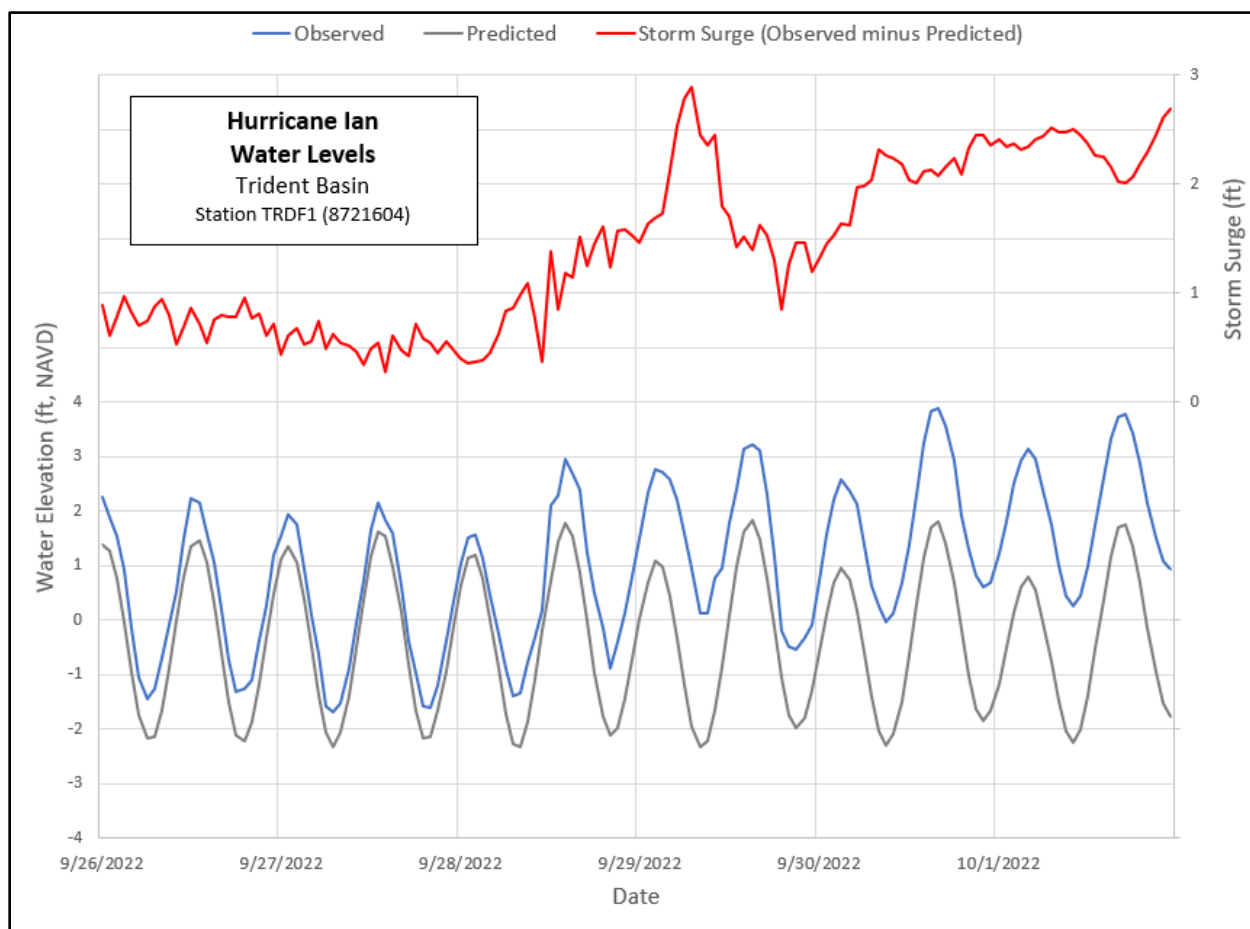
Figure 7. Water Levels Measured during Hurricane Ian.

Figure 7 displays the time series of water levels measured at the Trident Basin station as Hurricane Ian impacted the area. The greatest storm surge, calculated as the difference between the observed water level and the predicted tide, was +2.9 ft during the morning of September 29. The storm surge³ resulted in a storm tide⁴ of +3.9 ft NAVD at its peak. Based on pre- and post-storm profile

inspection, wave impacts and runup reached the toe of the dune in many places, which resides at around +7.5 ft NAVD along most of the County's coast.

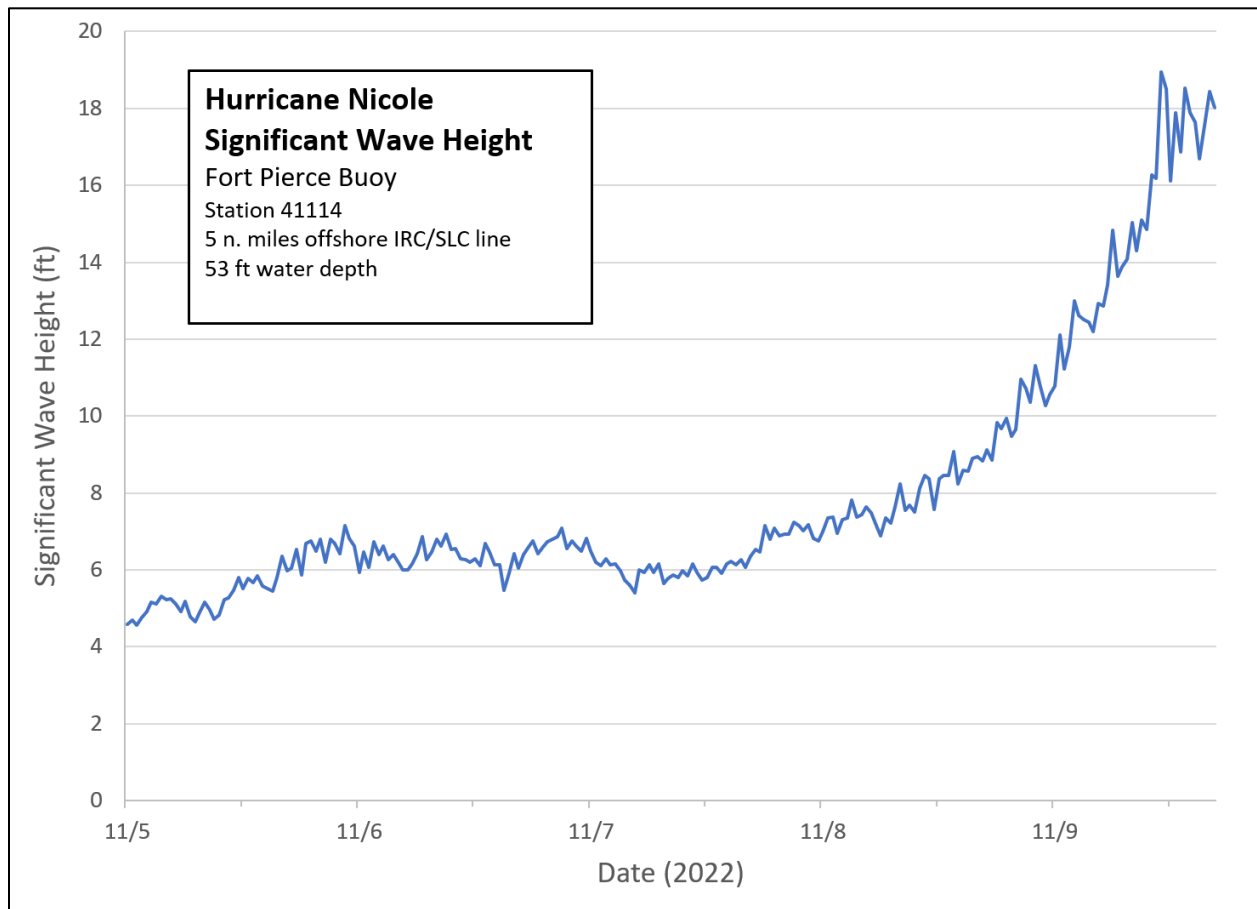
Figure 9. Significant Wave Heights Measured during Hurricane Nicole.

Figure 9 displays the time series of significant wave height measured at the Fort Pierce Buoy (NDBC #41114) as Hurricane Nicole impacted the area. Significant wave heights peaked at approximately 19 ft on November 9. The wave height readings went out shortly after the peak height was recorded. The storm's path relative to Indian River County resulted in elevated storm surge and large waves impacting the County's beaches for several days while the storm approached and impacted the County. The result was appreciable erosion to the beach berm and dunes of Sector 5. Post-storm photographs of the Sector 5 shoreline are found in **Appendix B**.

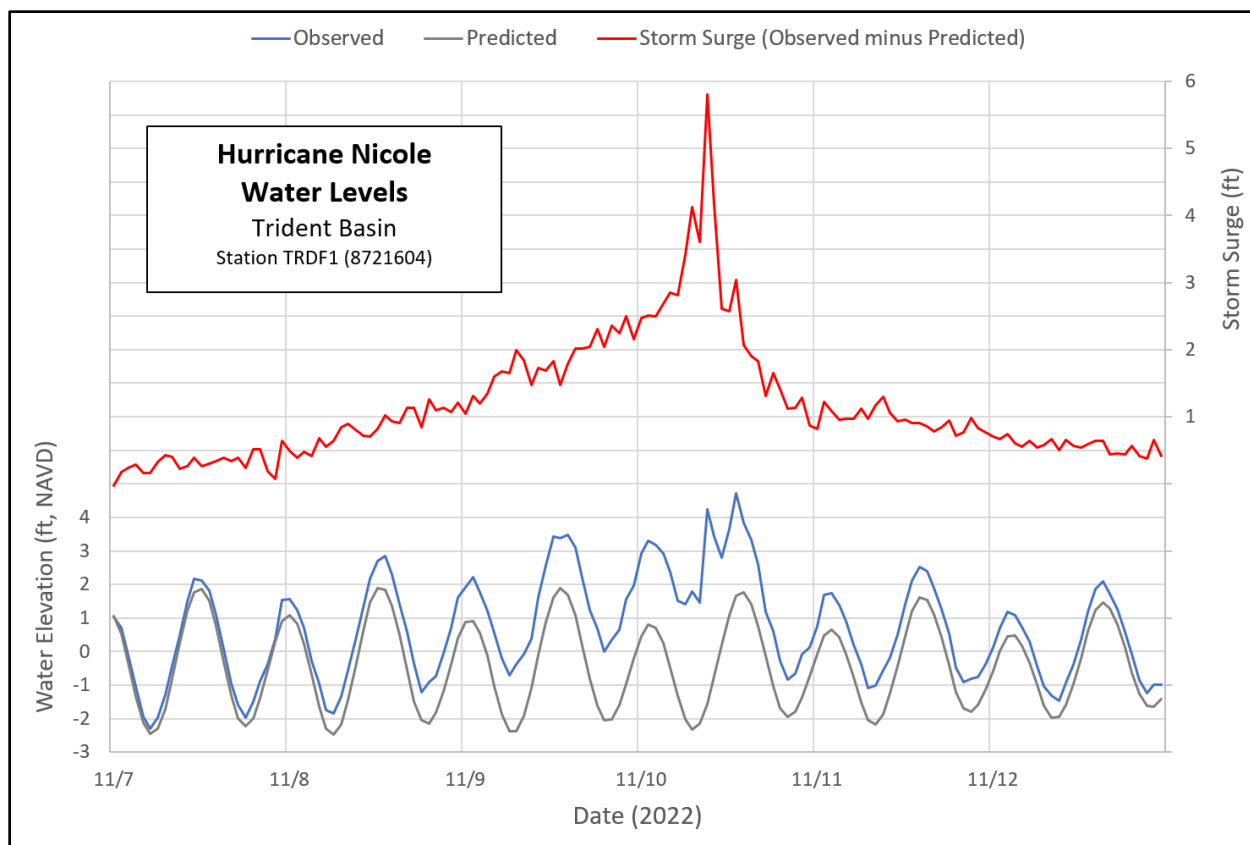
Figure 10. Water Levels Measured during Hurricane Nicole.

Figure 10 displays the time series of water levels measured at the Trident Basin station as Hurricane Nicole impacted the area. The greatest storm surge, calculated as the difference between the observed water level and the predicted tide, was +5.8 ft during the morning of November 10. The storm surge resulted in a storm tide of +4.7 ft NAVD at its peak. Based on pre- and post-storm profile inspection, wave impacts and runup reached the toe of the dune in many places and further exacerbated the conditions from Hurricane Ian.

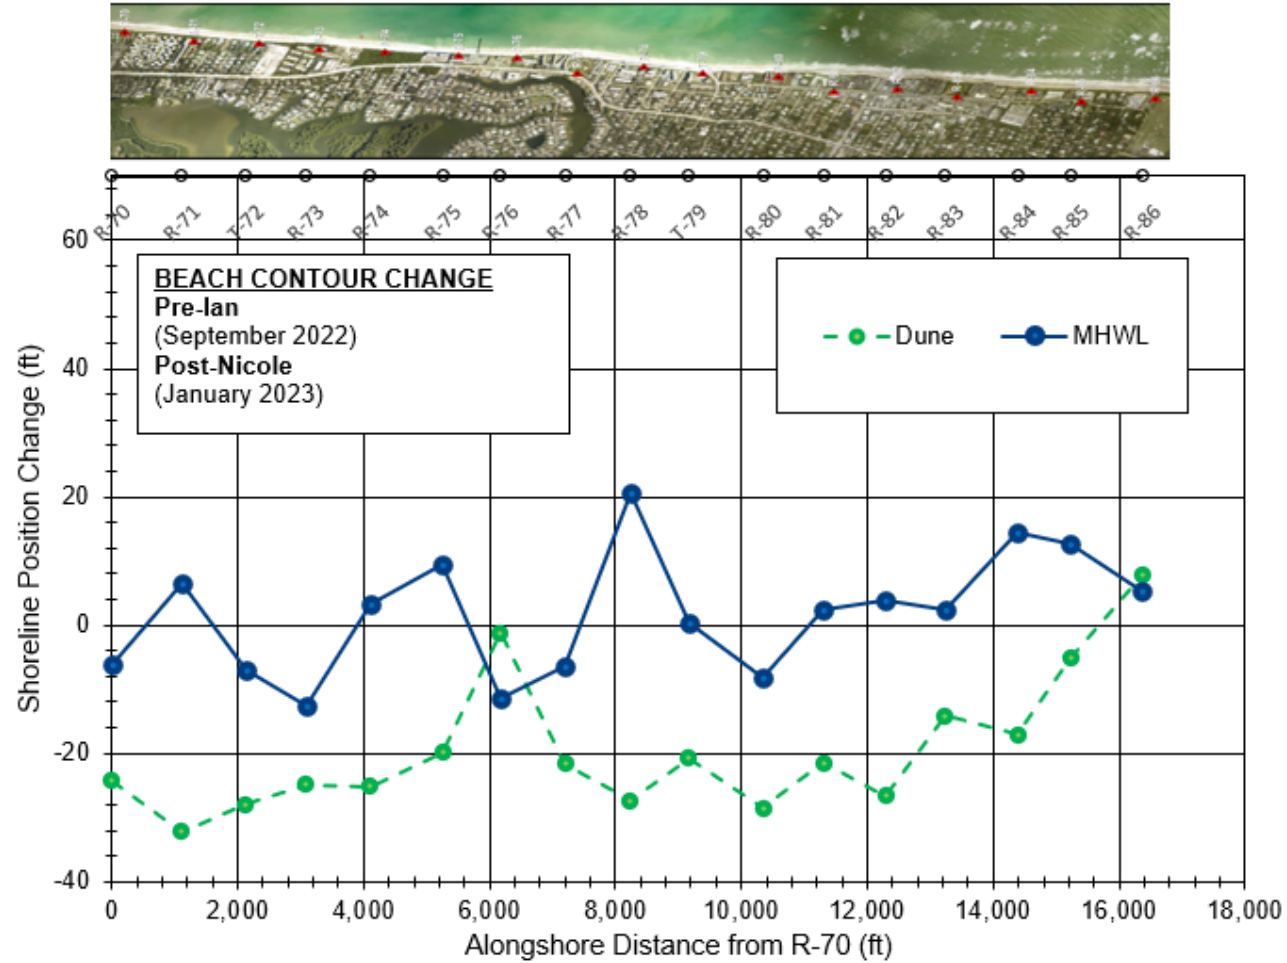
Figure 11. Shoreline and Dune Position Change.

The results of the contour change analysis are summarized in **Table 4** and **Figure 11**. The dune position experienced an average landward retreat of -19.4 ft, with at least -25 ft of dune retreat experienced at six monuments throughout the Sector (R-71, T-72, R-74, R-78, R-80, and R-82). These dune impacts are not expected to recover naturally based upon environmental conditions and have diminished the storm protection provided by the dune to upland infrastructure. The MHW shoreline experienced an average landward advance of 1.8 ft between the pre- and post-storm surveys due to a cross-shore transfer of sand from the upland portion of the profile. The greatest retreat, averaging -12.6 ft, occurred along the northern portion of the project at R-73.

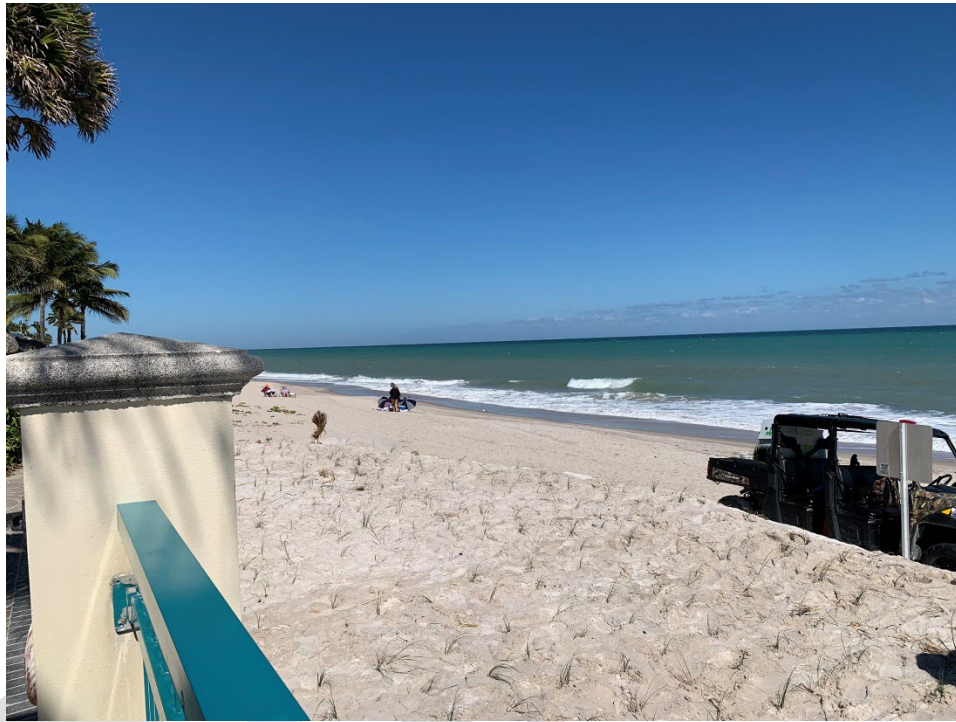
Figure 14. Newly planted sea oats from winter 2022.

Indian River County has proactively managed the Sector 5 dune system since the first major restoration project. The 2019/2020 project placed approximately 128,800 dune plants along the project area dune crest. In addition to planned dune maintenance, the County fortified the Sector 5 dune in winter 2022 with approximately 135,000 additional dune plants at increased densities (Figure 14).

The dune vegetation along the Sector 5 shoreline is in need of rehabilitation due to impacts from Hurricanes Ian and Nicole. The dune system provides valuable protection to coastal infrastructure in addition to serving as habitat. Based upon an analysis of the pre- and post-storm landward vegetation extents, there was an average overall cross-shore loss of vegetation of 19 ft. Utilizing dune retreat at each profile within the project area and the average loss of vegetated dune area, approximately 423,360 dune plants are required to fully replant the dune system.

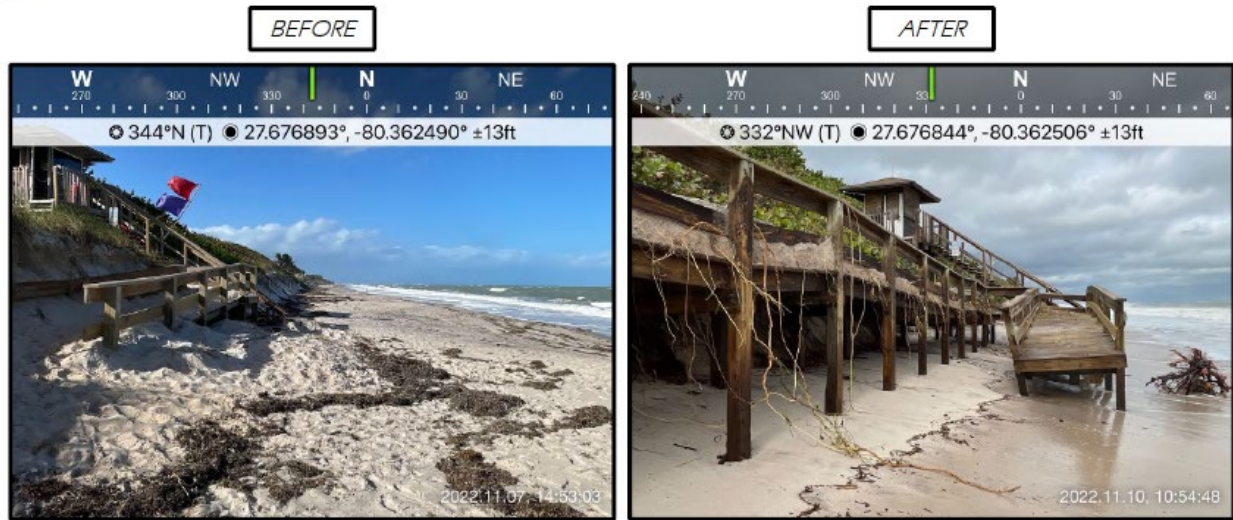
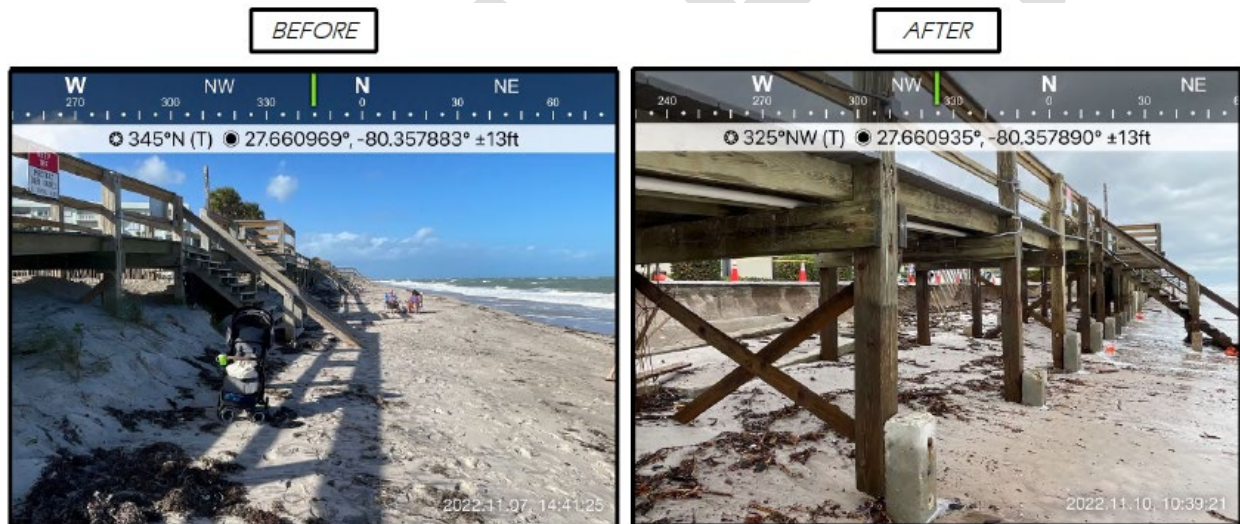
Tracking Station Beach Park

Staff observed a 3 ft lowering of the berm, with a dune retreat of 20 to 25 ft and an dune escarpment of 8 ft, resulting in Condition IV: Major Dune Erosion.

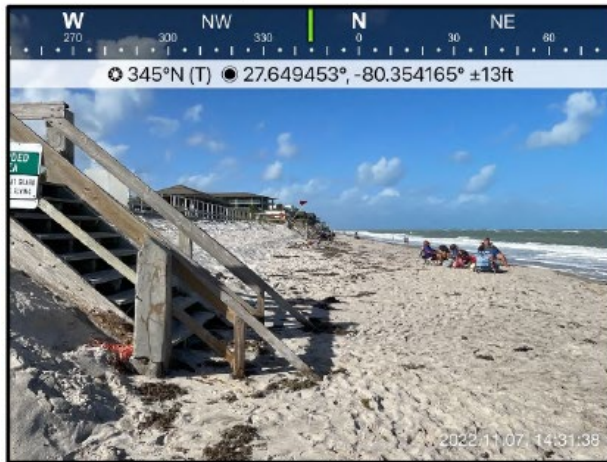
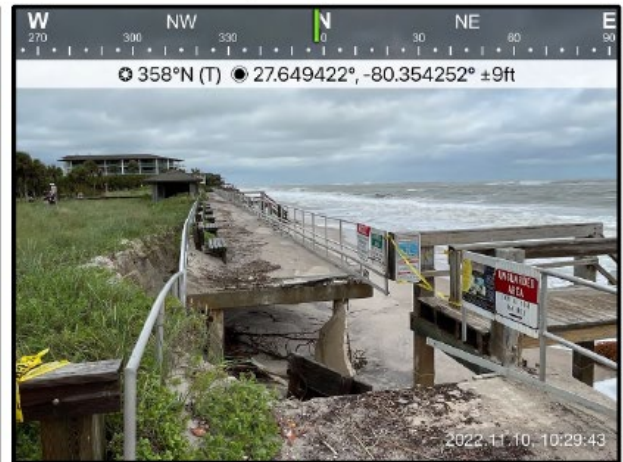
Jaycee Boardwalk

Staff observed a 3 ft lowering of the berm, with a dune retreat of 12 ft and an dune escarpment of 6 to 8 ft, resulting in Condition IV: Major Dune Erosion.

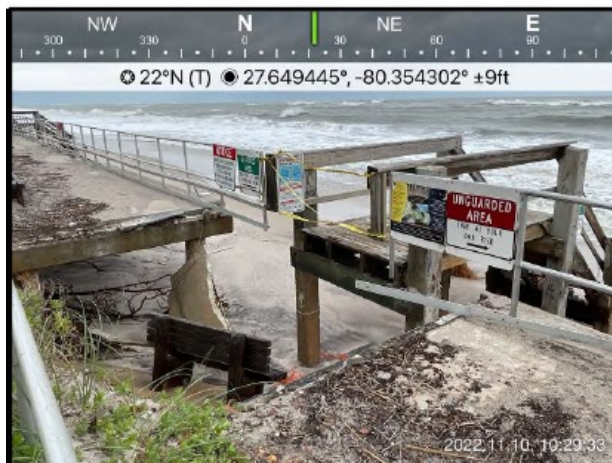
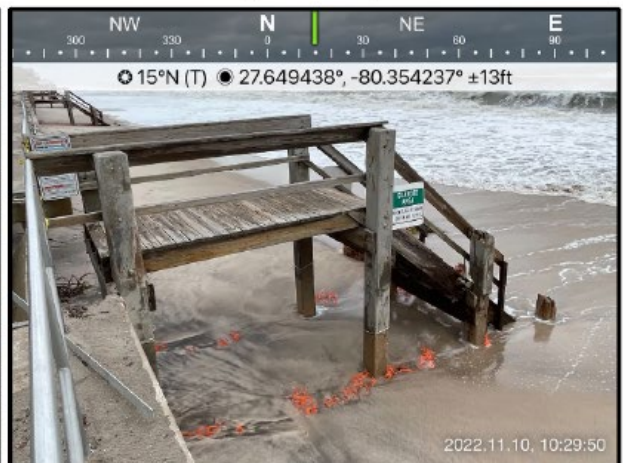
Humiston Beach Park

Additional photos of the damaged COVB Humiston Boardwalk.
