**INDIAN RIVER COUNTY, FL  
SECTOR 4 STORM DAMAGE REPORT:**

**HURRICANES IAN & NICOLE**

**INDIAN RIVER COUNTY, FL  
SECTOR 4 STORM DAMAGE REPORT:  
HURRICANES IAN & NICOLE**

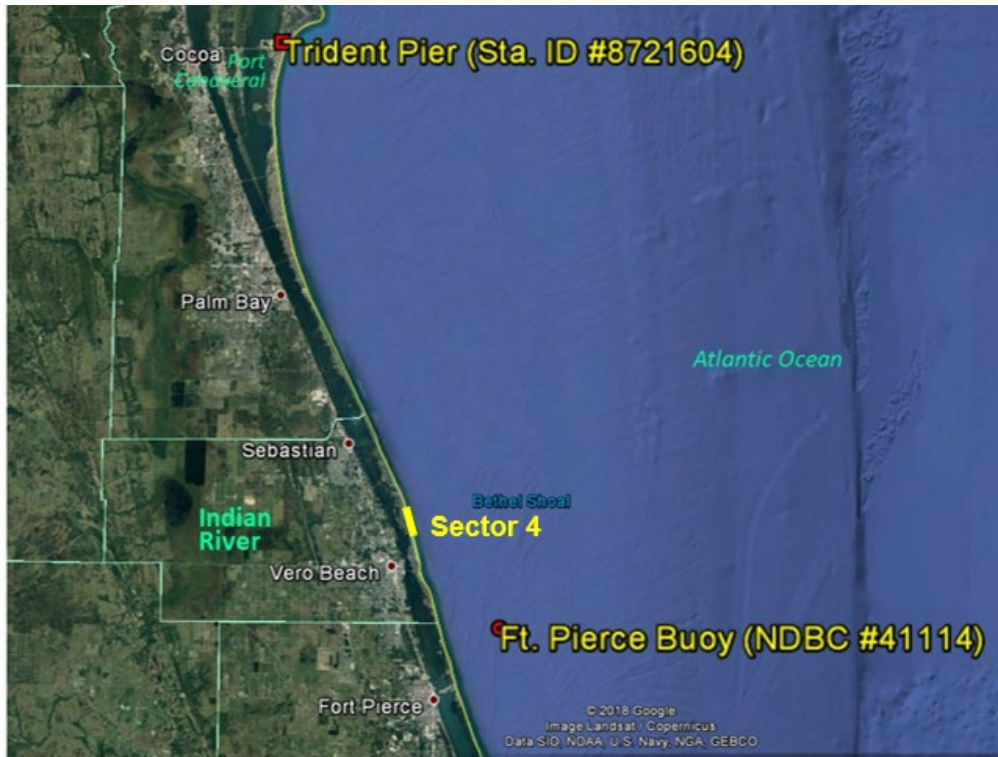
**Figure 4. Oceanographic Data Collection Stations near Indian River County.**

**Figure 4** displays the location of oceanographic data collection stations in the vicinity of Indian River County. The wave climate offshore of Indian River County is assumed to be representative of data collected by an offshore waverider buoy, Station 41114 – Fort Pierce, FL (134), published by the National Data Buoy Center (NOAA, 2022a). The buoy is located about 5 nautical miles offshore of the Indian River County / St. Lucie County line, in a water depth of approximately 53 ft. Data collection from the buoy includes significant wave height, wave period, wave direction, and other standard oceanographic and meteorological data.

Water levels near the coast of Indian River County are assumed to be representative of data collected by a tidal station located in the Trident Basin of the interior of Port Canaveral; Trident Pier, FL – Station ID: 8721604 (NOAA, 2022b). The station is located about 35 nautical miles north of the northern Indian River County boundary. It is noted that the tide gage is not located on the open Atlantic Ocean coast. Rather, the station is somewhat sheltered and does not experience the dynamic storm surge (including wave setup) that occurs on the open coast.

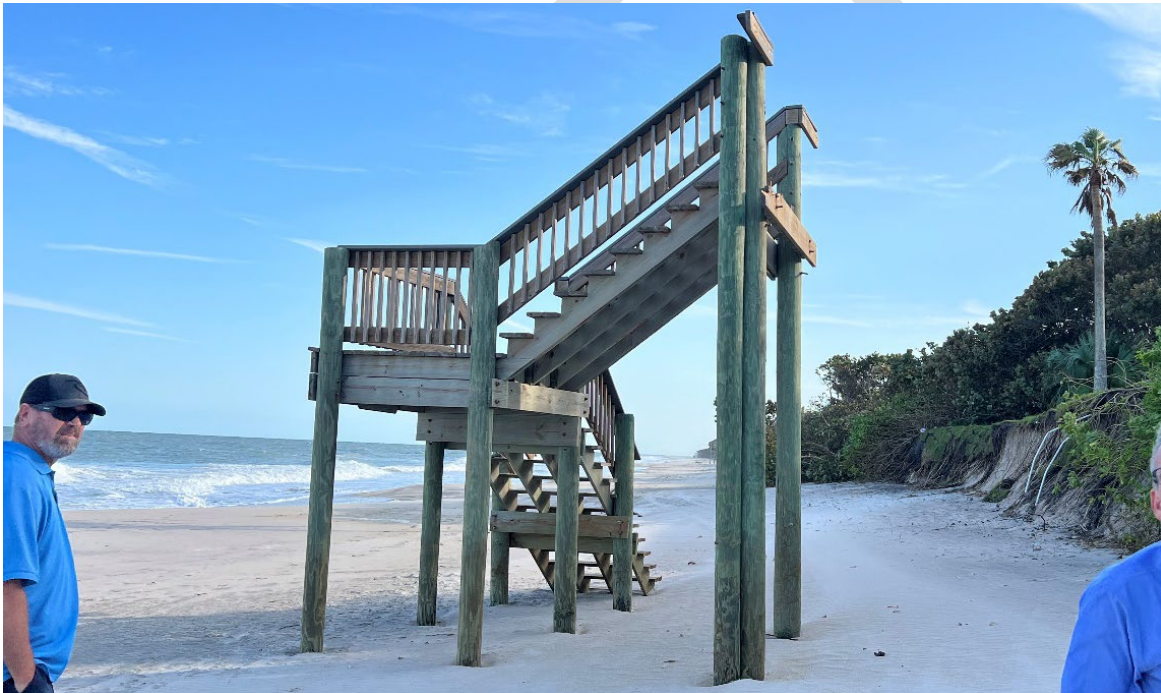
**Figure 10. Post-Nicole Conditions in Indian River Shores.**

**Figure 10** illustrates the extent of dunes lost within the monitoring area. As can be seen from the photograph, the dune has suffered severe erosion and the associated dune overwalk structure has been completely washed out. Irrigation lines, which were once installed along the top of the dune, are also exposed in the photograph to the left of the palm tree. Losses to the dune system, like shown in **Figure 10**, are not expected to naturally recover to their pre-storm conditions and will likely need restored to protect upland infrastructure. The results of the contour change analysis are summarized in **Table 3** and **Figure 11**. The MHW shoreline experienced an average seaward advance of 9.9 ft between the pre- and post-storm surveys. The greatest retreat, averaging -2.1 ft, occurred along the southern portion of the project between R-70 and R-72. The dune position experienced an average landward retreat of -19.2 ft, with at least -20 feet of dune retreat experienced at eight (8) monuments throughout the Sector (R-56, R-57, R-58, R-63, R-69, R-70, R-71, and R-72).

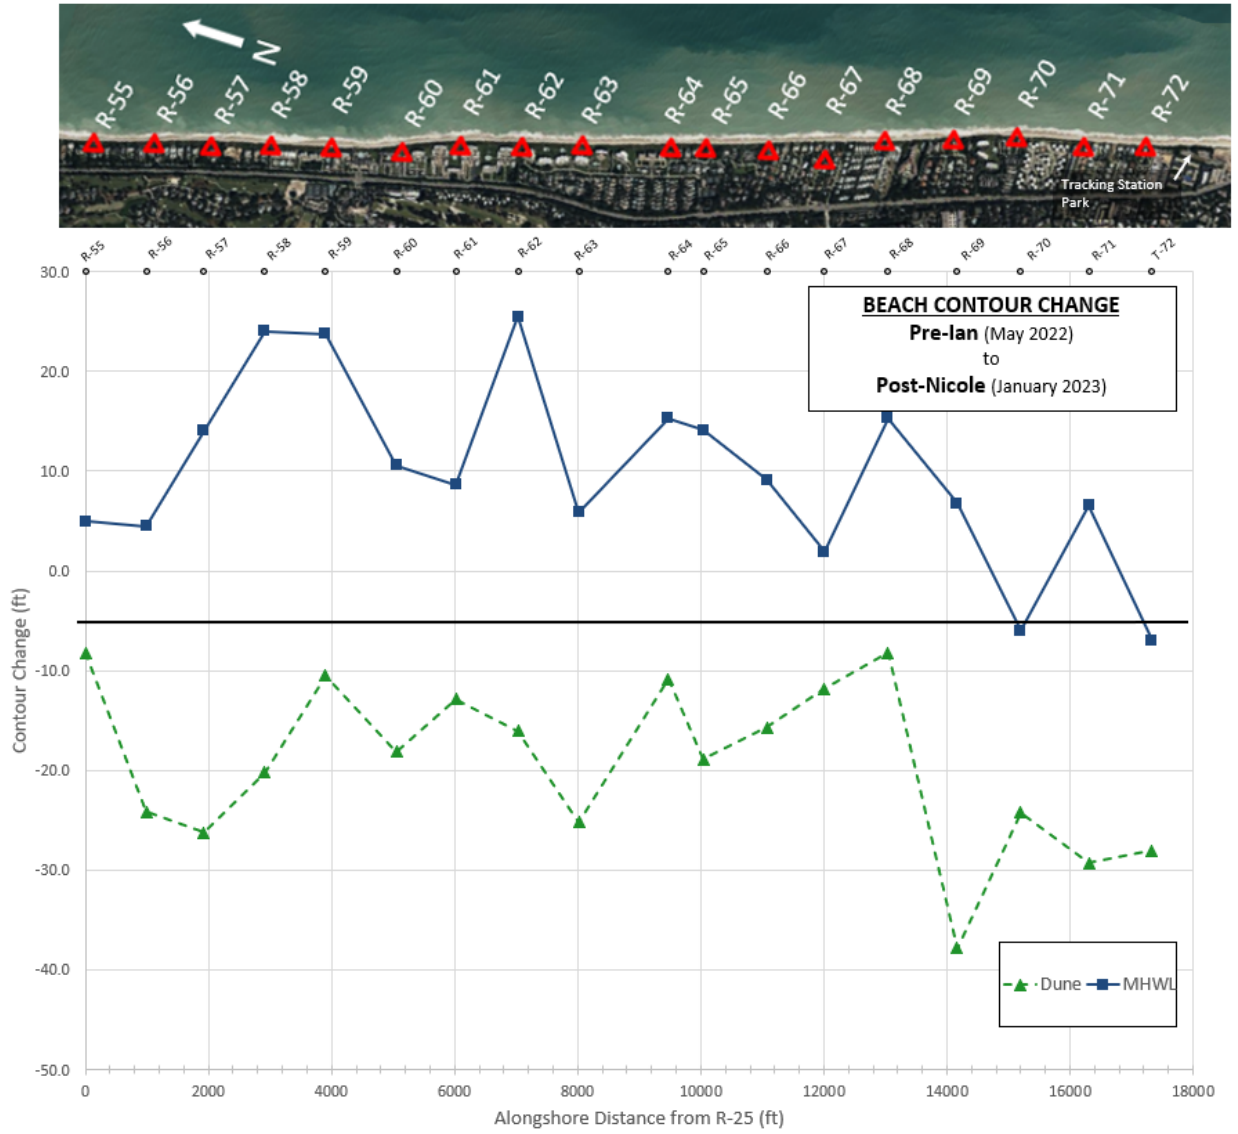
**Figure 11. Shoreline and Dune Position Change.**

Beach profile surveys collected before and after the 2022 hurricane season were analyzed to quantify the change in the location of the Mean High Water Line (MHWL) and dune position.

- MHW Shoreline:** The MHW tidal datum for the ocean shorefront of Indian River County is identified by NOAA Tides & Currents (Station ID 8722105) to be at +0.55 ft NAVD. FDEP’s Land Boundary Information System (LABINS) also provides interpolated MHW elevations along the County’s ocean shorefront at approximate one-mile intervals. At the County’s northernmost location, the MHW is specified at +0.63 ft NAVD, while it is +0.54 ft at the southernmost County location. Considering typical vertical survey accuracy (typically  $\pm 0.2$  ft), and to conform to previous studies within the County, a MHW elevation of +0.6 ft NAVD is used to define the shoreline location.

- Dune Position:** The dune position is defined as the seaward-most cross-shore location of the +10-ft contour. This contour typically corresponds to the average seaward face of the dune throughout the County, and has been used to track the dune position in previous studies, including the multiple iterations of the County’s Beach Preservation Plan (CB&I, 2015; Stantec, 2019).

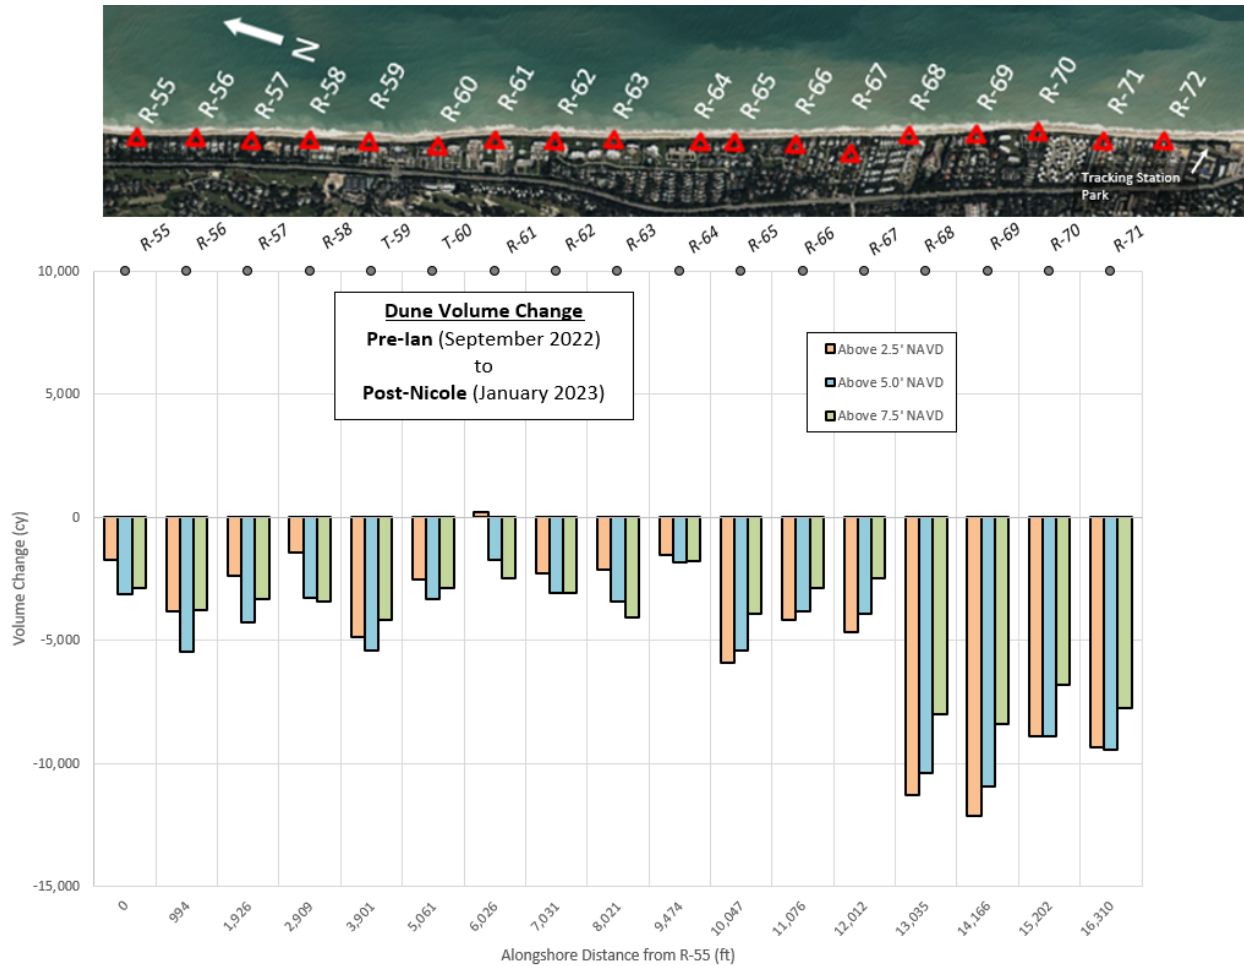
**Figure 14. Dune Volume Change.**

The results of the dune/dry beach volume change analysis are shown graphically in **Figure 14** and summarized in **Table 6**. Volume changes are computed above different vertical datums in order to assess the cross-shore changes in beach and dune volume. The volume changes are plotted in bar chart form as interpolated volume changes between each profile transect. The bars indicate the volume changes measured above different vertical elevations of the beach profile.

- Orange Bar: Above 2.5' NAVD
- Blue Bar: Above 5.0' NAVD
- Green Bar: Above 7.5' NAVD

Above 2.5' NAVD, Sector 4 lost -78,700 cy (average of -4.5 cy/ft) during the storm inter-survey period. Above 5.0' NAVD, the Sector lost -87,700 cy (average of -5.1 cy/ft) during the storm inter-survey period. Above 7.5' NAVD, Sector 4 lost -72,100 cy (average of -4.2 cy/ft) during the storm inter-survey period. When comparing pre- to post-storm profiles, the apparent dune losses commence at approximately +5' NAVD and continue to the most landward portion of the dune. **Figure 15** depicts the magnitude of dune erosion experienced within the Sector 4 project and the associated impact to upland infrastructure. As previously detailed, the dune system is currently in

a vulnerable state and future storms could impact upland infrastructure due to the loss of its protective value. Volume necessary to rebuild the dune to its pre-storm conditions should be consider by funding partners as a means to restore storm protection.

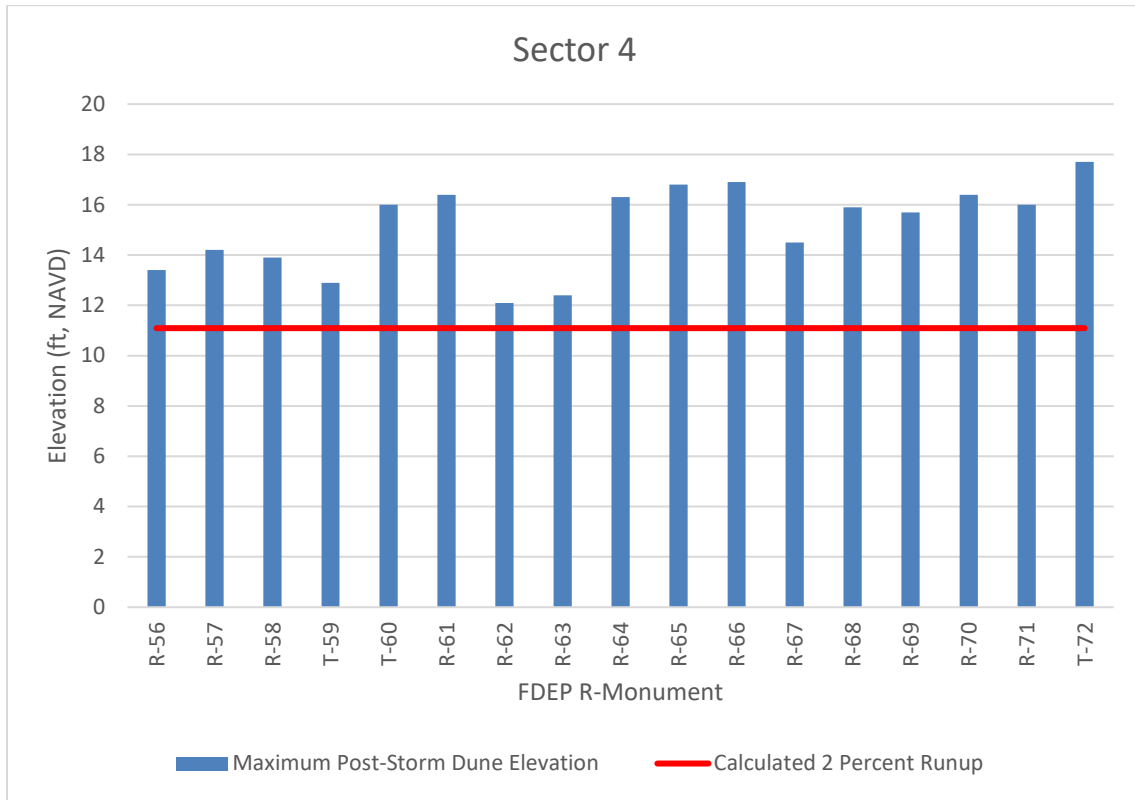
**Figure 17. Sector 4 Max Dune Elevation and Total Runup Elevation.**

The calculated runup value was then added to the 3.7-ft stillwater elevation to determine the total runup elevation for Sector 4 which is equal to 11.1 ft NAVD. The results of the calculations can be seen in **Figure 17**. The maximum dune elevation was determined for each profile from the Morgan & Eklund survey from January 2023. In Sector 4, the dune height at each R-monument is greater than the runup experienced with a 5-year storm. The Sector 4 profiles can be found in **Appendix A**. Although the maximum post-storm dune height minimally exceeds the total runup elevation, it is important to note the large loss of dune width within the project area and scarping of the dune due to wave action, which has already impacted an upland residence in the vicinity of

R-67. There is potential risk for damage to improved property if the total runup elevation is solely considered by FEMA for Category B funding within this area.
