FINAL STRUCTURAL REPORT

Roseland Community Center
12973 Bay Street
Sebastian, Florida 32958

Engineer's Project # 17-0201
August 15, 2017

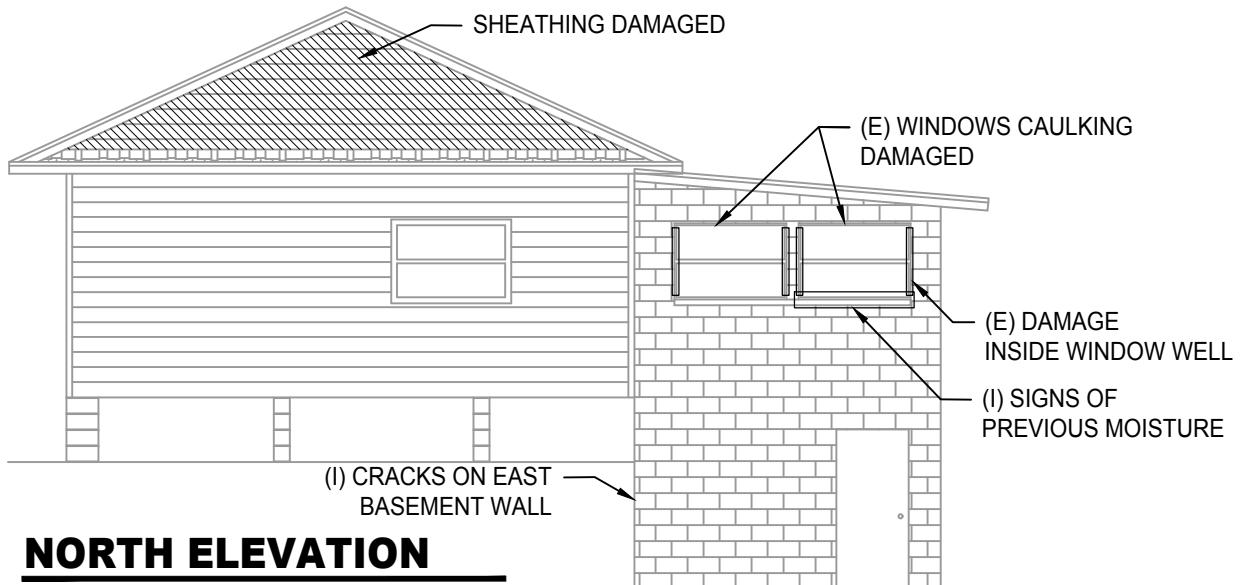
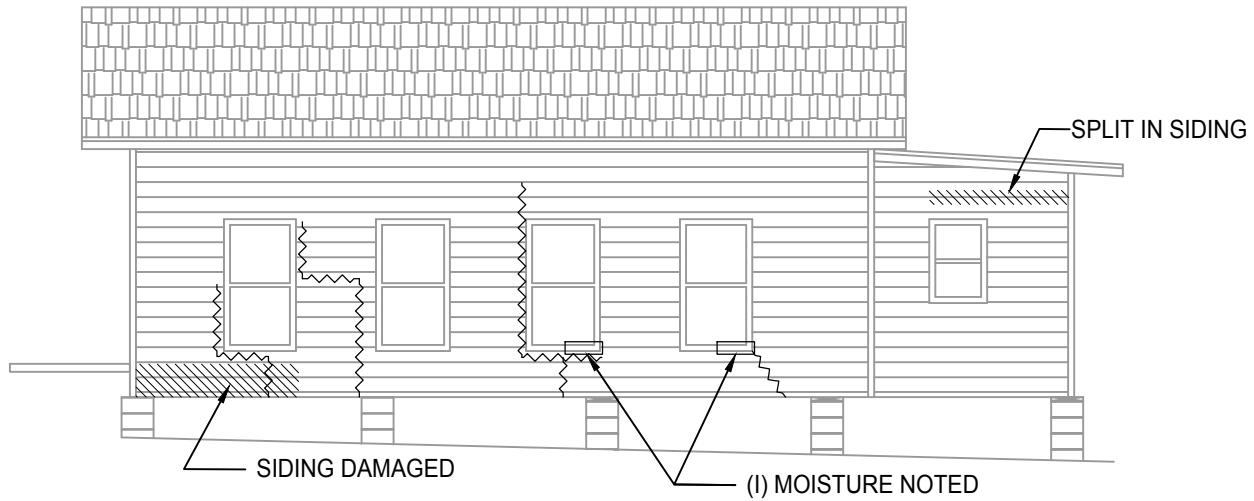
ROTTED SHEATHING

PREVIOUS MOISTURE DAMAGE

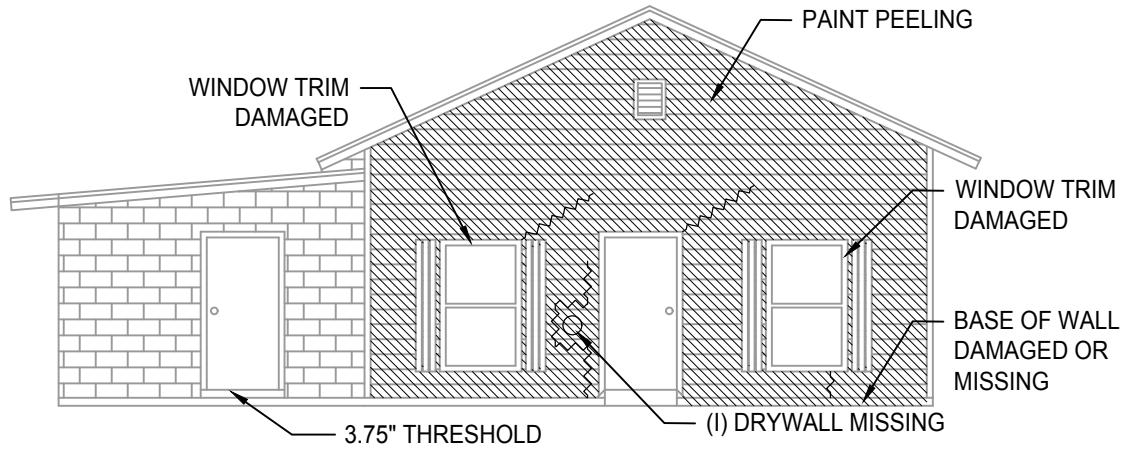
SOUTH ELEVATION

- The drywall on the exterior walls is cracking in multiple areas. The majority of the cracks are limited to the eastern wall with the south showing a few cracks as well. MBV Engineering, Inc. attributes these cracks to the excessive settlement the building experienced as well as to the foundation reinforcement project.

- The lap siding on the exterior of the structure is showing some areas of moisture damage. The majority of the paint which protects the structure is peeling away and will need to be redone.

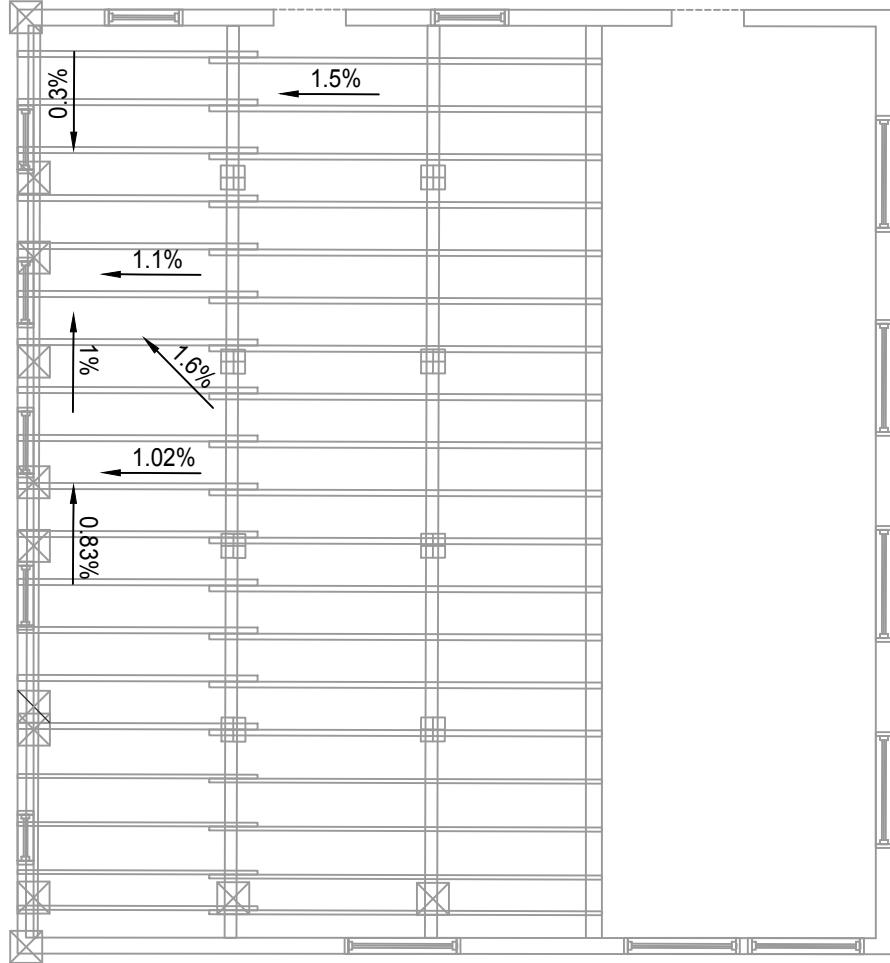
- MBV Engineering, Inc. performed an interior elevation survey to determine if the current floor slopes within the structure meet the ADA standards of not exceeding 1 unit vertical for every 48 units horizontal. An attached topographic map of the floor system can be seen and it was noted at the time of an inspection there is a 2" drop off in the southeast corner of the structure. After our investigation MBV Engineering, Inc. has determined the floor slopes are within the ADA tolerances.

ADA LIMIT IS 2%

AREA THAT EXCEEDS THE
LIMIT

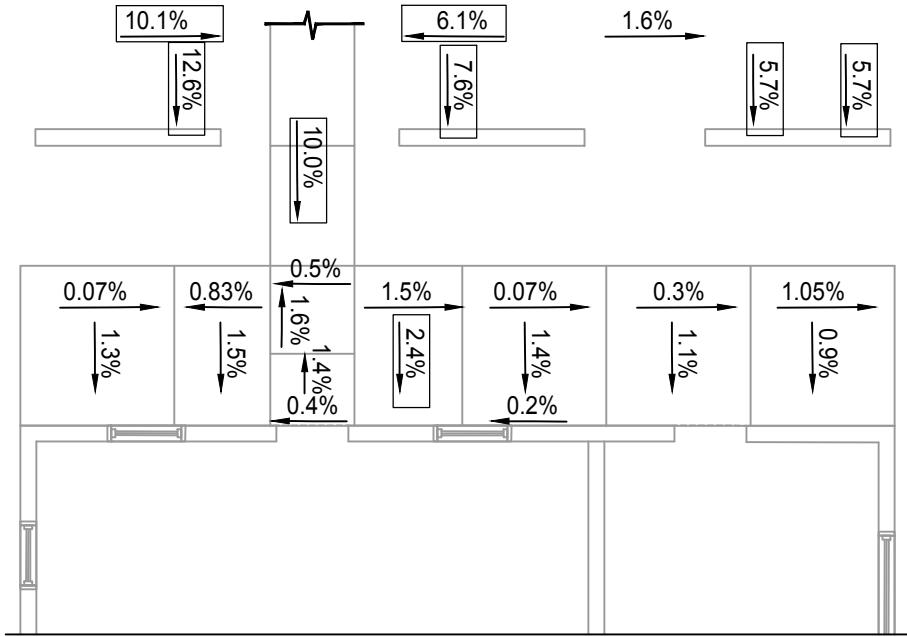
EXTERIOR SLOPE PLAN

ADA LIMIT IS 2%
 AREA THAT EXCEEDS THE
 LIMIT

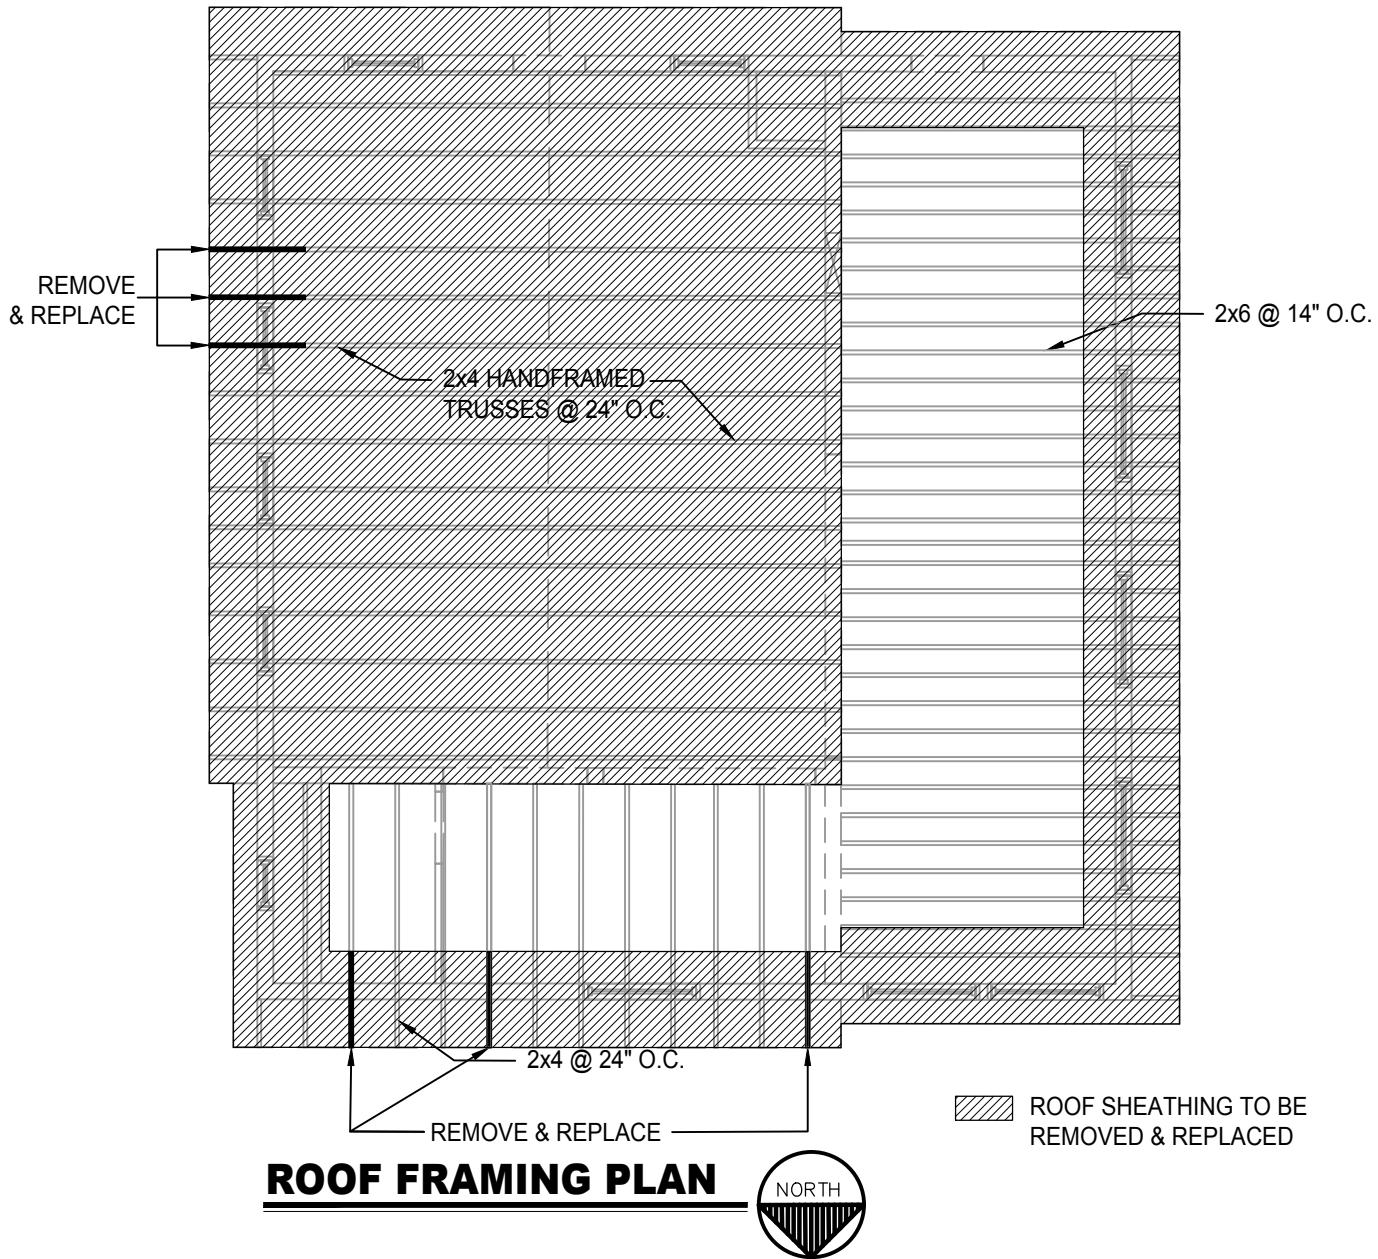
ROOF FRAMING
REPAIR PLAN

- Multiple areas on the overhangs were damaged and are noted on the plans. This damage is seen on the sheathing, members, and fascia.

- 16"x16" CMU
- 12"x12" WOOD
- 16"x16" CMU W/ HELICAL PIER
- FLOOR SHEATHING TO BE REMOVED & REPLACED

NOTE: OTHER MEMBERS MAY NEED
TO BE REMOVED & REPLACED ONCE
SHEATHING IS REMOVED
