**Durrance Place Property**  
**Indian River County Environmental Bond**  
**2024**

**Water & Air Research, Inc.  
6821 Southwest Archer Road  
Gainesville, Florida 32608  
Project No. 24-6442**

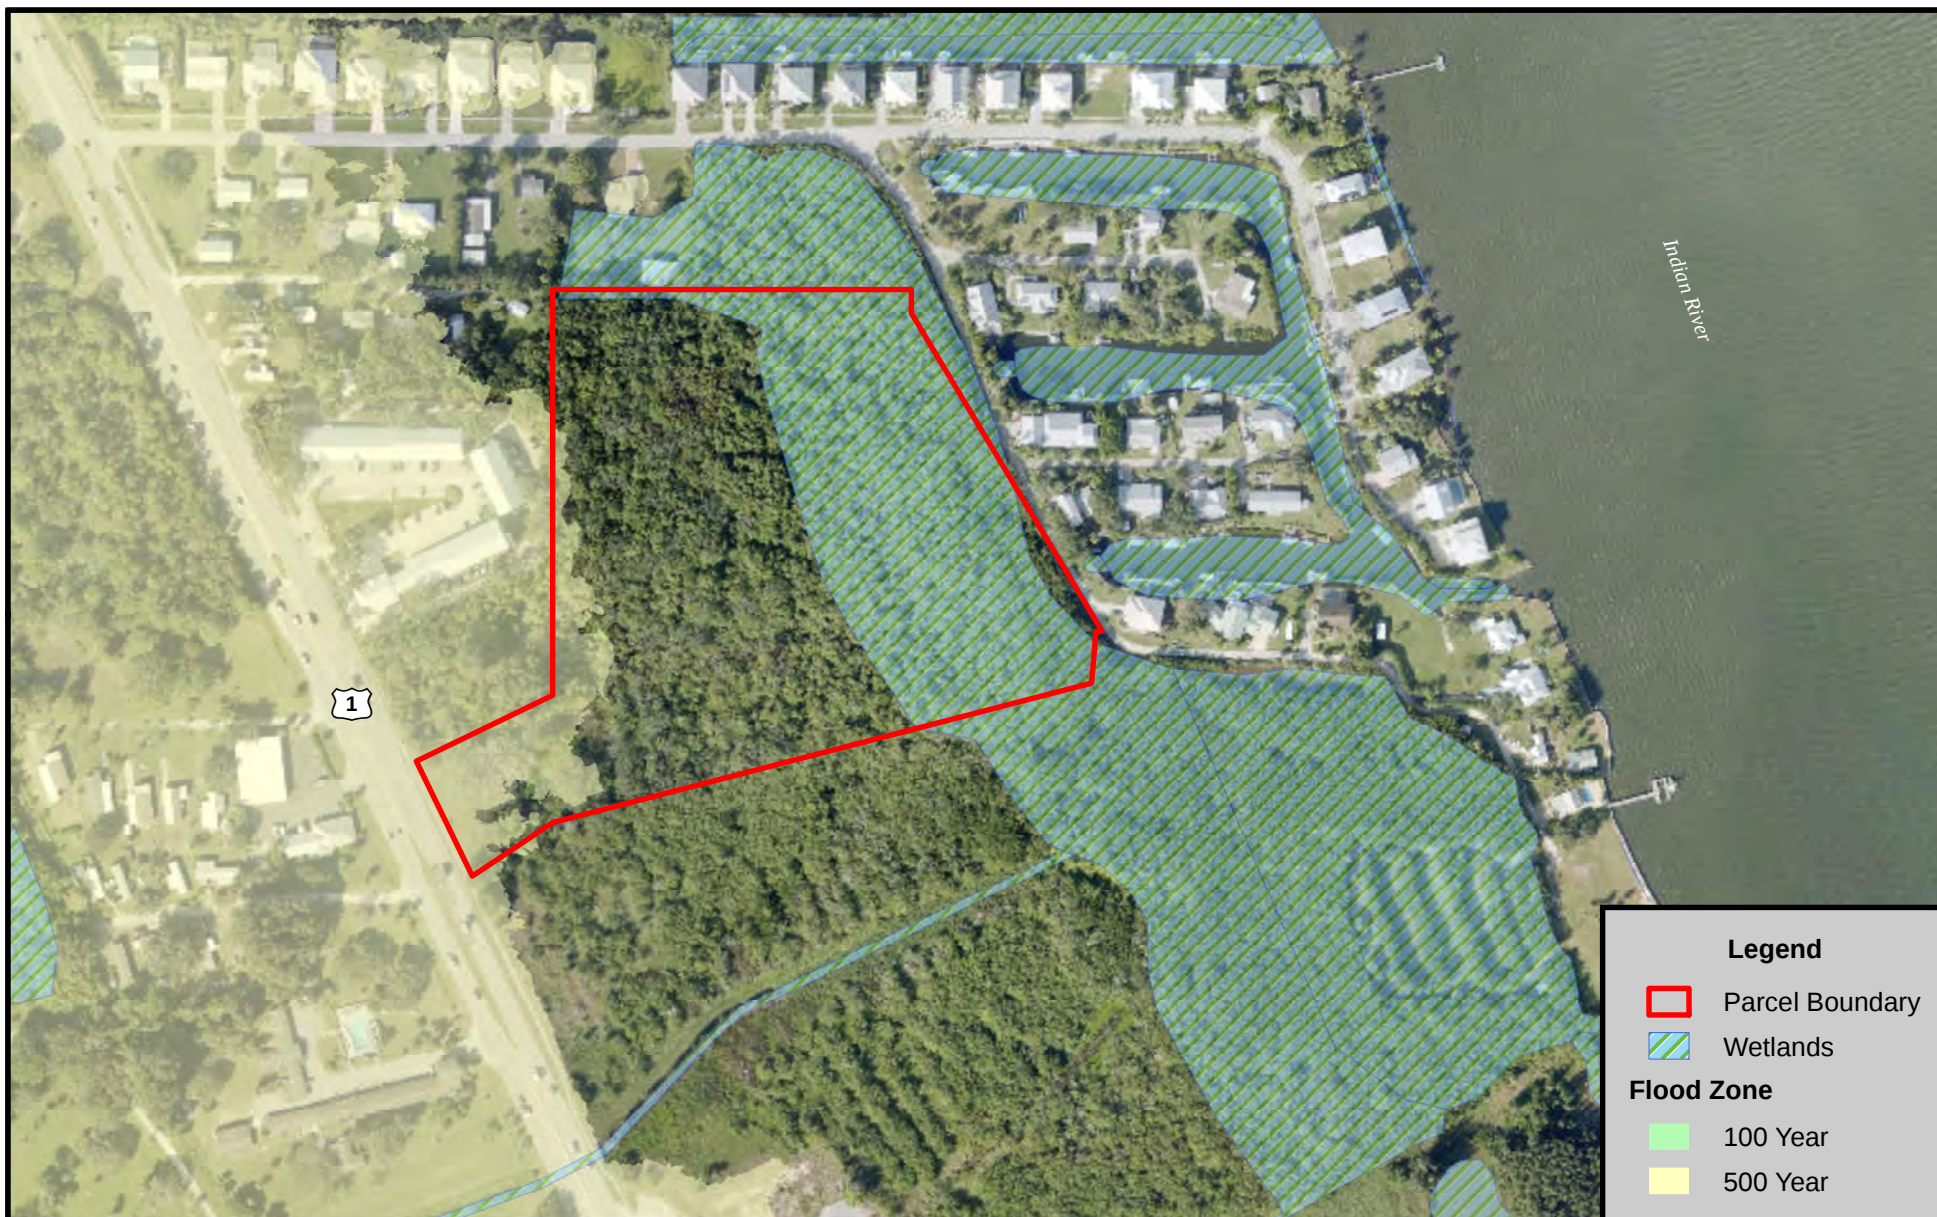
Figure 8.  
The NWI Wetlands and FEMA Flood Zones  
on the Durrance Place Property  
Indian River County, Florida

Figure 8 shows the wetlands, waterbodies, and flood zones located on the property from the National Wetlands Inventory (NWI) and Federal Emergency Management Agency (FEMA) maps. The NWI map identified 4.9-acres of Estuarine wetlands, 37.8 percent of the site.
