**Durrance Place Property**  
**Indian River County Environmental Bond**  
**2024**

**Water & Air Research, Inc.  
6821 Southwest Archer Road  
Gainesville, Florida 32608  
Project No. 24-6442**

The Durrance Place Property, Environmental Bond Nomination Number 18, was nominated by a local resident with the anticipated acquisition type of Fee Simple.

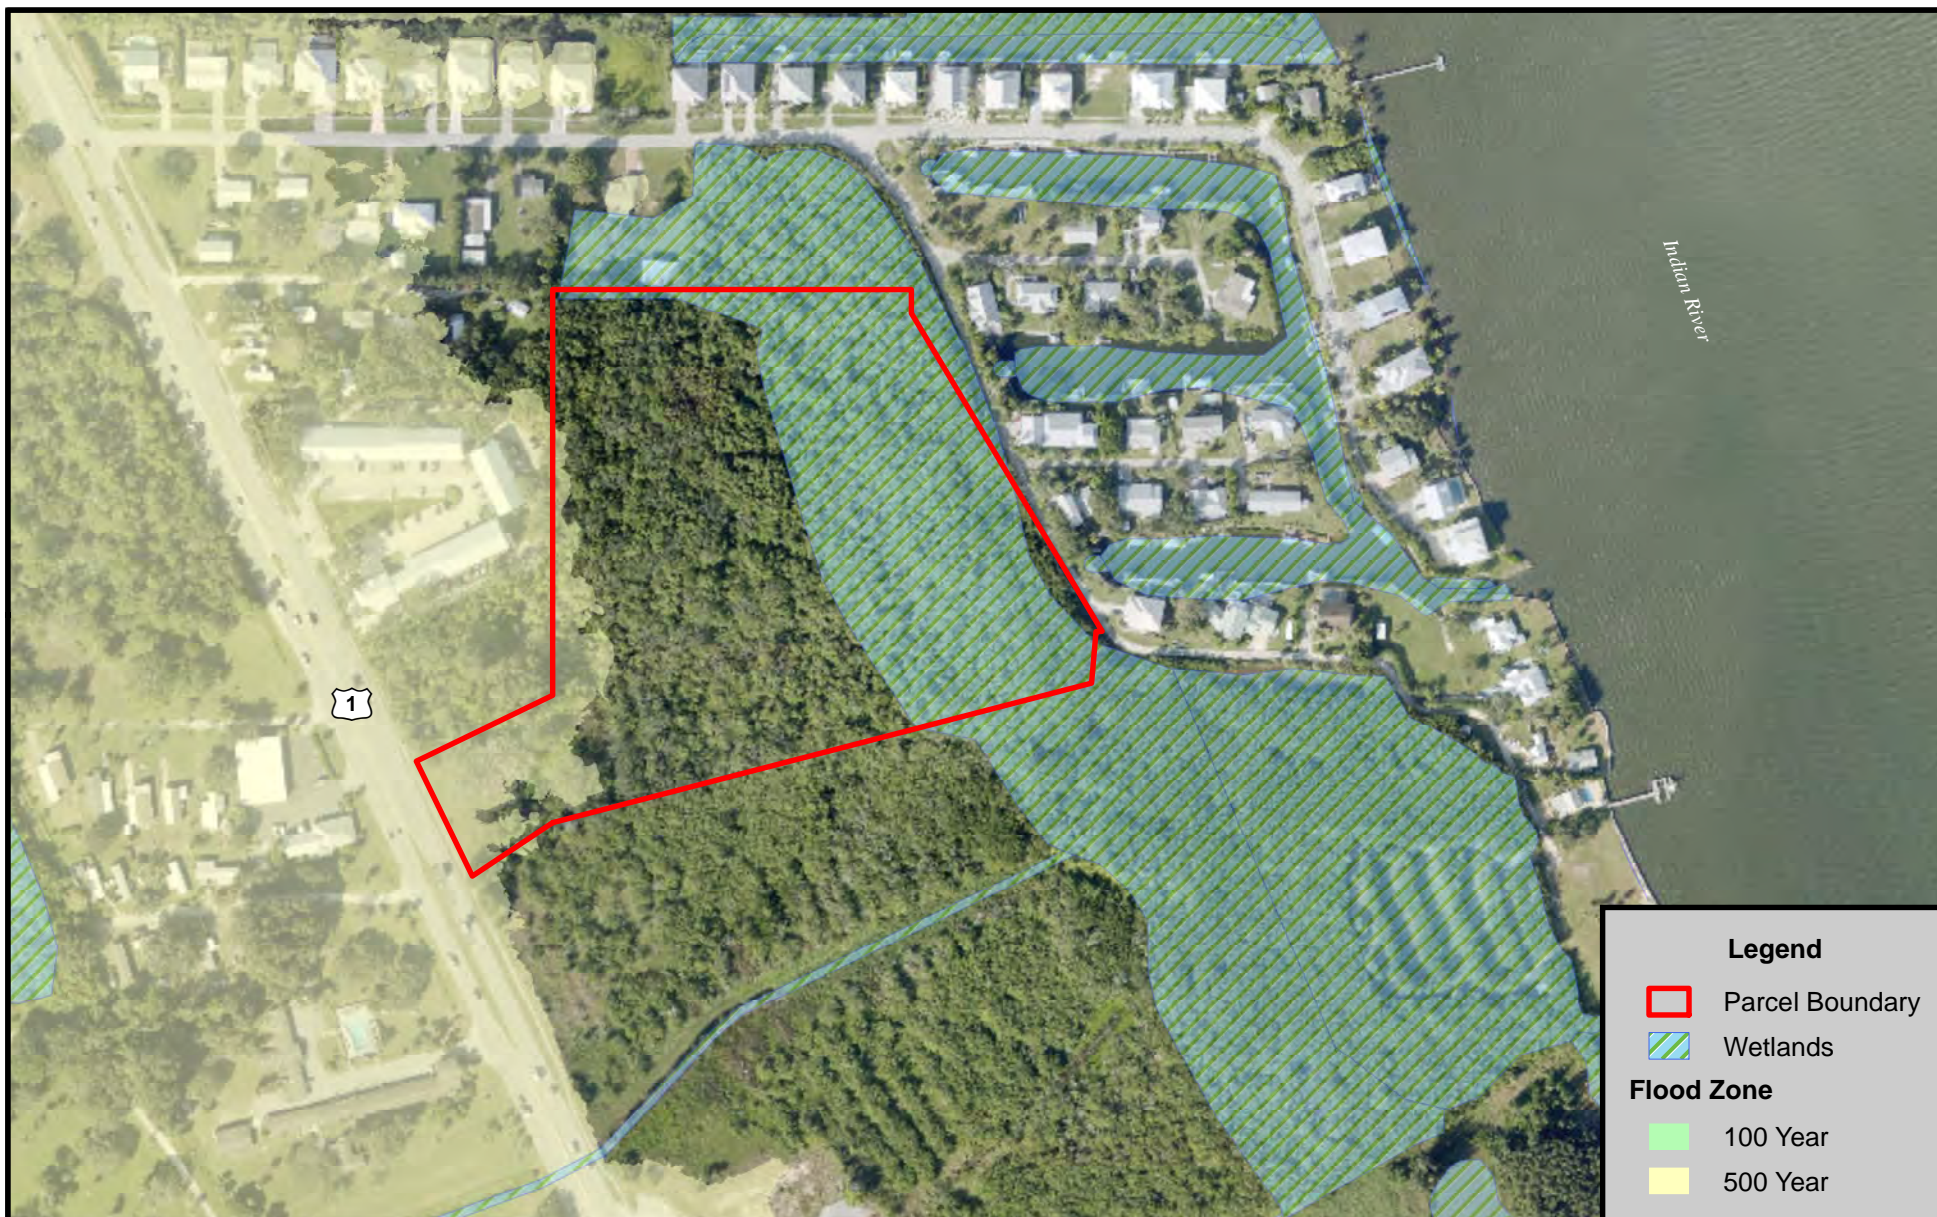
Figure 8.  
The NWI Wetlands and FEMA Flood Zones  
on the Durrance Place Property  
Indian River County, Florida

Figure 8 shows the wetlands, waterbodies, and flood zones located on the property from the National Wetlands Inventory (NWI) and Federal Emergency Management Agency (FEMA) maps. The NWI map identified 4.9-acres of Estuarine wetlands, 37.8 percent of the site.

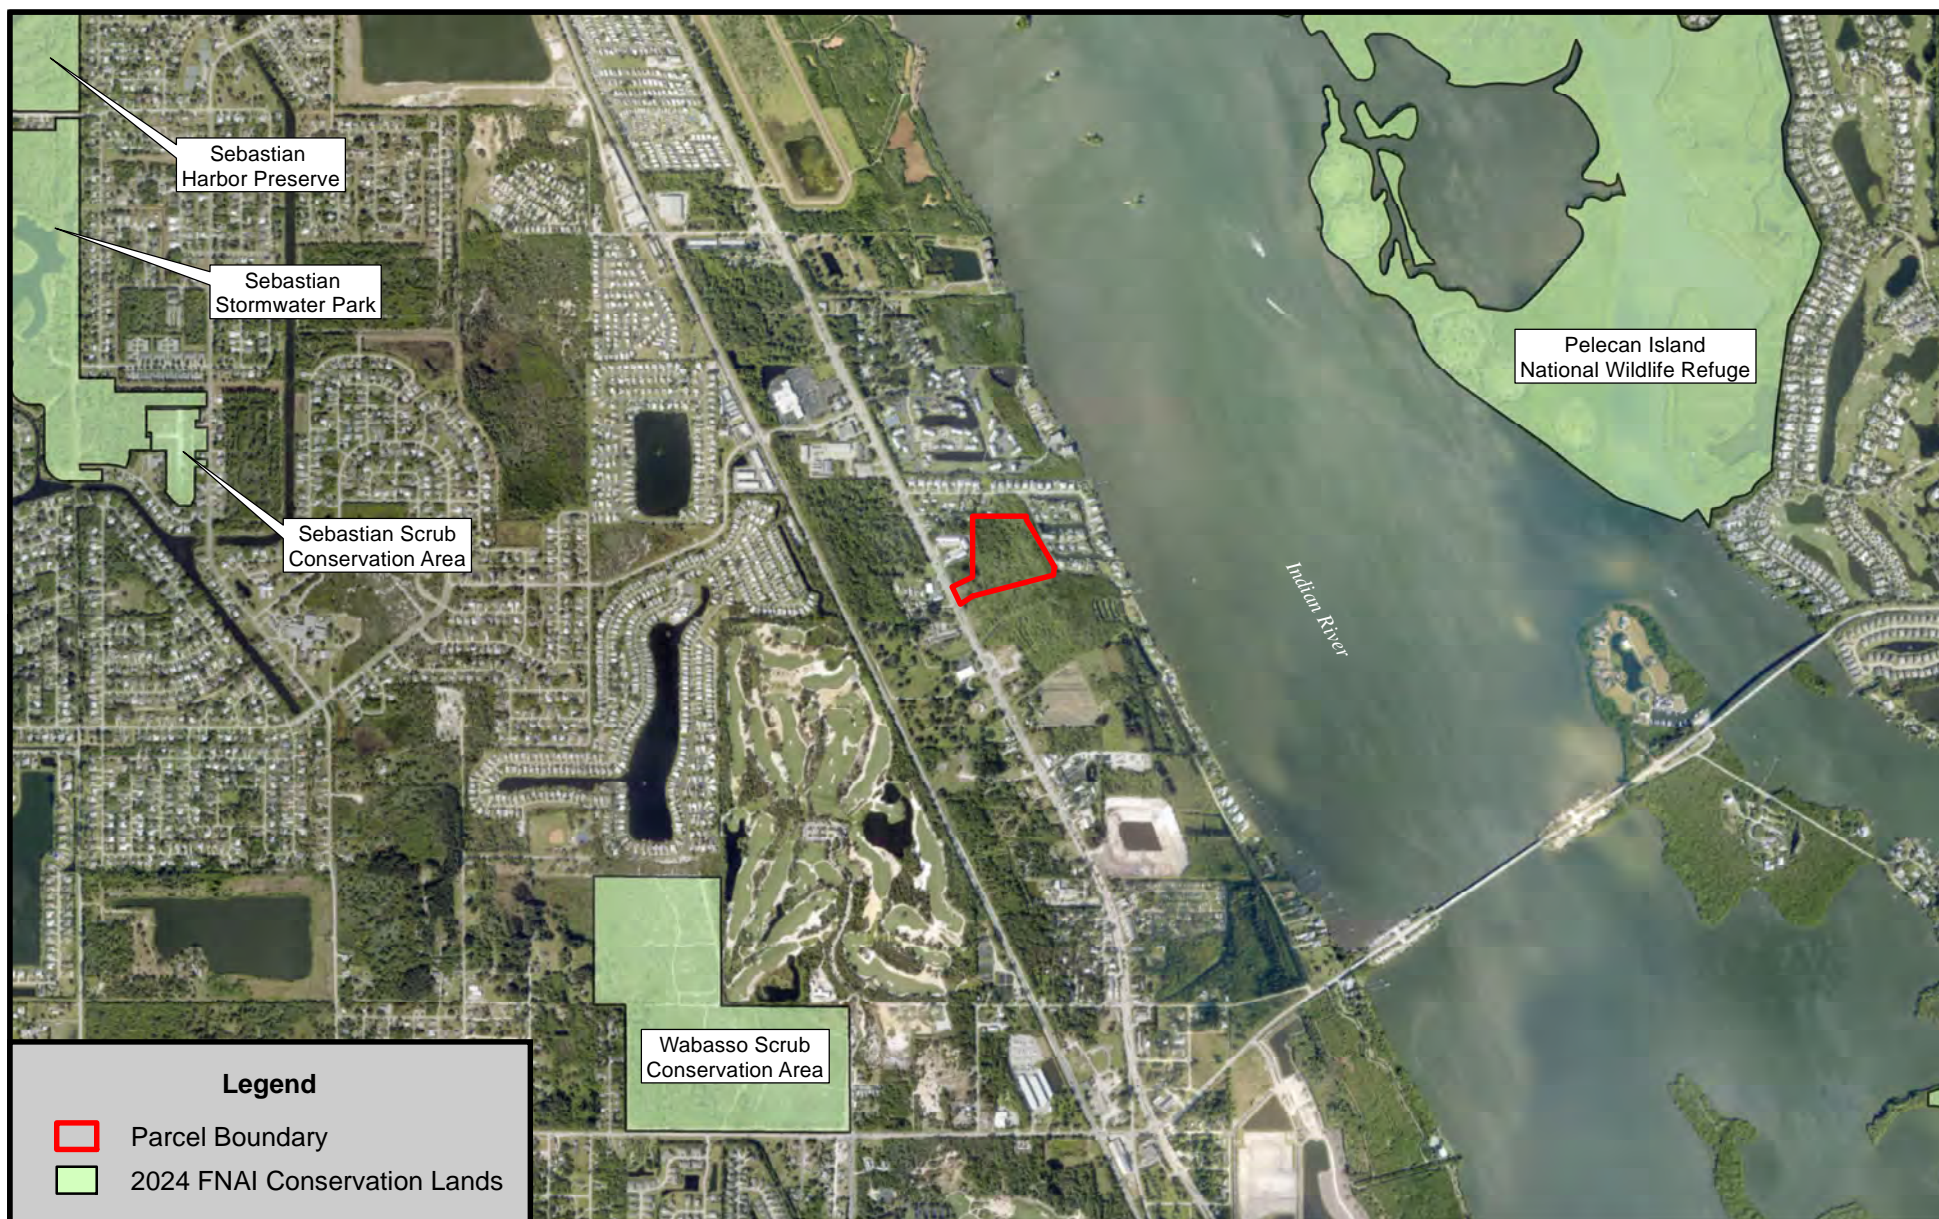
Figure 10.  
The Durrance Place Property  
and the Conserved Lands in the Vicinity  
Indian River County, Florida

The Durrance Place Property is relatively isolated and is not within or immediately adjacent to any greenways or corridors. The east boundary is within 200m of the Indian River Lagoon Blueway Corridor. The closest conservation area, Wabasso Scrub Conservation Area, lies approximately 1,100m to the southwest, Pelican Island National Wildlife Refuge is approximately 1,400m east across the Indian River and an unacquired parcel of the Indian River Lagoon Blueway Florida Forever BOT project is within 1,600m to the south (Figure 10). This parcel is part of a group of parcels that have been nominated for acquisition and the total area equals approximately 43 acres.
