**Durrance Place Property
Indian River County Environmental Bond
2024**

**Water & Air Research, Inc.
6821 Southwest Archer Road
Gainesville, Florida 32608
Project No. 24-6442**

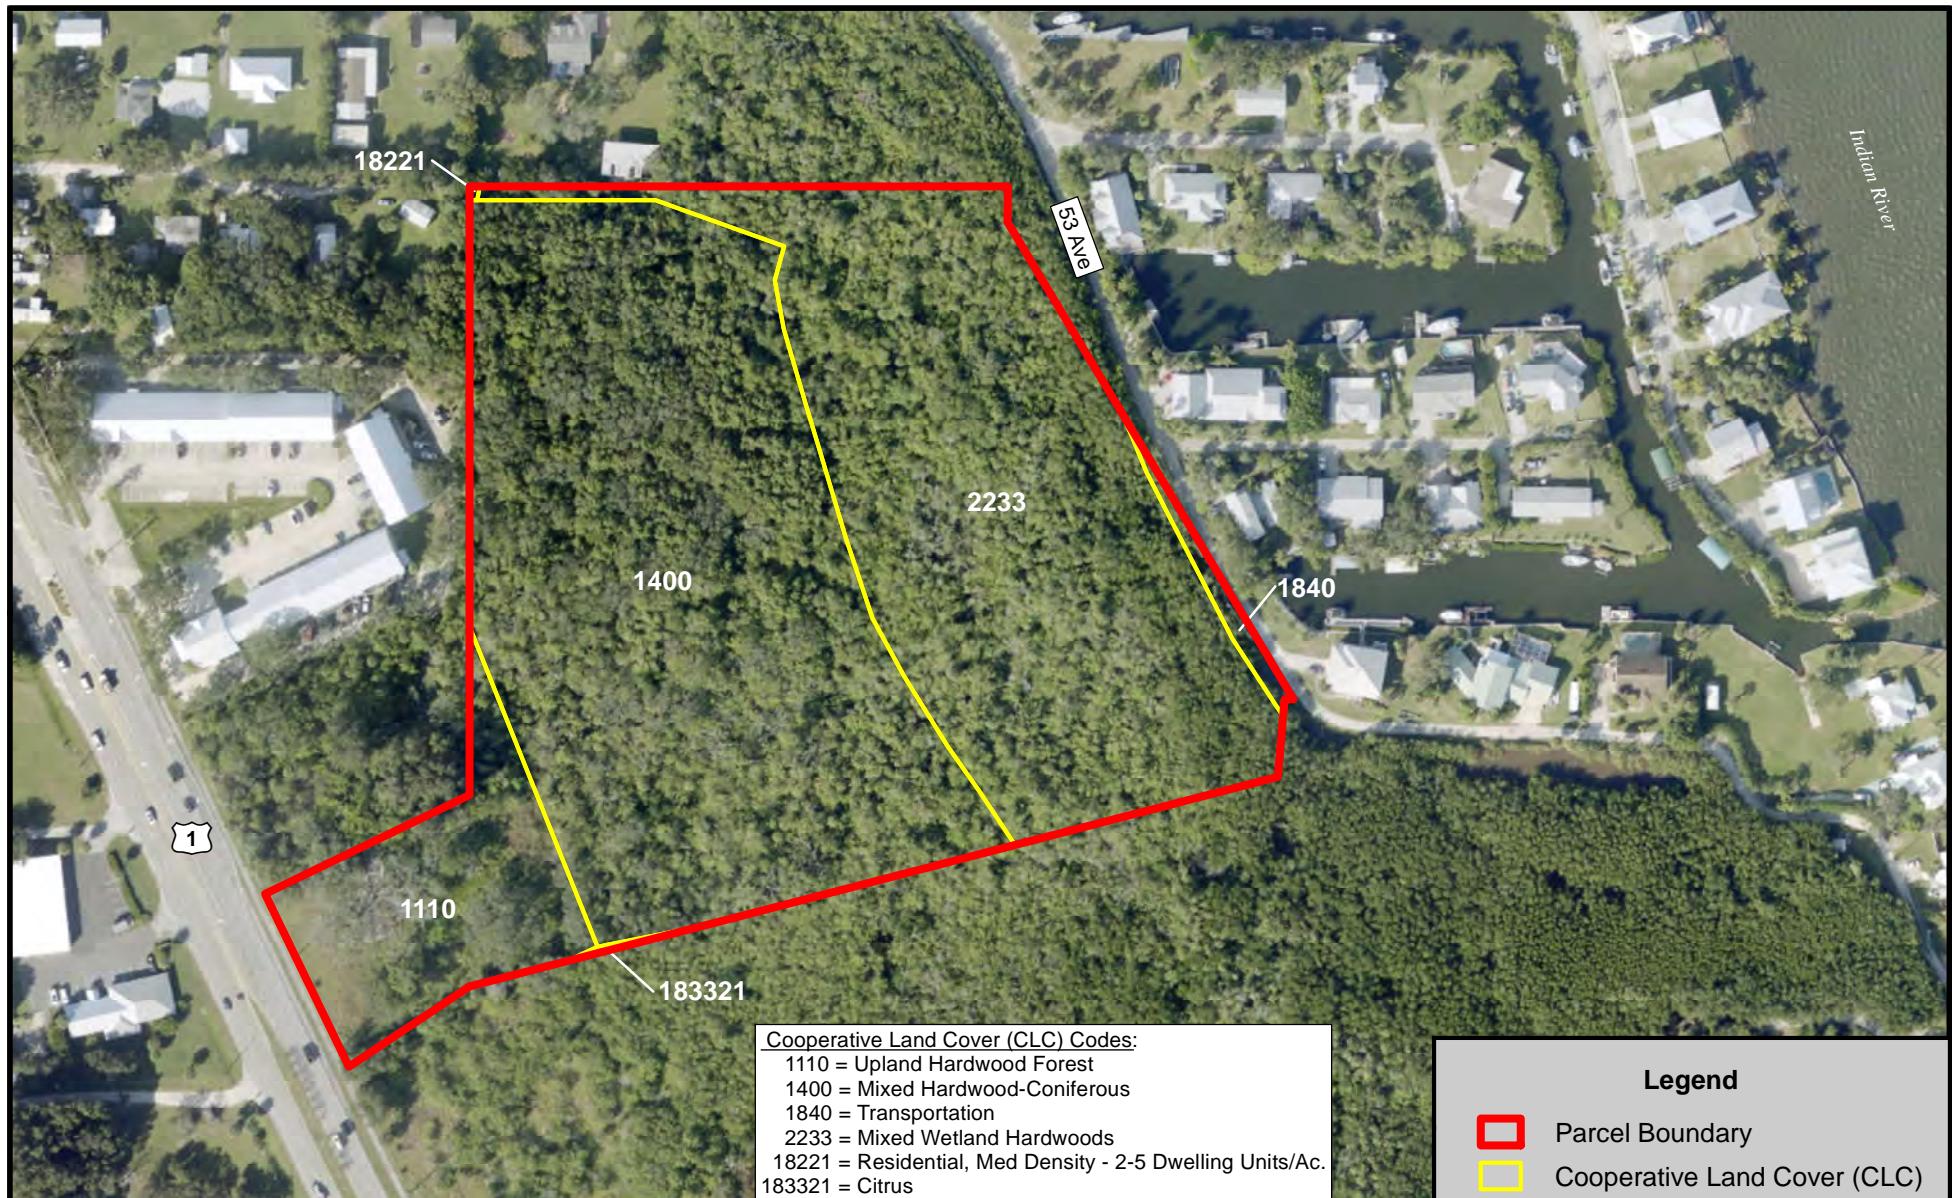
Figure 2.
The Florida Cooperative Land Cover Map
on the Durrance Place Property
Indian River County, Florida

There was one natural community type, and four altered land use types identified on the property from the 2023 Florida Cooperative Landcover Map (CLC) (Figure 2). Approximately 50 percent of the site was identified as Mixed Hardwood-Coniferous. This area consists of former citrus groves and is better described as Successional Hardwood Forest. Similarly, what was called Upland Hardwood Forest (11 percent), would also be better classified as Successional Hardwood Forest (FNAI 2010). Approximately 38 percent of the site was labeled Mixed Wetland Hardwood. The eastern half of this polygon has remained naturally vegetated; however, the western half of the polygon was planted with citrus in the 1940s through the 1950s. The CLC map Figure 3 and Table 1 present the acreage of each land use and natural community type on the property.

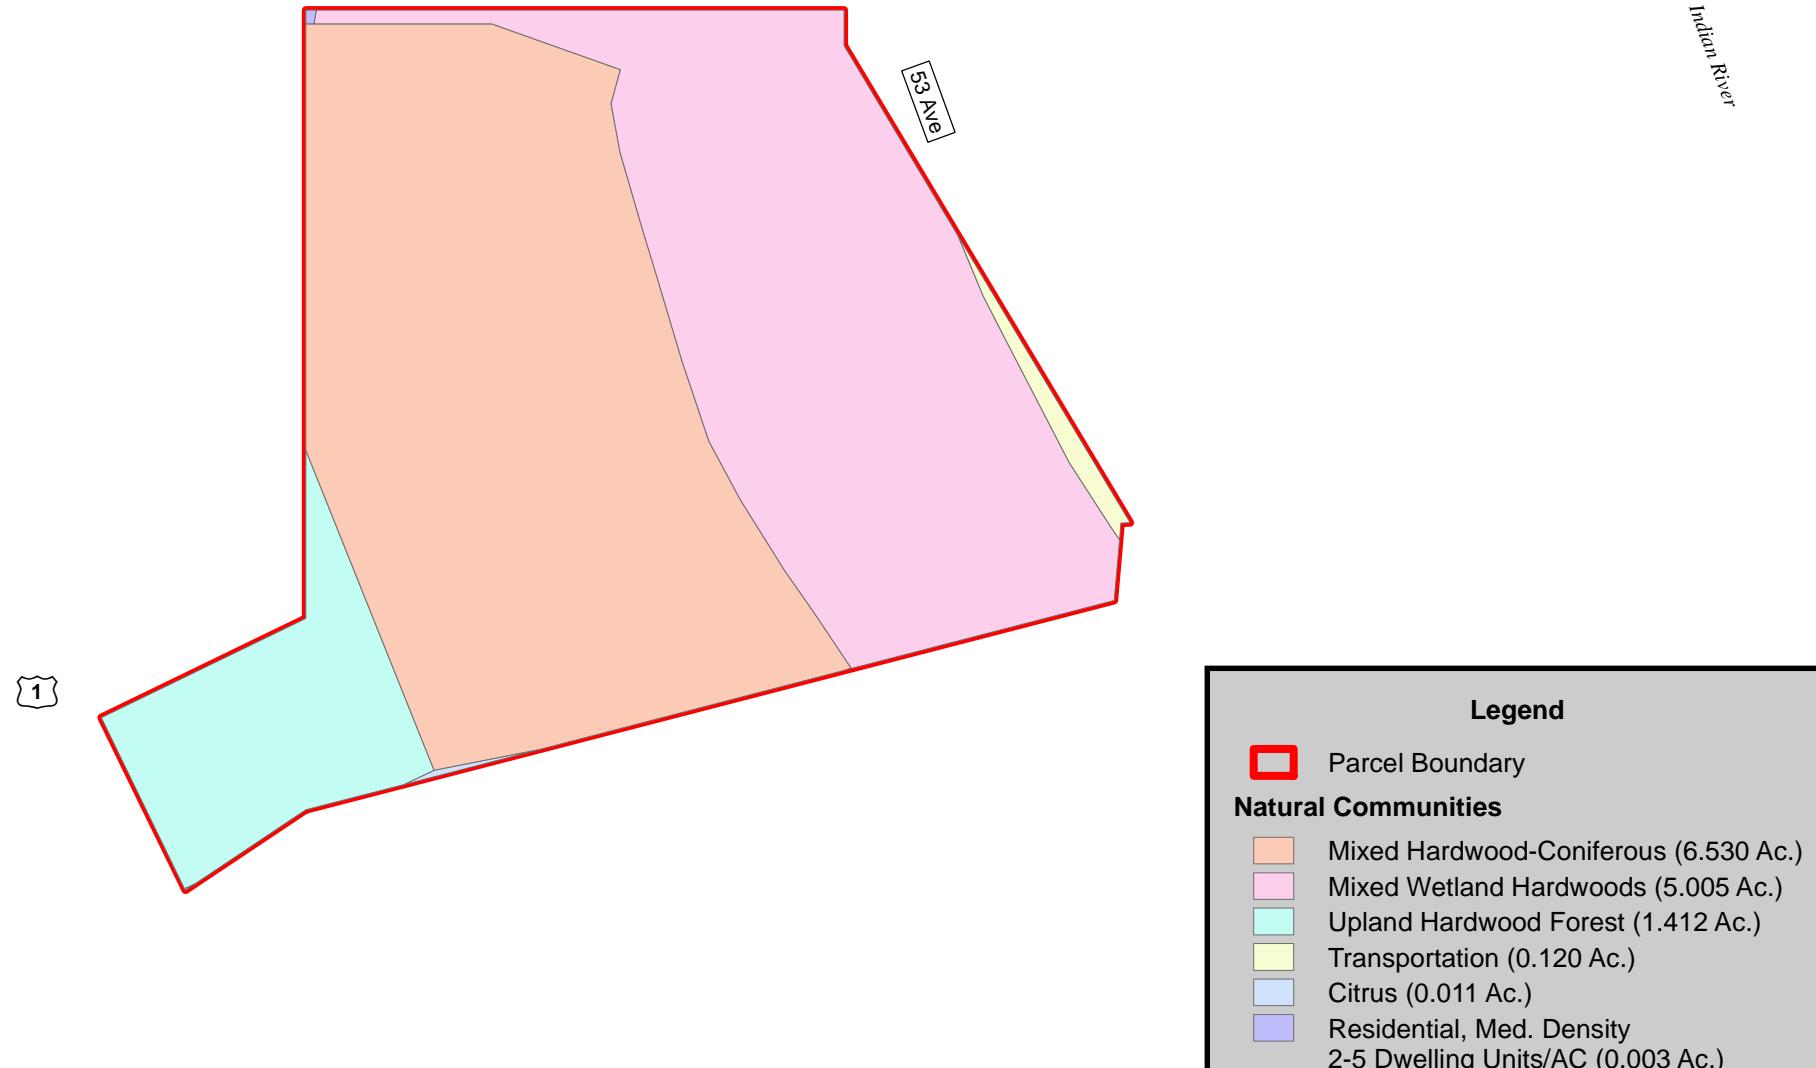
Figure 3.
The Land Use and Natural Communities
on the Durrance Place Property
Indian River County, Florida

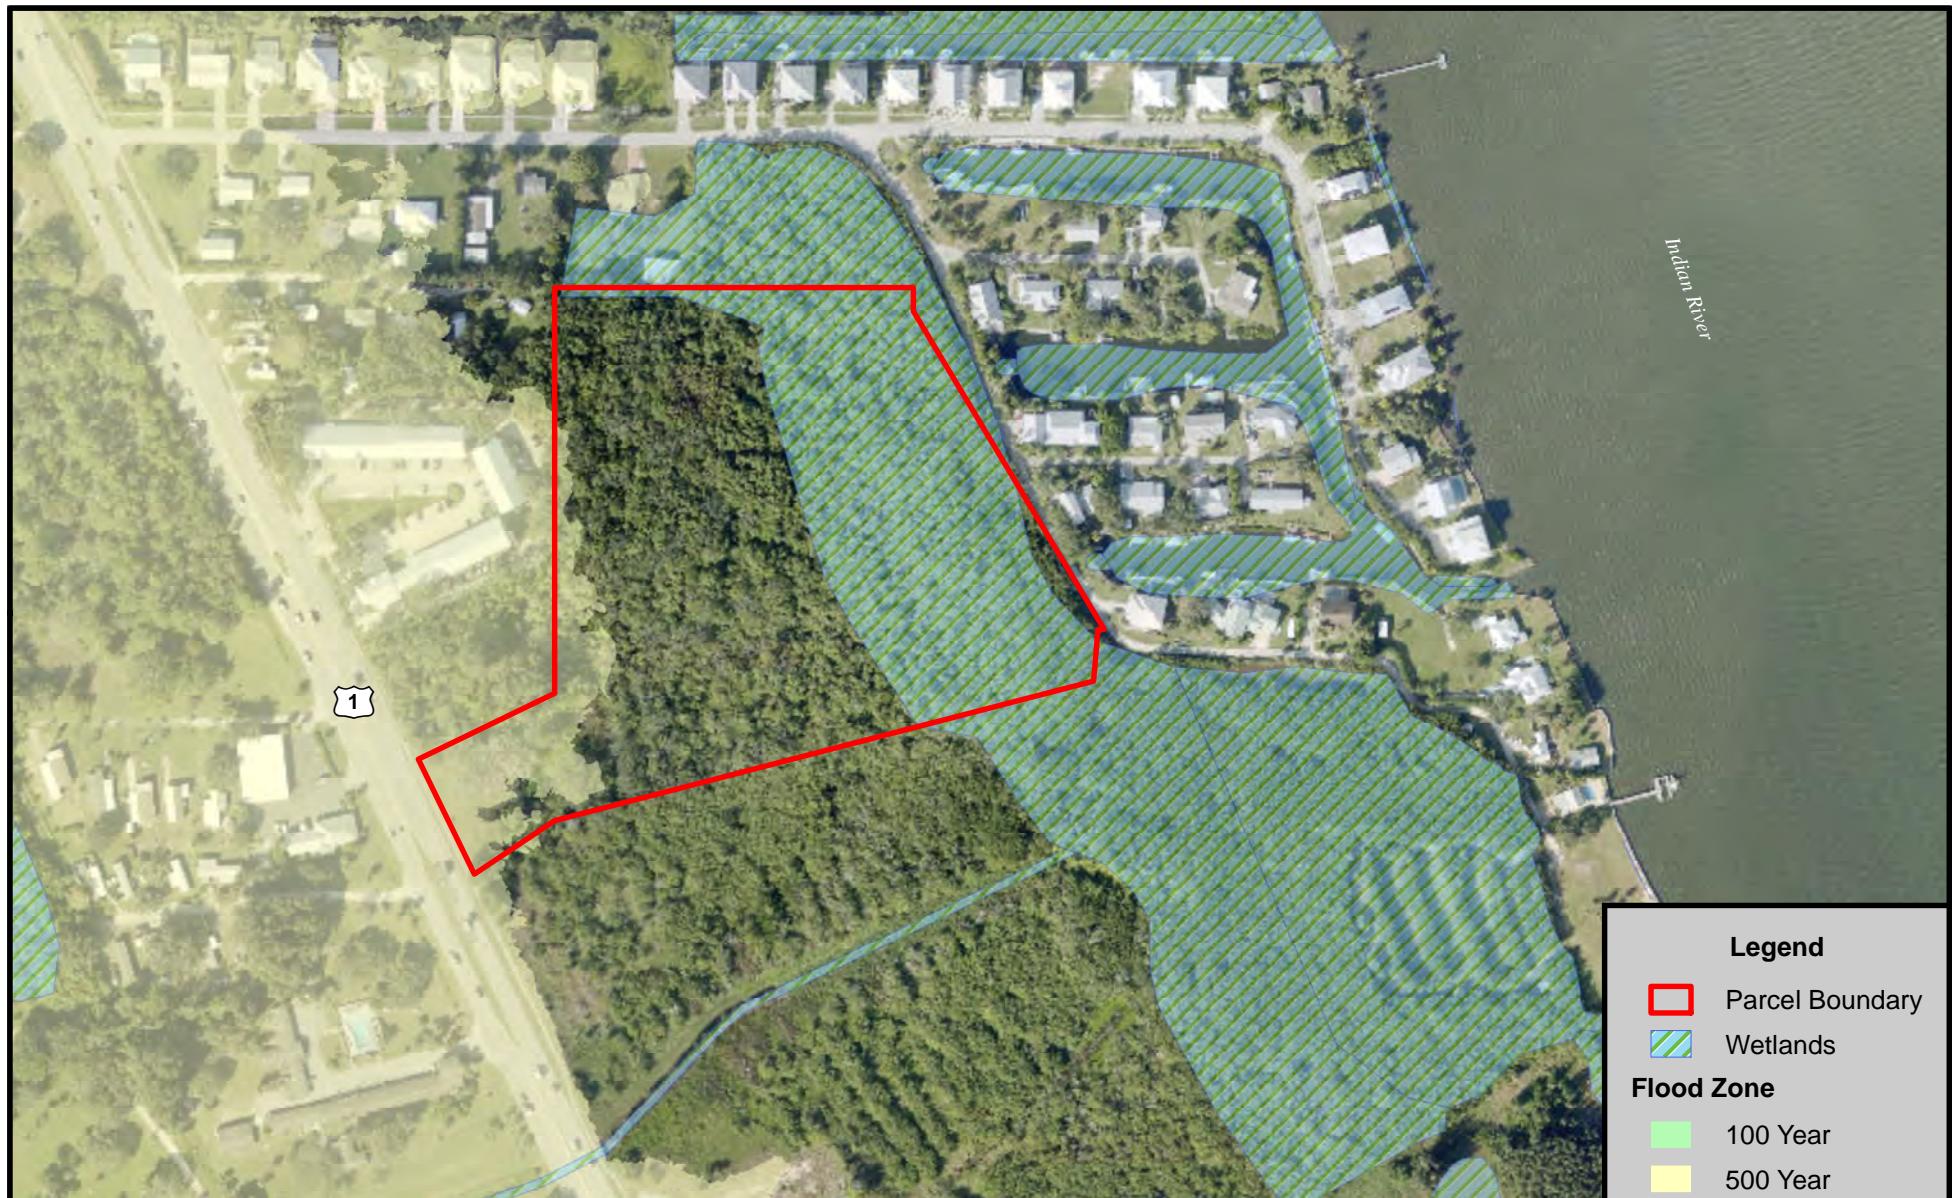
Figure 8.
The NWI Wetlands and FEMA Flood Zones
on the Durrance Place Property
Indian River County, Florida

Figure 8 shows the wetlands, waterbodies, and flood zones located on the property from the National Wetlands Inventory (NWI) and Federal Emergency Management Agency (FEMA) maps. The NWI map identified 4.9-acres of Estuarine wetlands, 37.8 percent of the site.

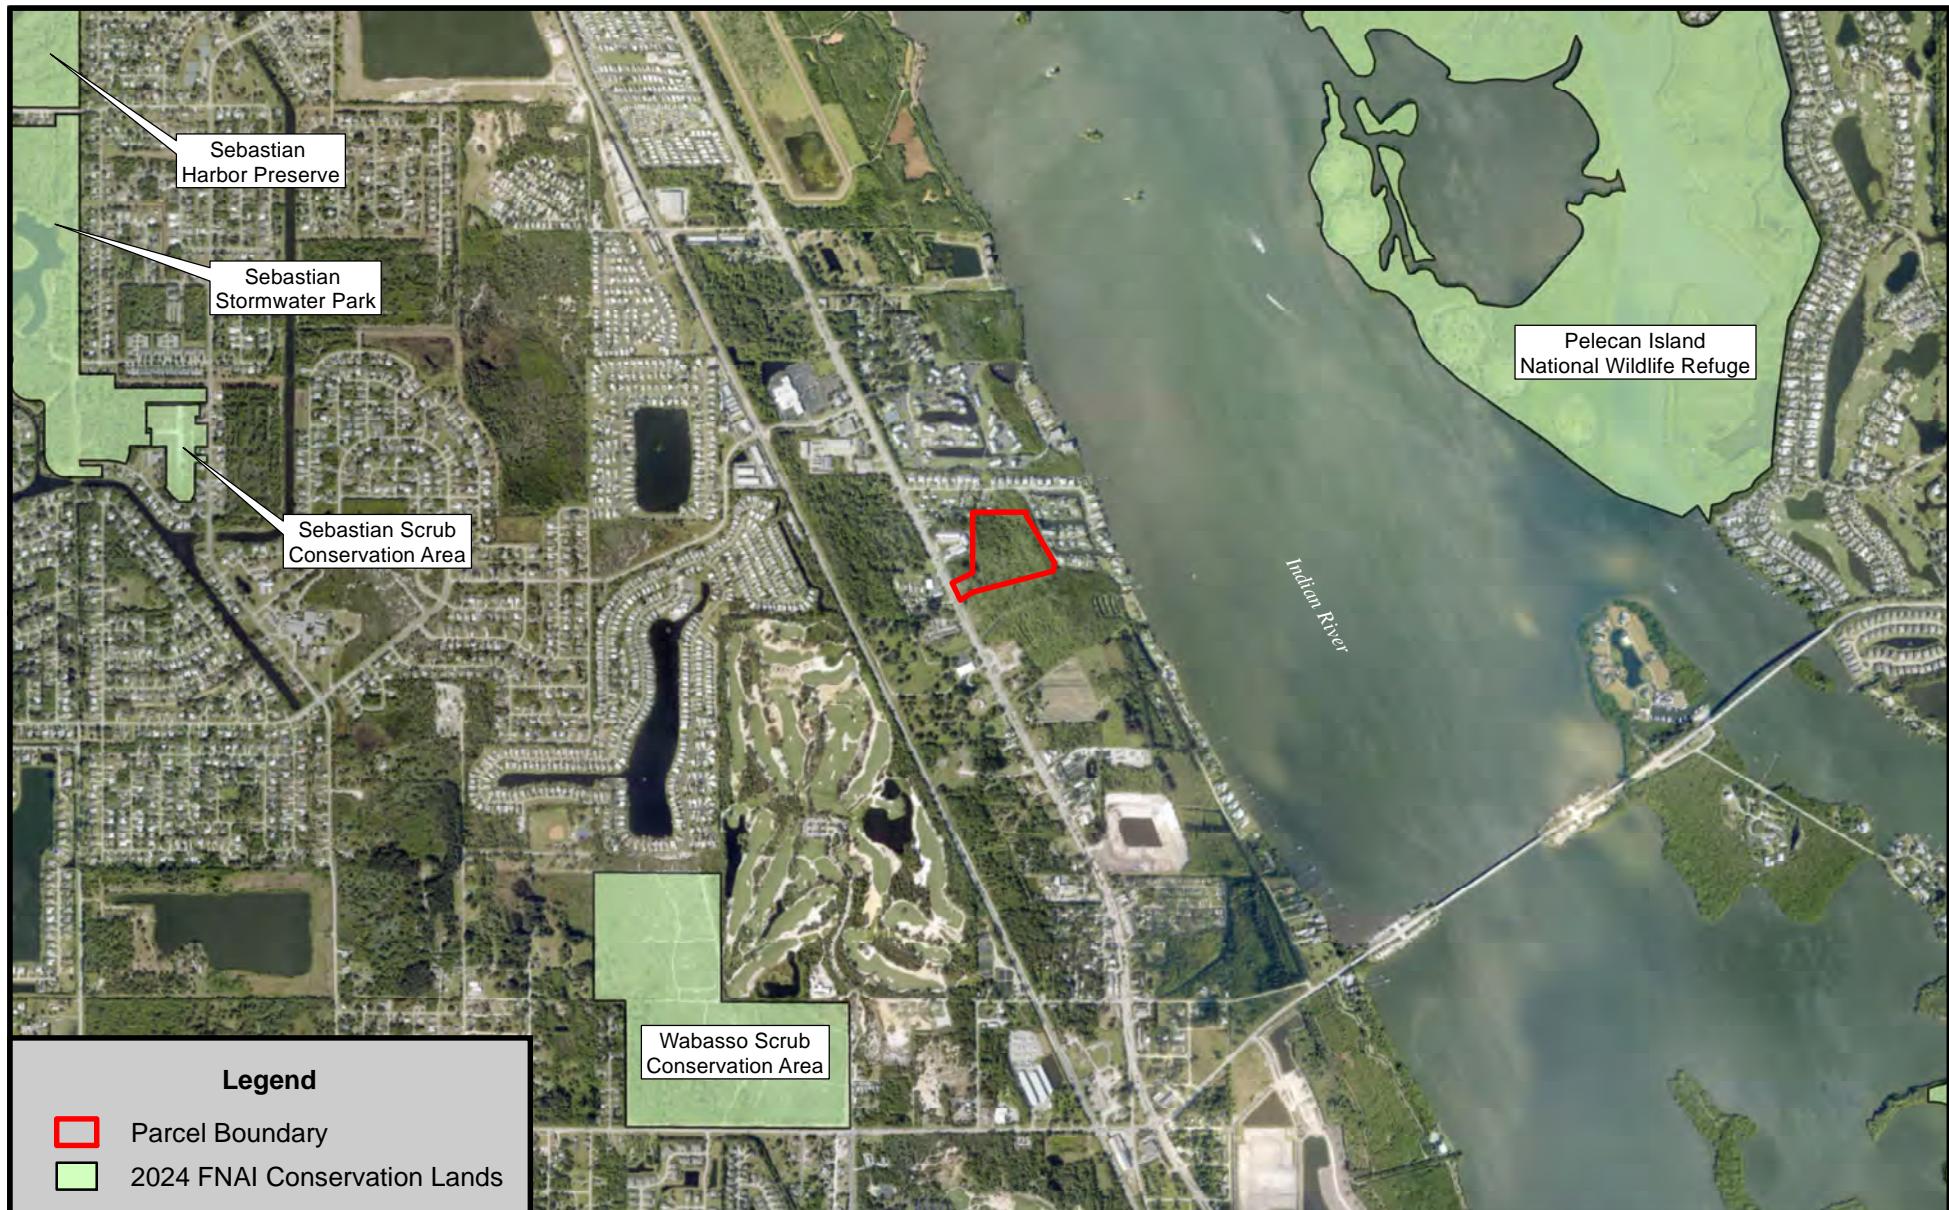
Figure 10.
The Durrance Place Property
and the Conserved Lands in the Vicinity
Indian River County, Florida

The Durrance Place Property is relatively isolated and is not within or immediately adjacent to any greenways or corridors. The east boundary is within 200m of the Indian River Lagoon Blueway Corridor. The closest conservation area, Wabasso Scrub Conservation Area, lies approximately 1,100m to the southwest, Pelican Island National Wildlife Refuge is approximately 1,400m east across the Indian River and an unacquired parcel of the Indian River Lagoon Blueway Florida Forever BOT project is within 1,600m to the south (Figure 10). This parcel is part of a group of parcels that have been nominated for acquisition and the total area equals approximately 43 acres.
