CITY OF VERO BEACH DEPARTMENT OF PUBLIC WORKS	JACKIE ROBINSON CANAL CLEARING	
	DATE 4/2025	DRAWN BY: AML
APPR.		DWG NO.
REV.

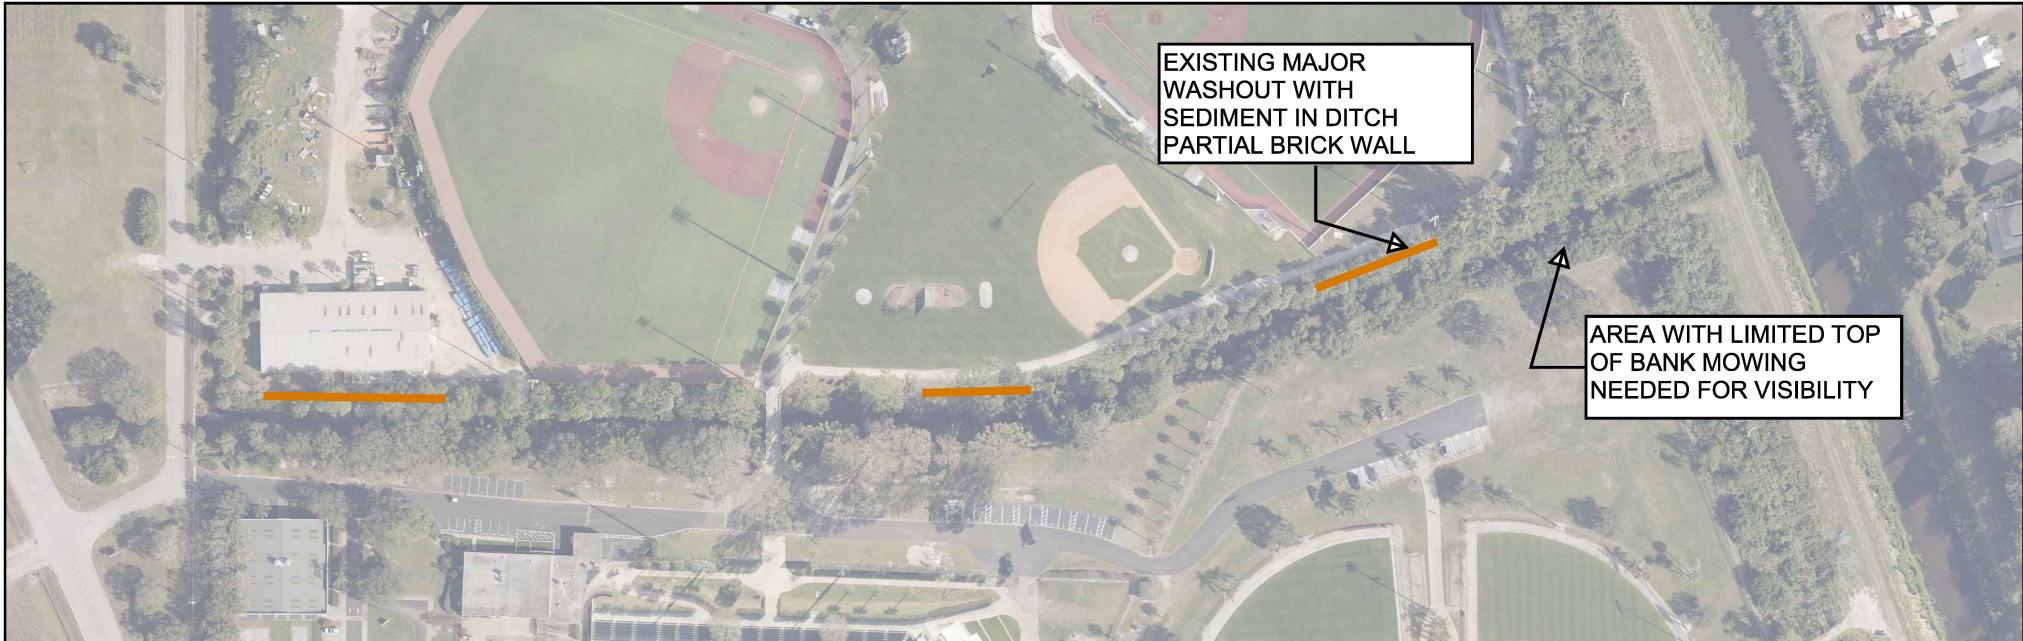
CLEARING WORK SHALL BE PERFORMED PRIMARILY FROM WITHIN THE CANAL AND THE WESTERN BANK. HEAVY EQUIPMENT WILL NEED TO ENTER AND EXIT THE CANAL AT EACH CROSSING WHICH MAY IMPACT THE BANK AND REQUIRE MINOR REPAIR. VEGETATION REMOVAL MAY NOT OCCUR IN AREAS WHERE THE BANK IS DESTABILIZED IN ITS EXISTING CONDITION TO MINIMIZE ANY FURTHER DAMAGE.

WORK WILL OCCUR UNTIL CONDITIONS NO LONGER PERMIT HEAVY EQUIPMENT ACCESS DUE TO WATER LEVELS.

PREEXISTING BANK EROSION IDENTIFIED IN AREAS ALONG EASTERN BANK (APPROXIMATE LOCATIONS MARKED IN ORANGE). AREAS IDENTIFIED WERE VISIBLE FROM TOP OF BANK AND MAY NOT BE ALL INCLUSIVE.

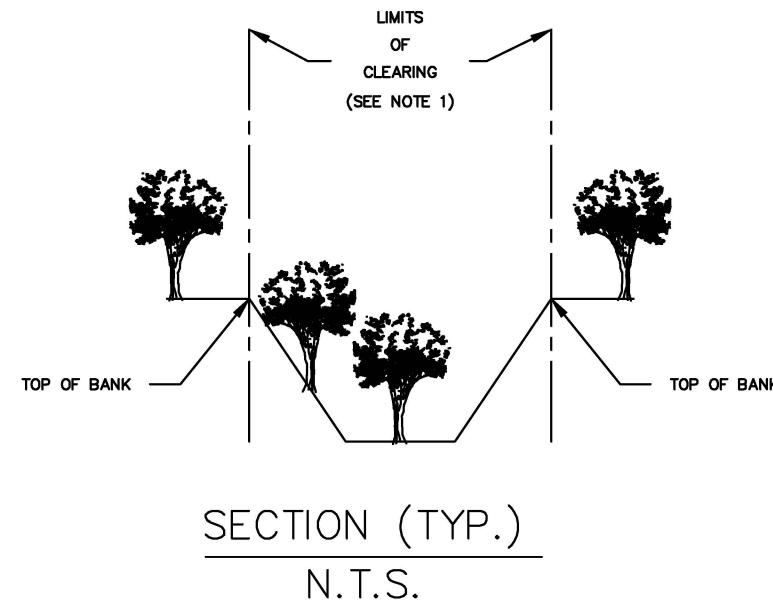
1. THE LIMITS OF CLEARING ELIGIBLE FOR REIMBURSEMENT FROM THE CITY OF VERO BEACH WILL BE FROM TOP OF BANK TO TOP OF BANK, PER THE TYPICAL SECTION.
2. ANY CLEARING BEYOND THE TOP OF BANK AS SHOWN IN THE TYPICAL SECTION WILL BE SUBJECT TO APPLICABLE PERMITTING AND WILL NOT BE ELIGIBLE FOR REIMBURSEMENT FROM THE CITY OF VERO BEACH.
