# **Jungle Trail Island Manor Property Indian River County Environmental Bond 2024**

**Water & Air Research, Inc.  
6821 Southwest Archer Road  
Gainesville, Florida 32608  
Project No. 24-6442**

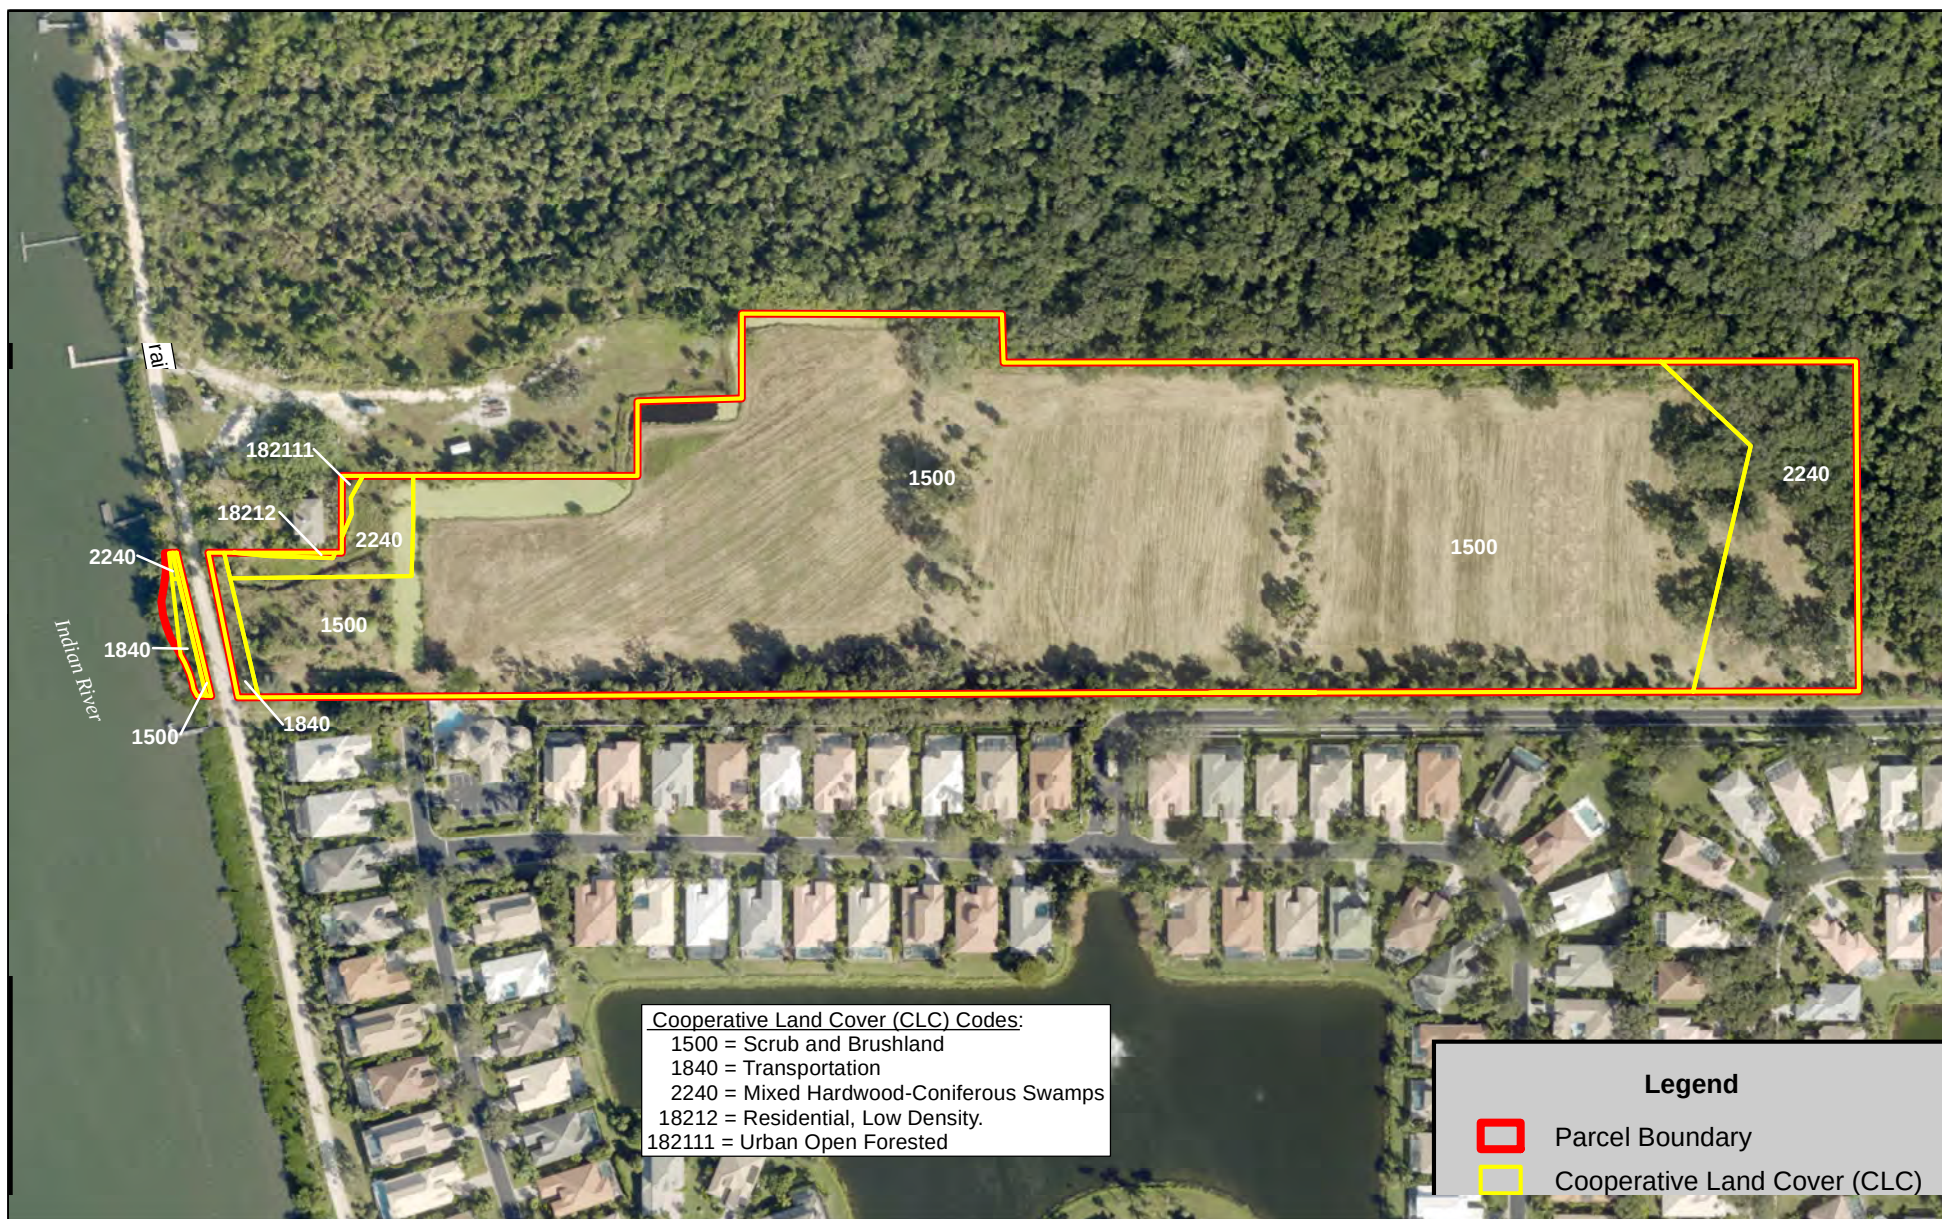
Figure 2.  
 The Florida Cooperative Land Cover Map  
 on the Jungle Trail Island Manor Property  
 Indian River County, Florida

There was one natural community type, and five altered land use types identified on the property from the 2023 Florida Cooperative Landcover Map (CLC) (Figure 2). Approximately 88 percent of the site consists of cleared brushland that was likely formerly maritime hammock (Table 1). There was a small area (approximately 1.8-acres) of forested land on the far eastern boundary that was typed “unaltered” mixed hardwood-coniferous swamp, however within this polygon there is

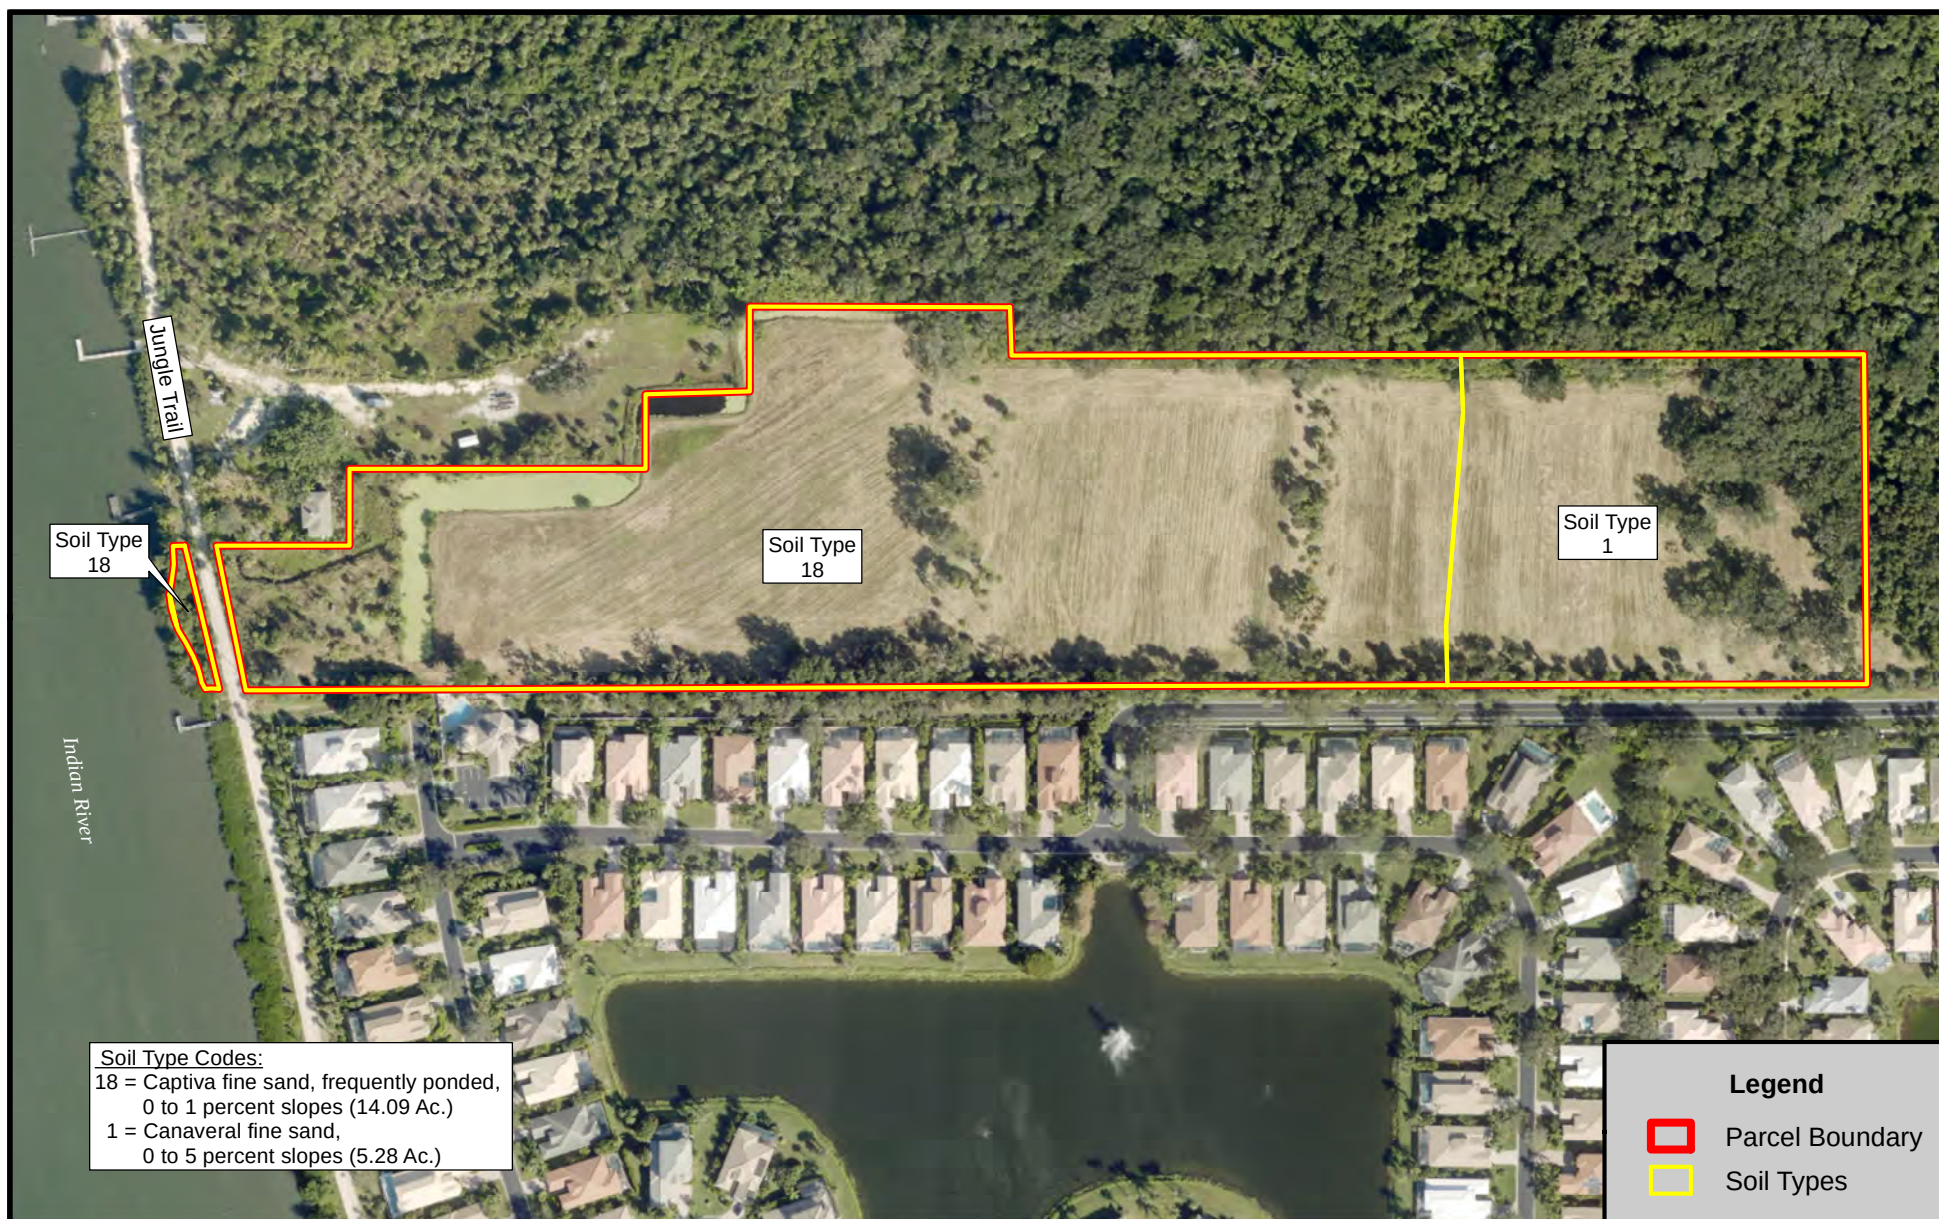
Figure 5.  
 The Soil Types Found on the  
 Jungle Trail Island Manor Property  
 Indian River County, Florida

The soil types found on the Jungle Trail Island Manor Property are represented in Figure 5. Captiva (14 acres) and Canaveral (5 acres) were the only two soil types identified on the property. The Captiva series makes up most of the western 0.75 of the site and is currently labelled Shrub and Brushland (old citrus grove) with some small areas labelled as Mixed Hardwood – Coniferous Swamps. The typical vegetation for the Captiva soils series is sand cordgrass, leather leaf fern and Brazilian pepper but on this property, it was historically likely Mixed Hardwood – Coniferous Swamps. The Captiva series consists of very deep, poorly drained, very rapidly permeable soils on broad, low flats near the coast. Internal drainage is impeded by a shallow water table. The water table is within depths of 10 inches for 1 to 2 months during the normal summer rainy season and other periods of high rainfall. In some years the soil is covered by standing water for several days. The Canaveral series makes up the eastern 0.25 of the site and consists of very deep, somewhat poorly to moderately well drained, very rapidly permeable soils on side slopes of dune-like ridges bordering depressions and sloughs along the coast in Peninsular Florida. The native vegetation consists of cabbage palm, scattered saw palmetto, magnolias, bays, and slash pine with an under-story of gallberry and pineland threawn.

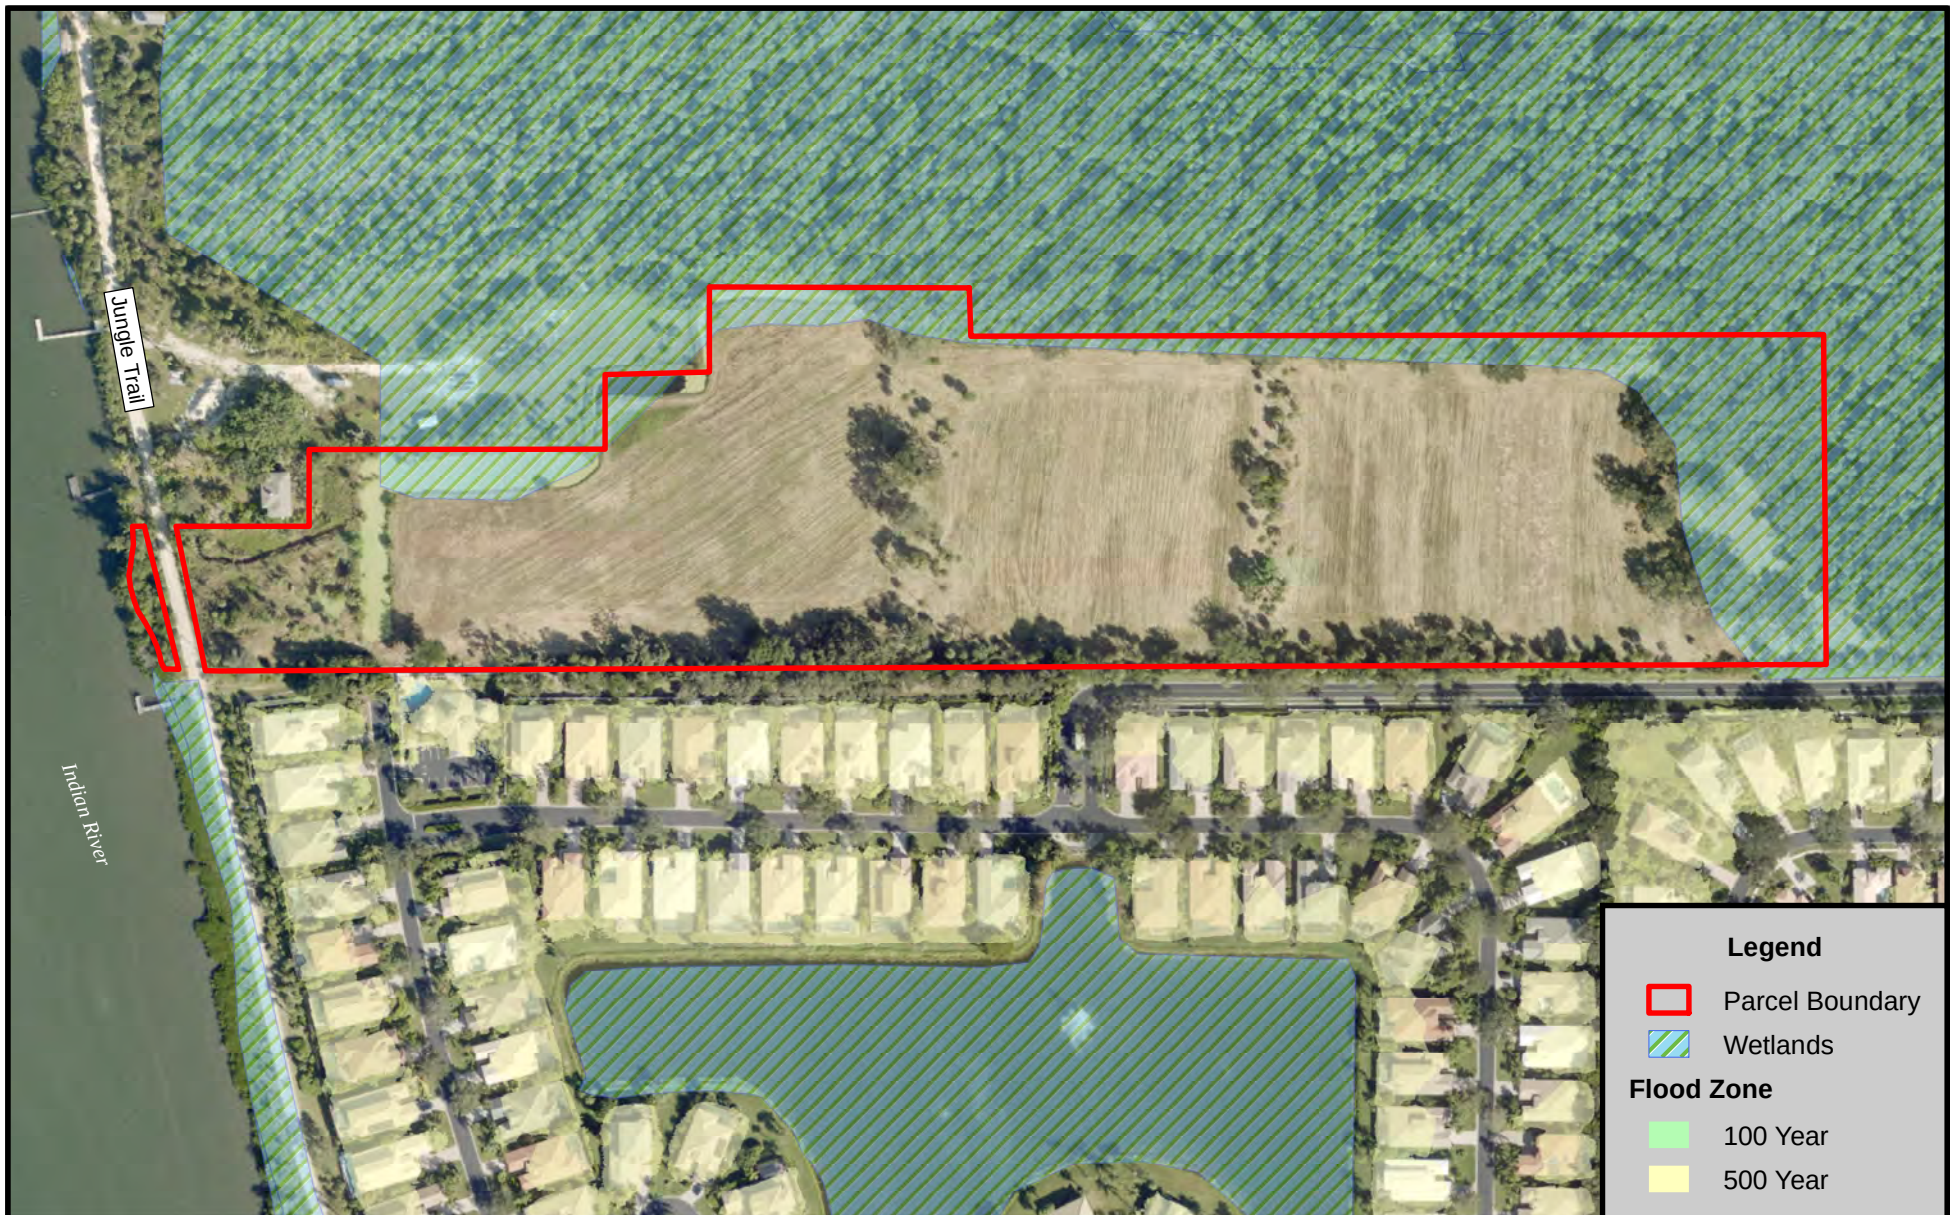
Figure 8.  
The NWI Wetlands and FEMA Flood Zones  
on the Jungle Trail Island Manor Property  
Indian River County, Florida

Figure 8 shows the wetlands, waterbodies, and flood zones located on the property from the National Wetlands Inventory (NWI) and Federal Emergency Management Agency (FEMA) maps. The NWI map identified 3.3 acres of wetlands, 17 percent of the site, and only freshwater forested/shrub wetland was documented. The excavated ponds, ditches and the Estuarine and Marine wetland polygon west of Jungle Trail were not depicted on the NWI or CLC maps.

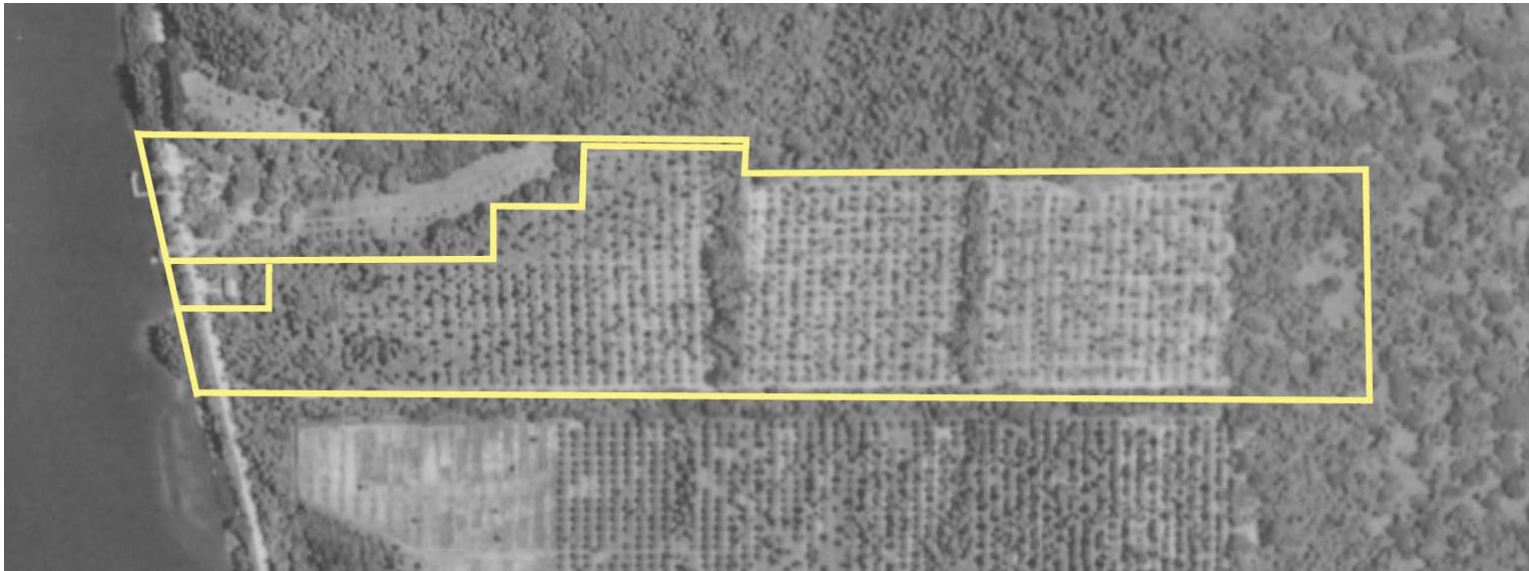
1943 Aerial Photograph

- Jungle Trail road runs along the west boundary of the property adjacent to the Indian River Lagoon
- Young citrus grove has been planted on approximately 12.6-acres of the property
- Within the grove two linear north south oriented forested strips remain
- Small areas east and west of the citrus grove and west of Jungle Trail (mangroves) are still forested
- The adjacent forested natural lands (to the north and east – currently the Captain Forster Hammock Preserve) are densely canopied with some minor jeep trails. The Jungle Trail Island Manor property was historically likely a continuation of the adjacent natural communities
- South of this property is a large citrus grove

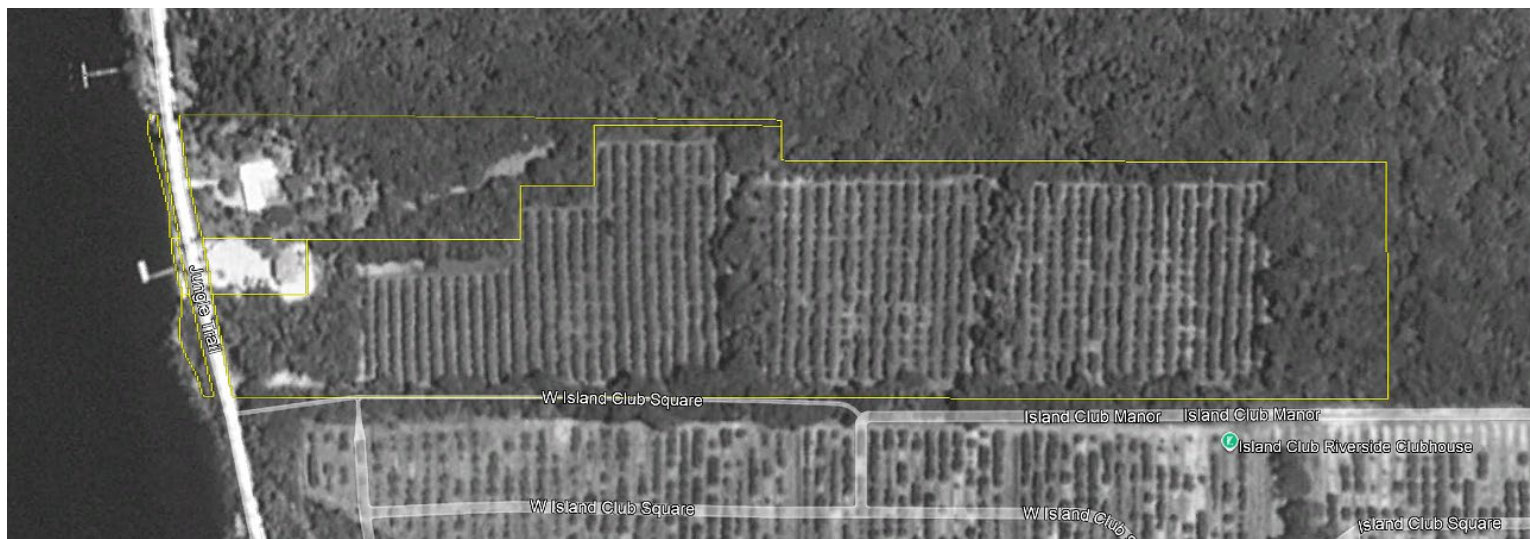
1994 Aerial Photograph

- Borrow pit excavation appears to be starting along the northwestern edge of the citrus grove, fill dirt may have been spread around the two new houses on the adjacent properties to the north (Fischer and Skiscim Properties)
- The offsite forested areas to the north and east remain, currently Captain Forster Hammock Preserve

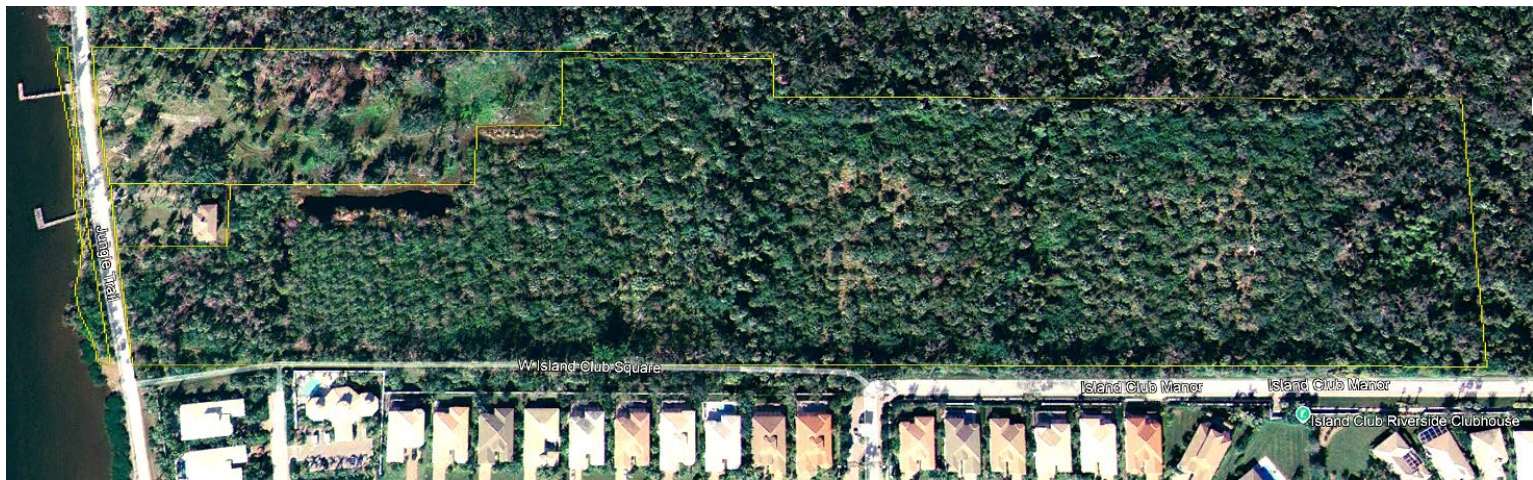
2005 Aerial Photograph

- The citrus grove has become fallow with recruitment of various tree species including palms
- The citrus grove to the south has been converted to houses and retention ponds

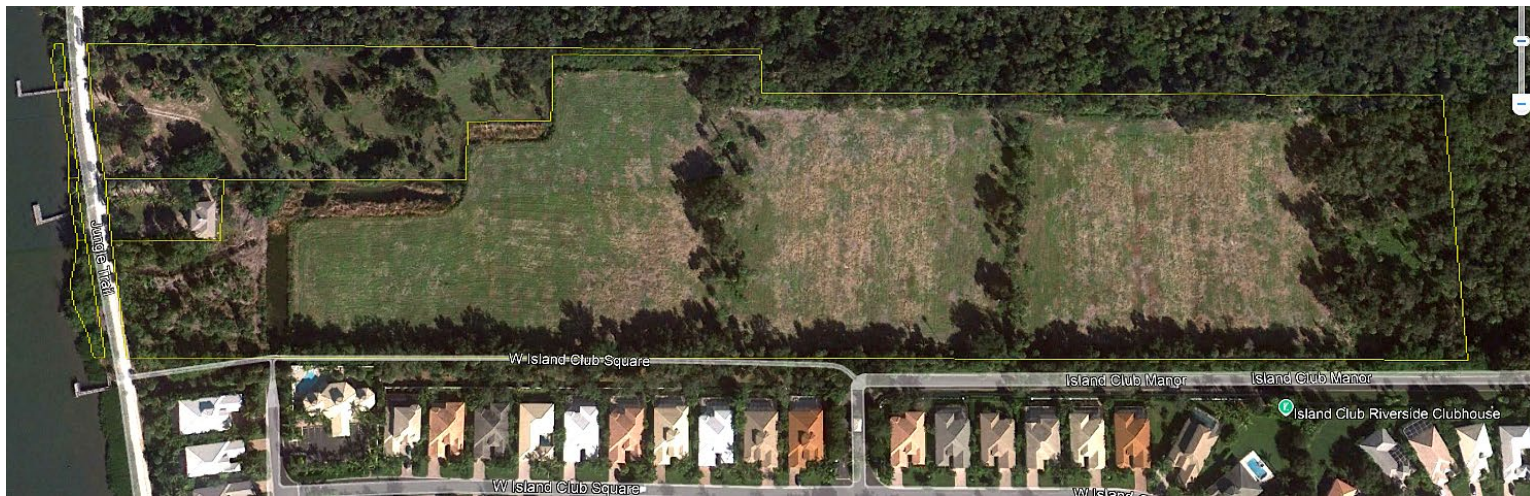
2010 Aerial Photograph

- The entire fallow citrus grove onsite has been cleared and mowed; all woody species have been removed
- Portions of the linear north south forested areas in the former citrus grove have been removed and the tree canopy thinned
- The forested area west of the former citrus grove and south of the existing house (Skiscim property) has been thinned and there is a 78m long east-west ditch apparent that runs from the series of borrow pits to the Jungle Trail road
- The forested area in the eastern portion of the site appears relatively undisturbed (as well as, in the 2017 aerial)

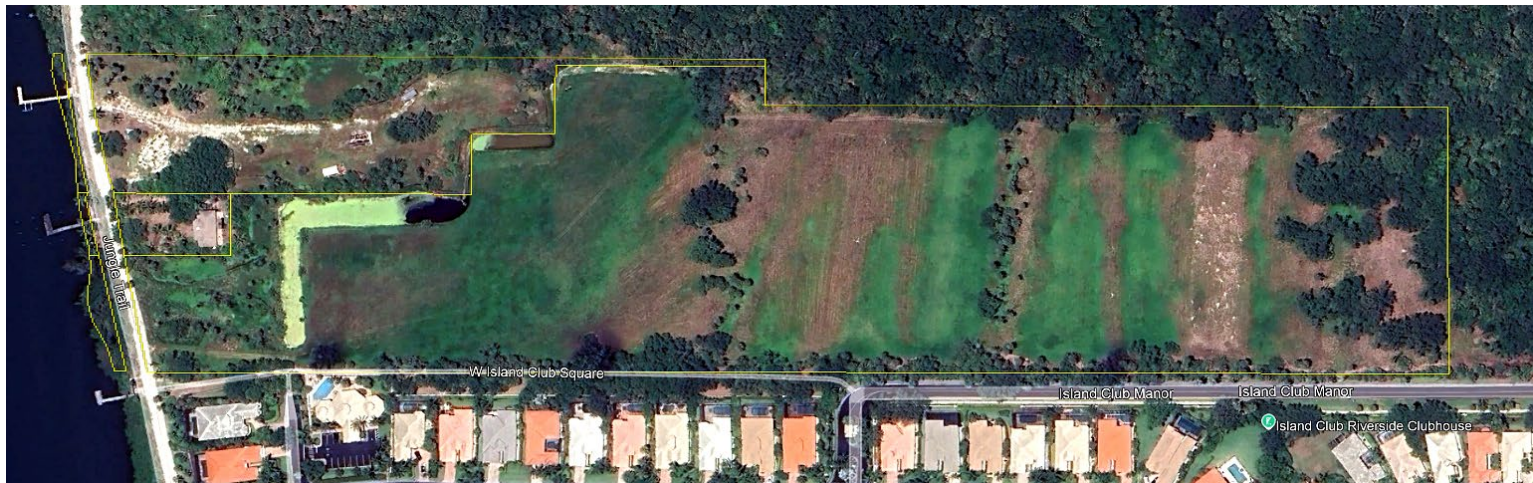
2024 Aerial Photograph

- The north south linear forested areas in the mowed area (former citrus grove) have been thinned and cleared of about half the trees (live oaks and cabbage palms remain)

- Vegetation in and around the borrow pits has been cleared and the pits may have been deepened, some new fill visible on the Fischer property, the “pits” form a continuous zig-zag channel that totals more than 330m in length and some segments are up to 12m wide

- The forested area west of the former citrus grove has been mostly cleared, some ditches and a woods road along the southern boundary are visible
- The forested area on the eastern boundary has been cleared of some large trees and bare ground is visible (live oaks and cabbage palms remain)

- In the mowed areas (former citrus grove) there is a band of exposed soils/ground near the east end, possibly a drier soil or remnant dune
- In the mowed area some wetter areas are visible, one is west of the band of exposed soil
